# PROACTIVE INSPECTIONS REPORT

## Activity Report

FINANCIAL YEAR 2023-24

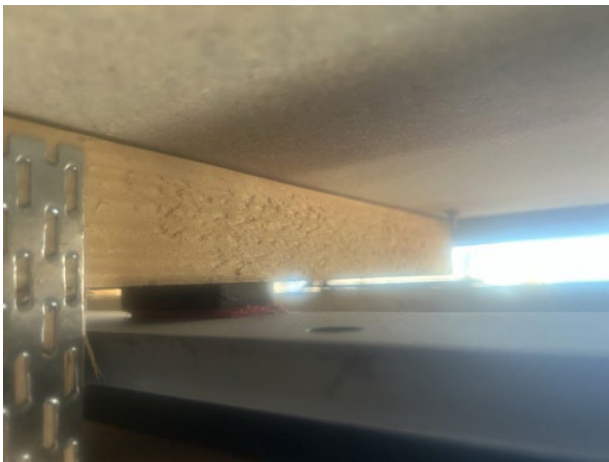
Inadequate packing under top chord support and floor trusses were not fully bearing, contrary to the manufacturer's installation guide.

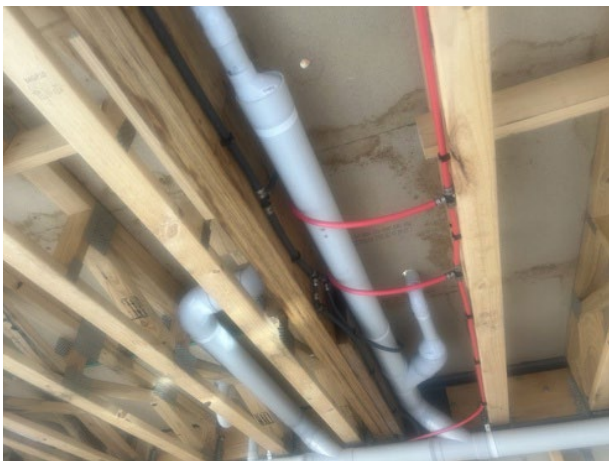
Strong backs were not supported at the ends by walls or intersecting beams, as required by the manufacturer's installation guide.

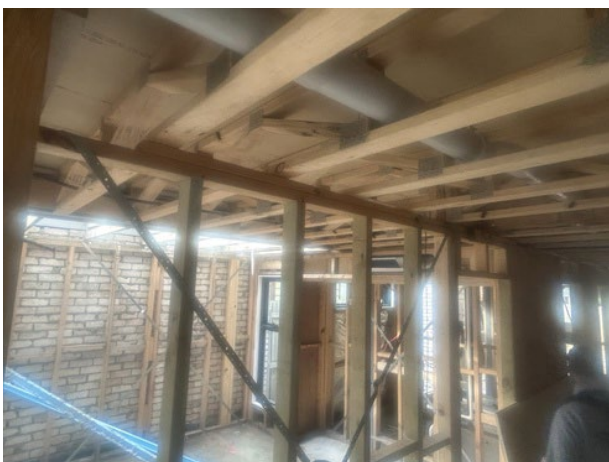
Floor truss (supported by internal wall) had no vertical web provided at the load point. Also, no strong backs were provided to the front section of the dwelling.

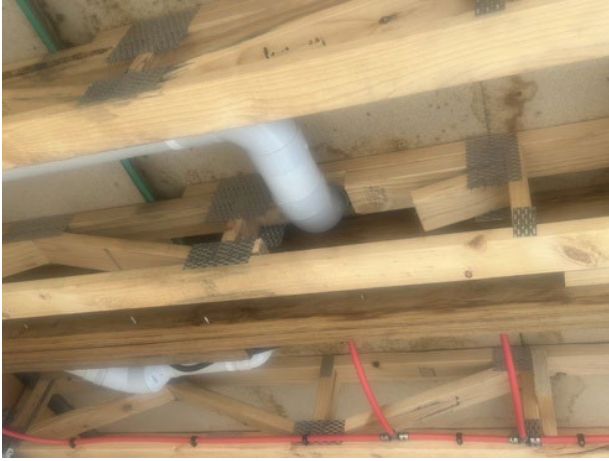
Floor truss webs were cut to allow for plumbing services.

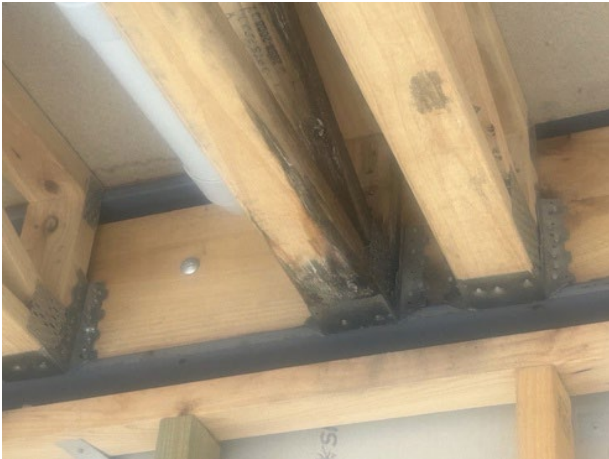
Various floor trusses had significant signs of degradation due to exposure.

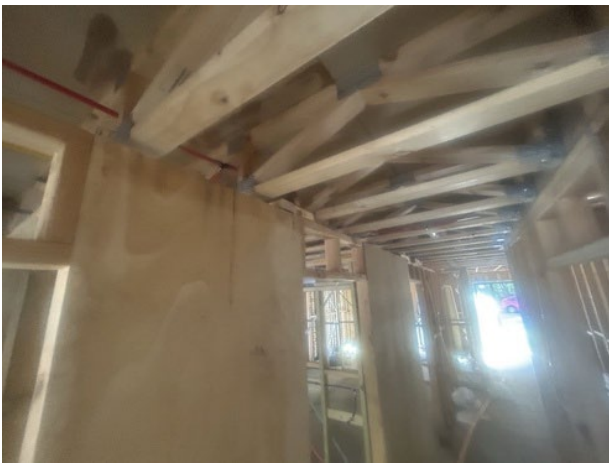
Internal braced walls were missing shear blocks, contrary to AS 4440 – 2004 Clause 2.2.3.

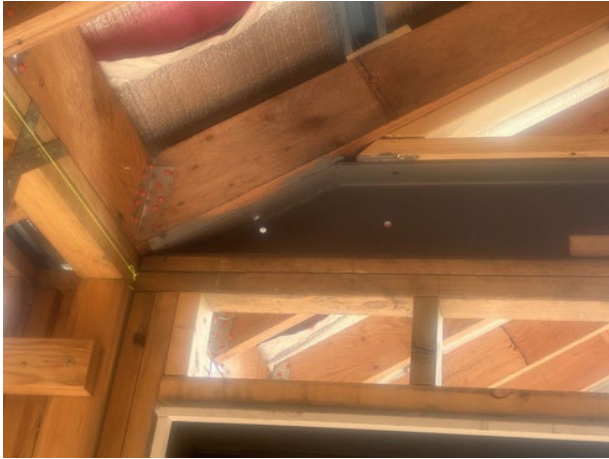
Chamfered steel beam had no stiffener installed where the chamfer begins.

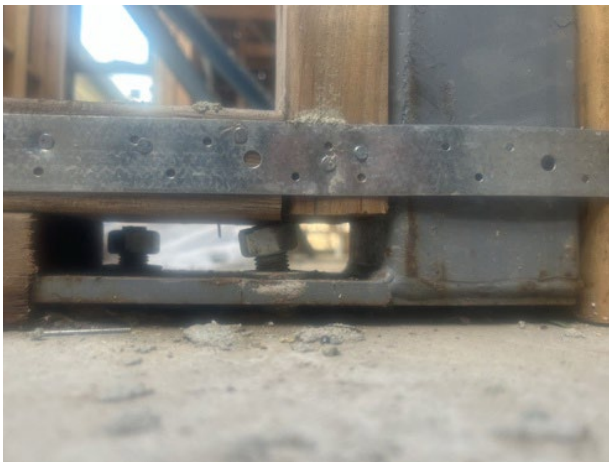
Where steel column base plates are bolted to the slab, various bolts were not tightened throughout.

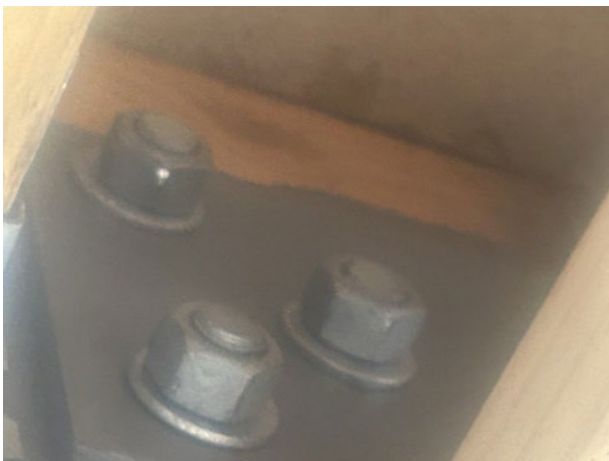
Bolts did not adequately pass through nut (currently negative pass), contrary to AS 4100 Clause 14.3.6.1.

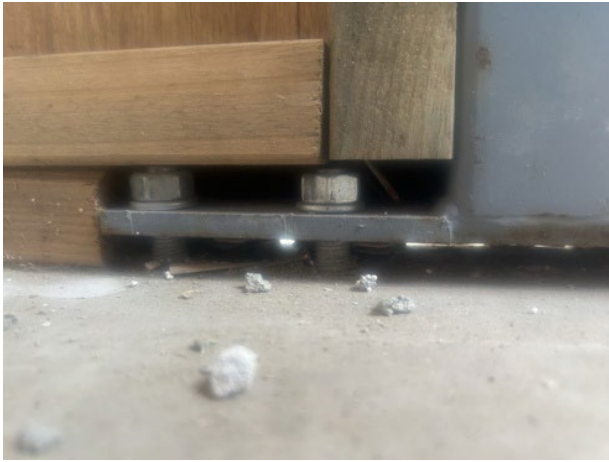
Cavity between steel column baseplates and slab were not fully packed/filled, and column was not fully bearing on slab.

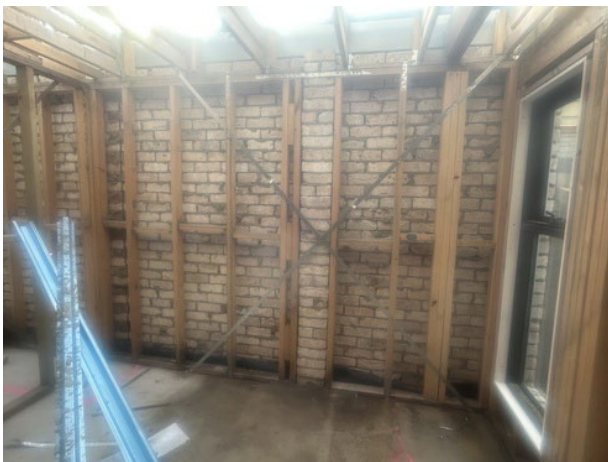
External walls did not have a pliable building membrane installed.

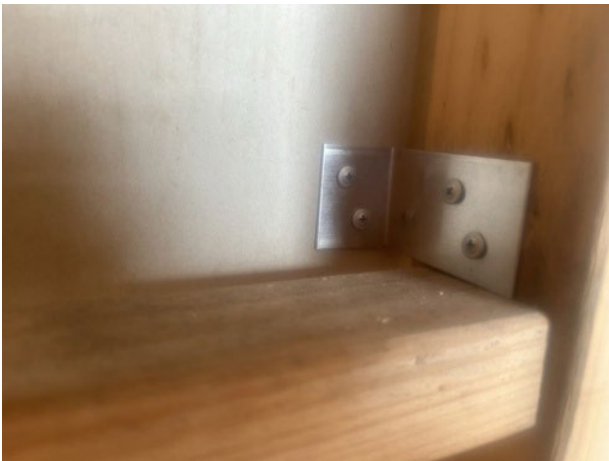
Aluminium clips were fixed directly to shaft liner panels, contrary to the manufacturer's installation guide.

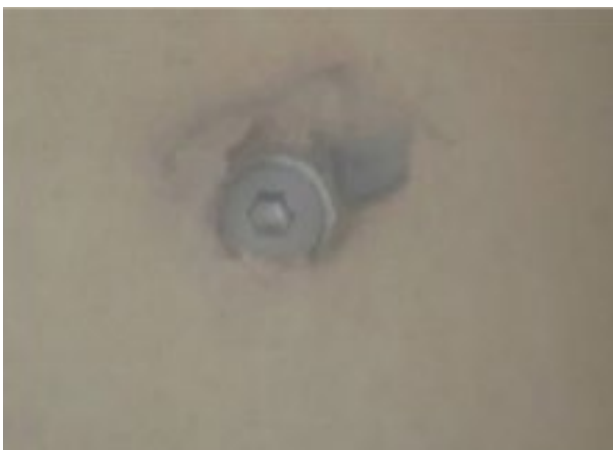
Lamination of fire shield uses a combination of nails and batten screws, contrary to the manufacturer's installation guide. Nails penetrated the entire way through the party wall system.

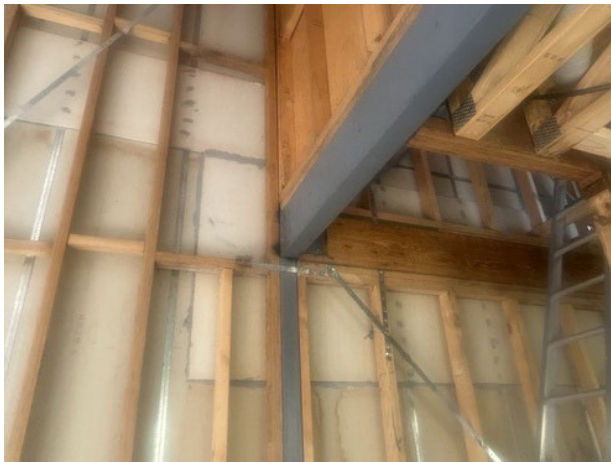
Clips were not installed on both sides of party wall, contrary to the manufacturer's installation guide.

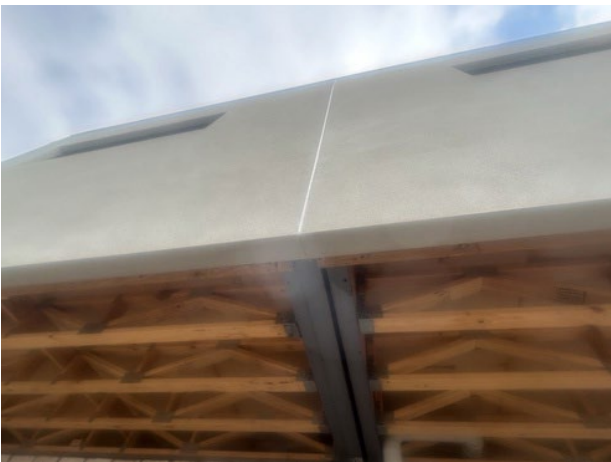
EPS cladding spanned across the face of the dwelling junctions compromising the required FRL 60/60/60.

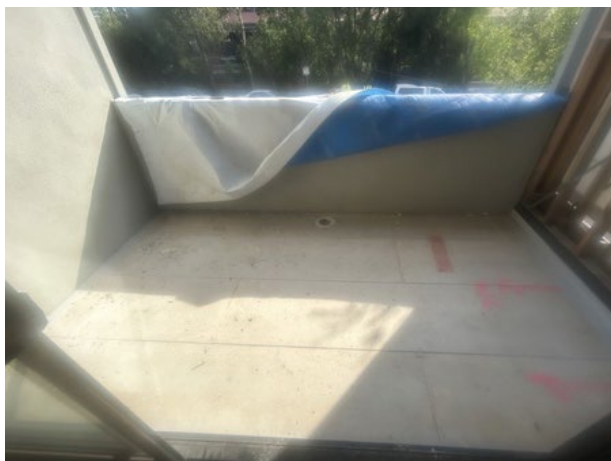
An overflow provision was not installed, contrary to AS4652.2-2012 Clause 2.11. The installation of the substrate was not in accordance with the manufacturer's installation guide.

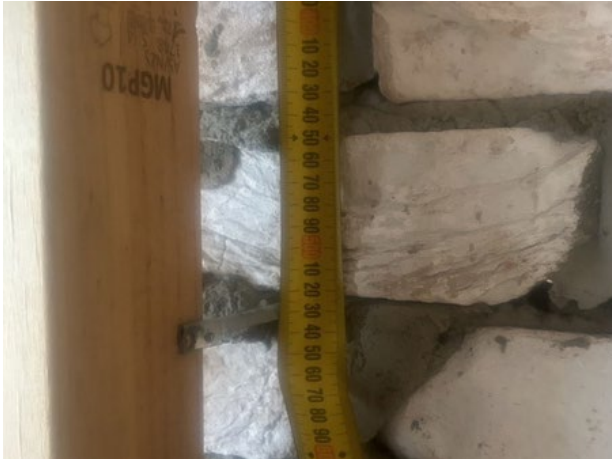
Fixing of wall ties to brickwork exceeded 400mm vertical cuts, contrary to NCC 2019 Vol. 2 Part 3.3.5.10.

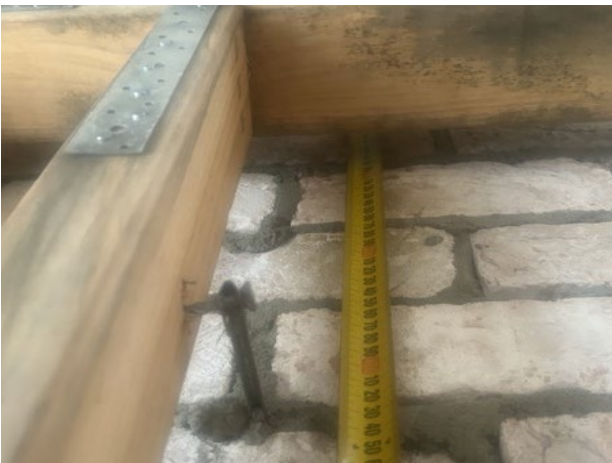
Placement of wall ties at the top of the wall were not within two courses of the top of veneer, contrary to NCC 2019 Vol. 2 Table 3.3.5.3b.

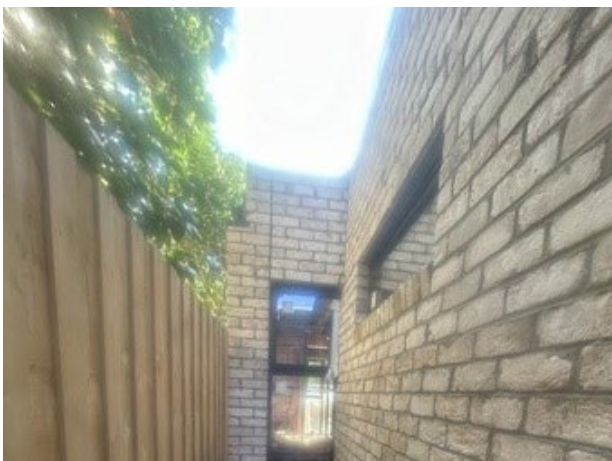
Sill flashings were not installed to the 'openings', contrary to AS 4773.2-2010 Clause 9.6.2.2.

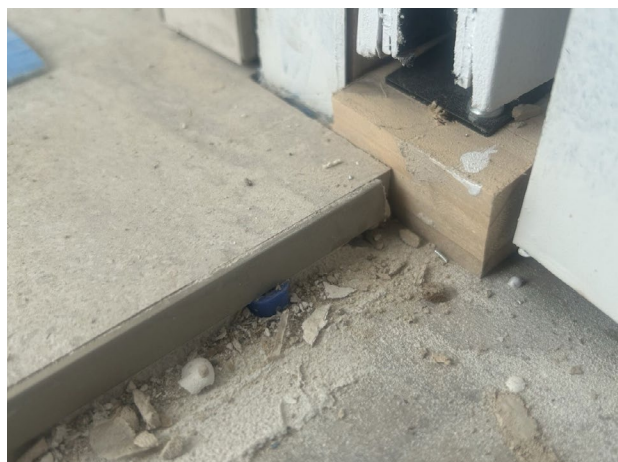
- Waterstops (including at cavity sliders) and perimeter flashings in all wet areas were incorrectly installed, contrary to AS 3740-2010 Part 3.9.1.2; perimeter flashings were not completed at the thresholds and the vertical leg of the waterstop terminated below the finished level of the tile.
- Waterstops and waterproofing at the extremity of the shower areas were incorrectly installed, contrary to AS 3740-2010 Clause 3.13.5, and the shower membrane continued under the waterstop.
- Water ingress was occurring at certain sections of the basement, indicating a potential failure of the waterproofing system.
- The external Finished Floor Level (FFL) is less than 50mm below the FFL of the dwelling, contrary to NCC 2019 Vol. 2 Part 3.1.3.3.

Floor level openings where waterstops and perimeter flashings are incorrectly installed.

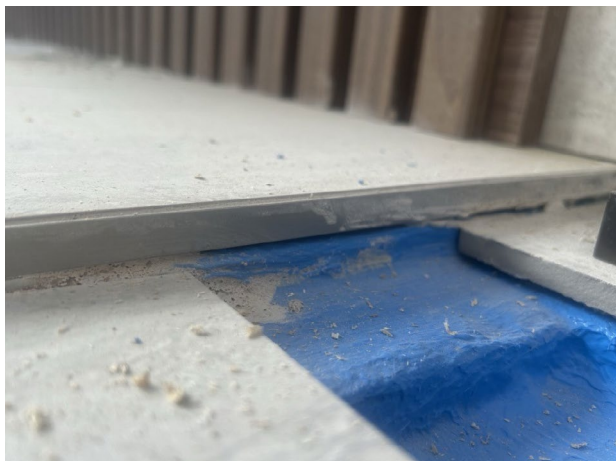
Shower extremity where water stops, and waterproofing are incorrectly installed.

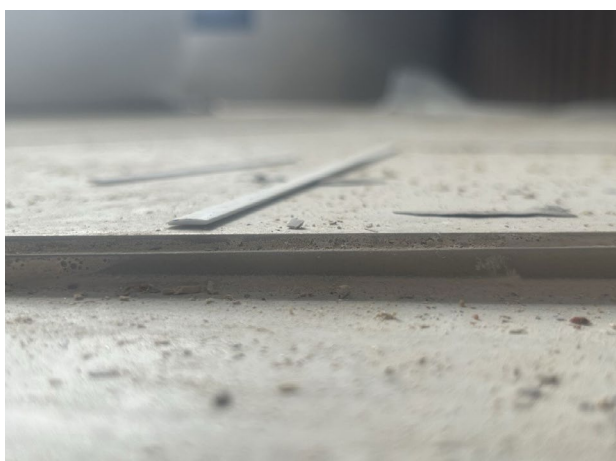
Vertical leg of waterstop terminating below finished tile surface.

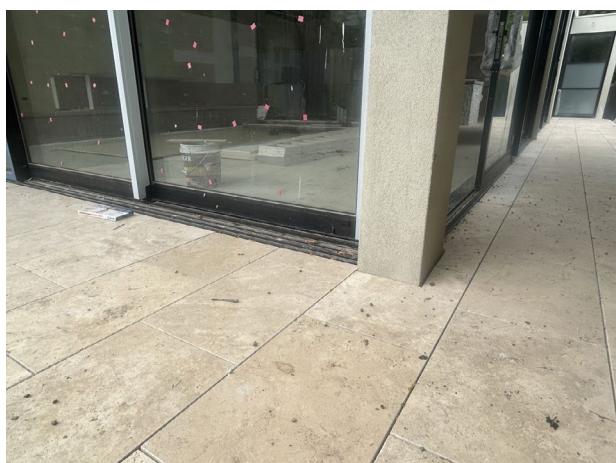
External FFL less than 50mm below FFL.

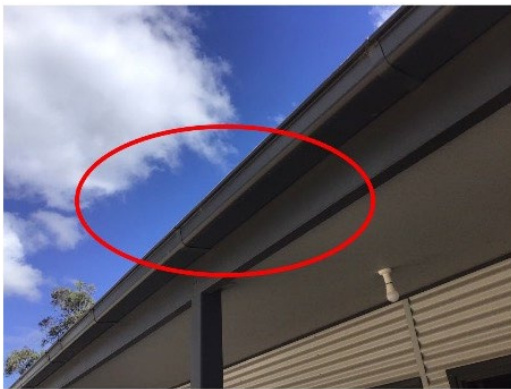
Eave gutters did not have overflow provision to prevent the entry of water into the dwelling in accordance with AS/NZS 3500.3:2021 clause 3.5.

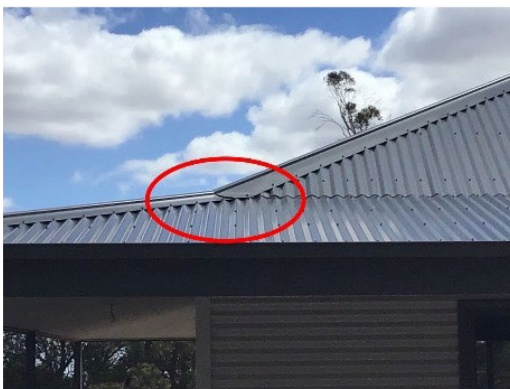
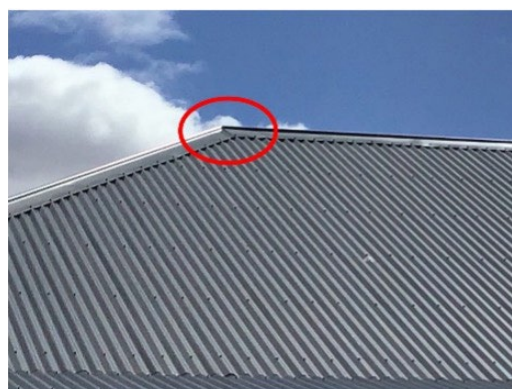
Soldered or silicone-sealed joints were not flush and lapped 25mm in the direction of the fall throughout the building in accordance with HB39-2015 Clause 5.8.1.
