# Proactive Inspections Program

## Activity report

October – December 2020

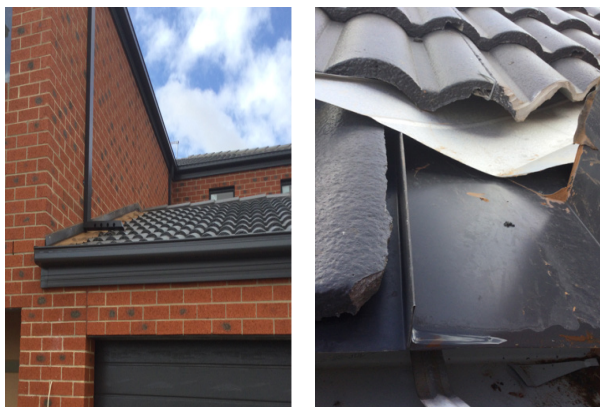
#### *Sanitary drainage systems issues*

A proactive inspection of a new single storey dwelling found multiple issues with the roof drainage plumbing work. Spreaders were terminating over flashings/cappings and discharging water onto roof sheets. Soaker gutter upstands were undersized (must be 100 mm minimum in height) and gaps in valley gutters were not sealed to the sheet metal. A VBA notification of medium-risk building activity sent to the builder prompted the rectification of the roof plumbing issues. The VBA closed the matter after receiving comprehensive photographic evidence of the rectified work.

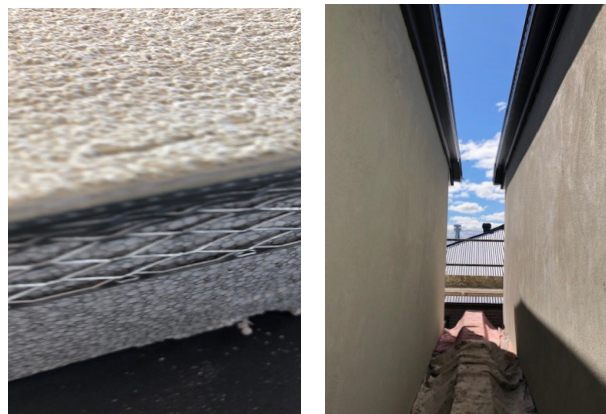
### Construction of a new class 1 dwelling

#### *Serious fire separation issue*

The proactive inspection carried out after the mandatory frame stage inspection revealed among other non-compliances that the external walls of two townhouses (located less than 900mm from one another) did not have the required Fire Resistance Level of (FRL) 60/60/60 and therefore did not comply with clause 3.7.2.4 of Volume 2 of the BCA. As a result of the significant risk letter sent to the builder, the combustible expanded polystyrene (EPS) sheeting was replaced with fire rated plaster and cement sheet cladding, thus achieving the required FRL of 60/60/60. This was a significant find as the relevant building surveyor (RBS) had already approved the frame inspection and was not aware EPS had been installed on the external walls required to have an FRL.

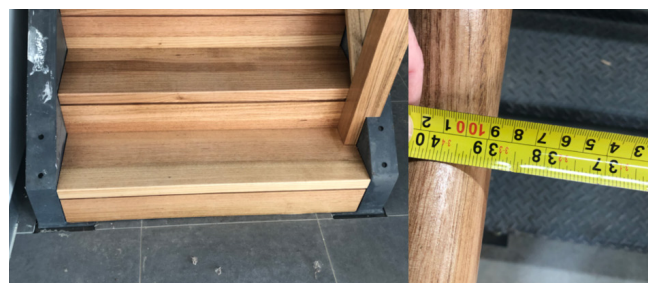
The stairs across multiple warehouses were not achieving the required 1m clear as required by the NCC 2016 Part D1.6. Provide evidence of how compliance is achieved.

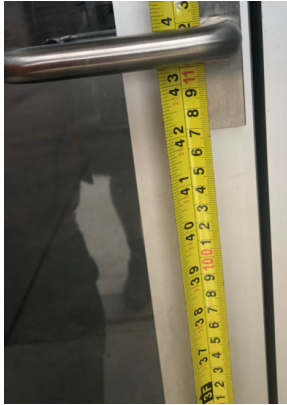
The door handles to the exit door have been installed above 1.1m in height contrary to the NCC 2019 Volume 1 Part D2.21.

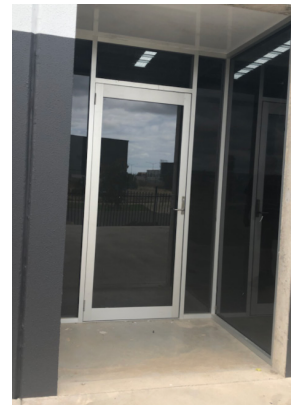
The doors leading to the factory do not provide the required door circulation space as per AS1428.1 – 2009 Part 13.3.1 and Figure 31.

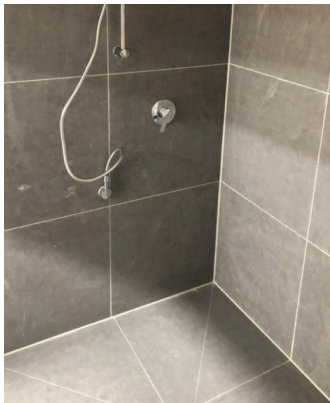
A folding seat has not been provided within the accessible shower as required by AS1428.1 Part 15.5.9.

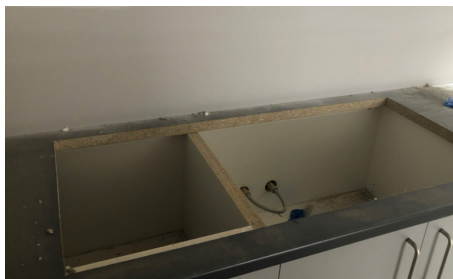
The works on site across both warehouses show the proposed installation of a sink within kitchenettes and wet areas without providing a water-resistant substrate as required by the NCC 2016 Volume 1 Part F1.7 and AS3740
