PRACTITIONER EDUCATION SERIES

# Proactive Inspections Program Findings: Buildings

# Common issues in timber framing

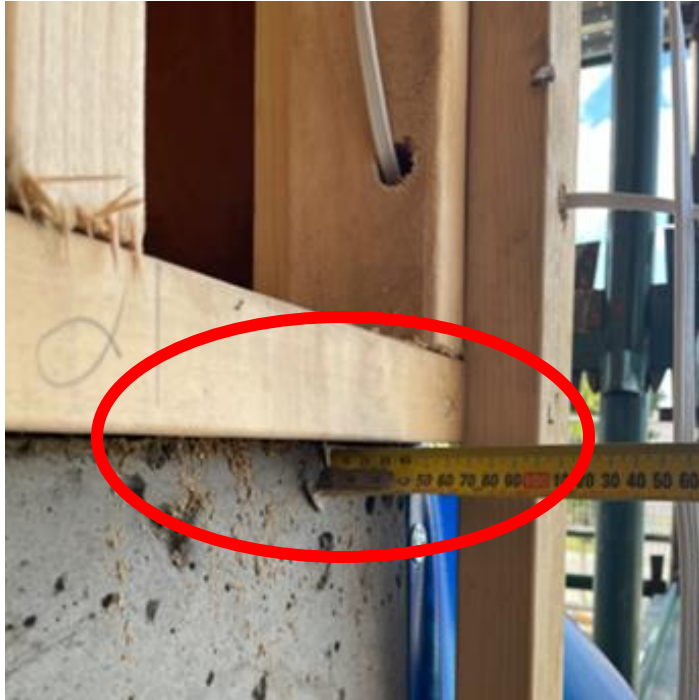
- Under AS1684.2 there are no prescribed allowance for timber frame overhangs.
- The Guide to Standards and Tolerances (currently under review) only allows a 90mm wide stud to overhang a maximum of 10mm
- Areas that exceed the allowed tolerance require a review from the relevant registered civil engineer to provide evidence that compliance with the NCC 2019 Volume 2 Part 2.1 is being achieved.

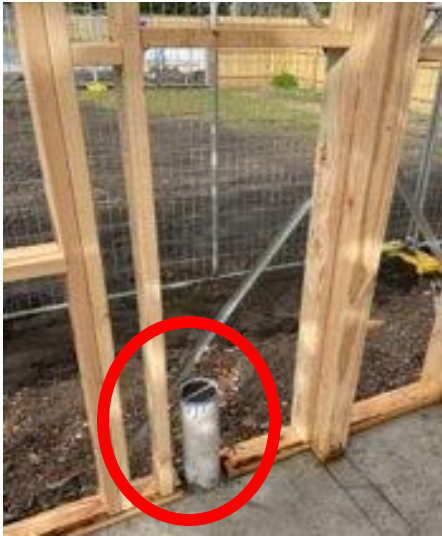
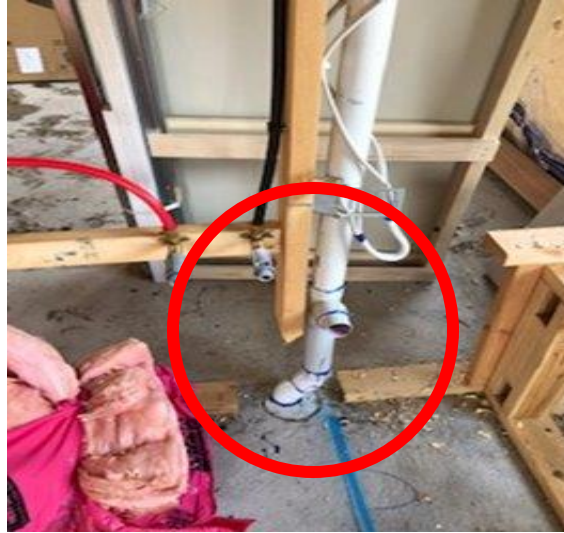
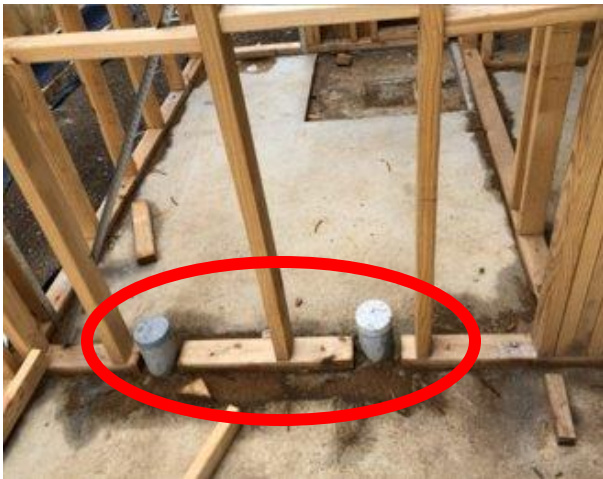
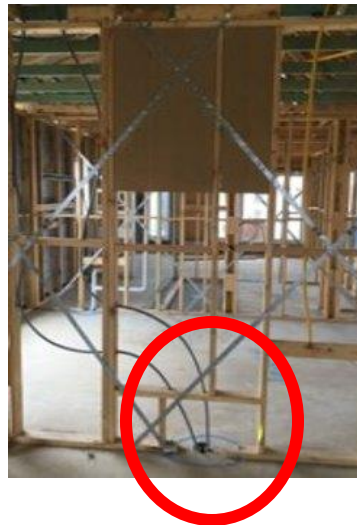
- AS1684 allows for a maximum hole diameter of 25mm on the face of the bottom plate.
- Part 6.2.1.4 must be followed.
- Where the notch exceeds this in a braced wall, consideration must be given to be Part 8.3.6 noting that sheet braced walls require a continuous bottom plate
- Studs are required to be evenly spaced and extend from the underside of the top plate down to the bottom plate.

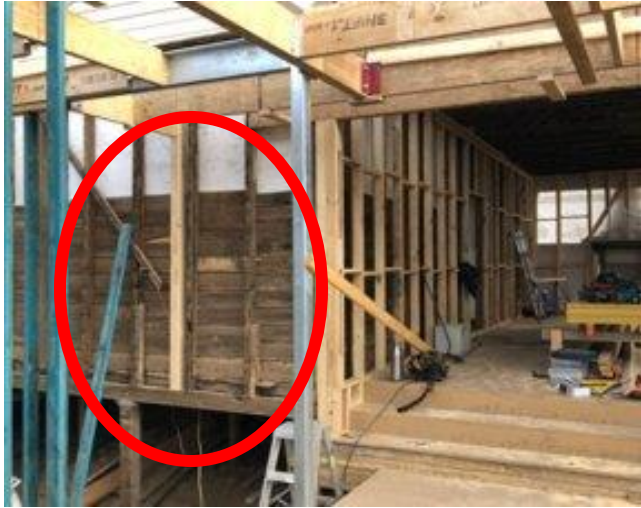
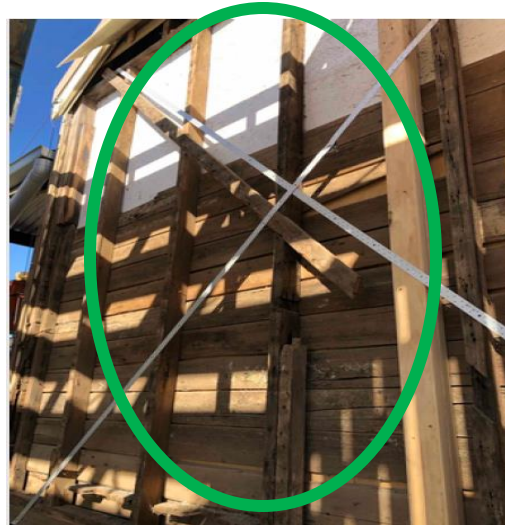
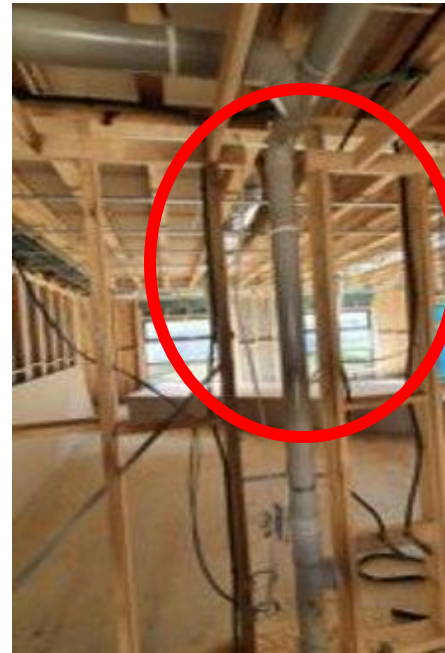
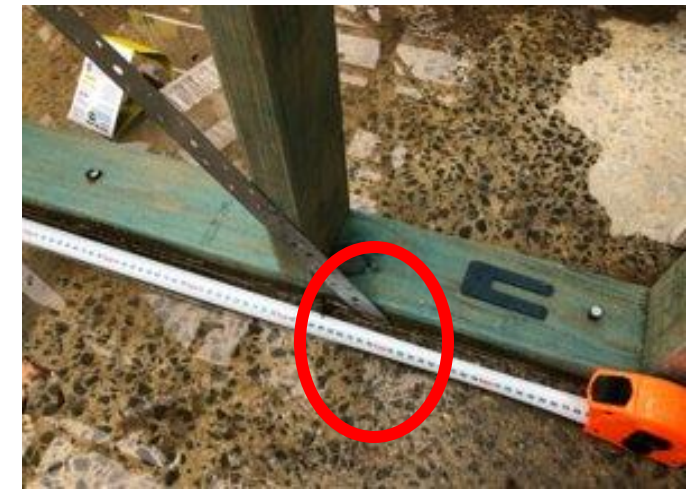
- Metal bracing is to span from the bottom plate to top plate. Where bracing is cut the wall no longer provides the design bracing capacity.

- Bracing above did not achieve the required 1800mm minimum span

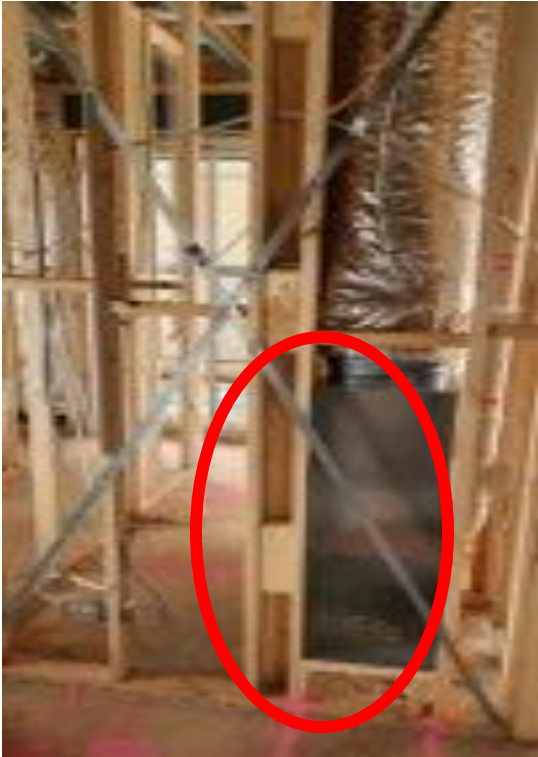
- When considering the location of braced walls, it is important to factor in the proposed services/fittings to ensure they will not be compromised.

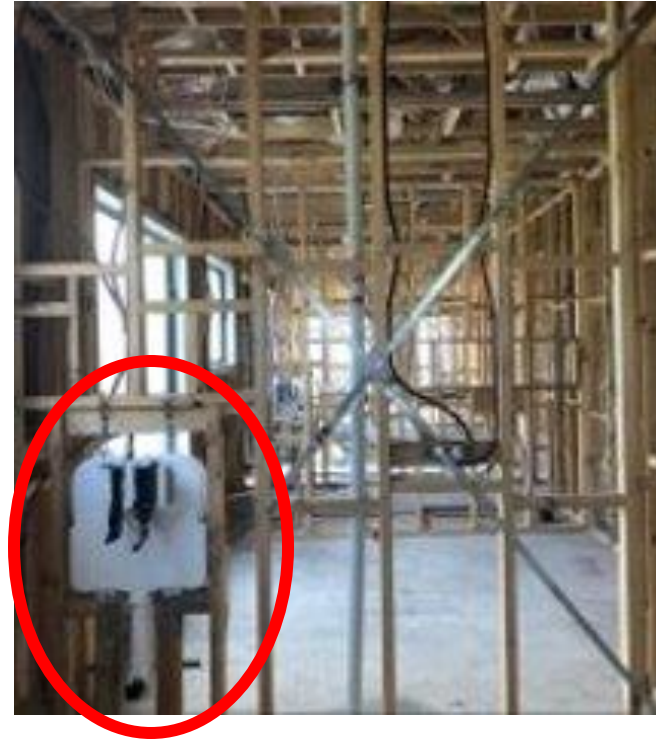
- Where bracing is cut to allow for ducting/toilet fittings the wall is no longer working towards providing the initial assumed bracing capacity.

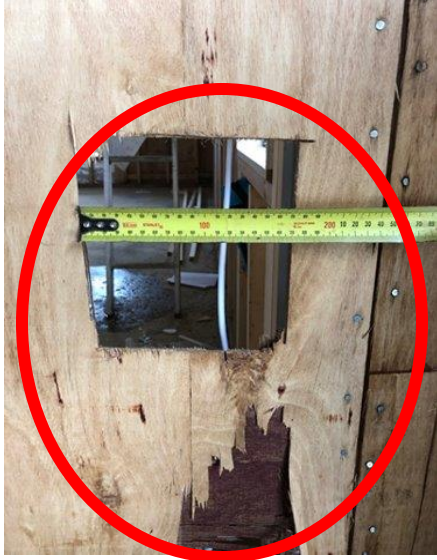
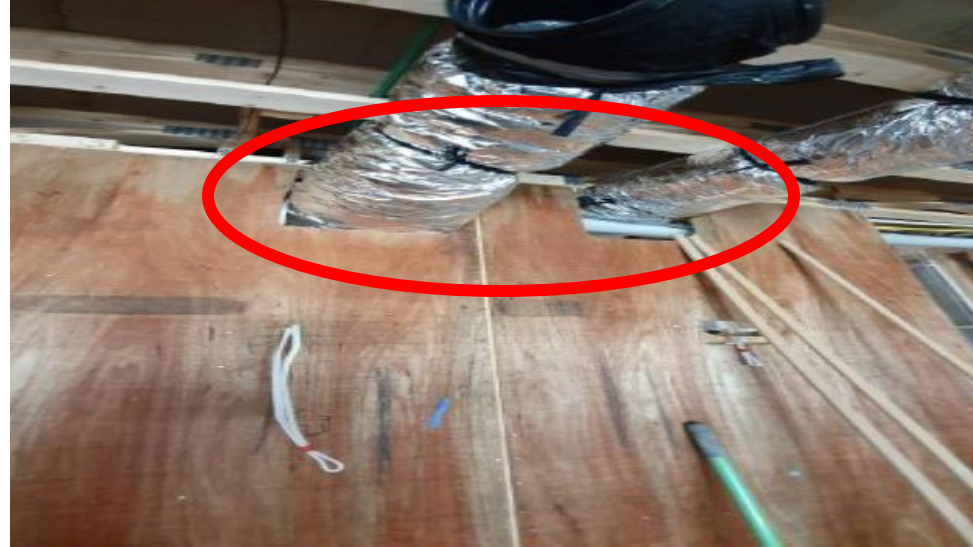
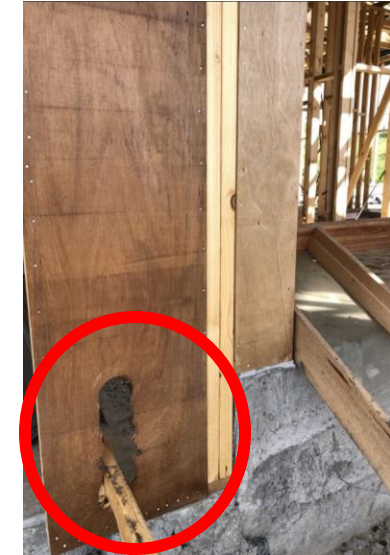
- Penetrations have occurred within the sheet bracing contrary to the manufacturers installation guidelines.
- It is critical to ensure that the manufacturers installation guides are being followed.
- Unless otherwise specified the sheet bracing must span a minimum of 900mm wide

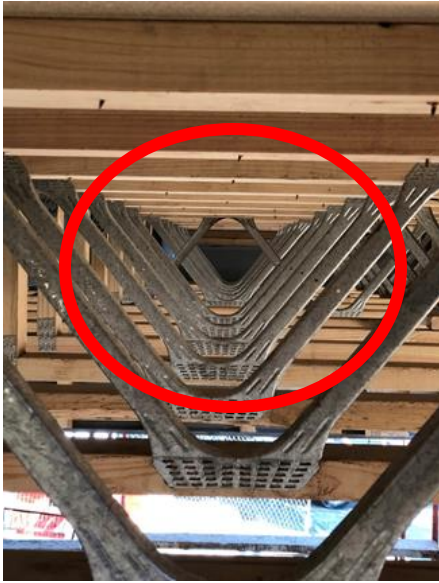
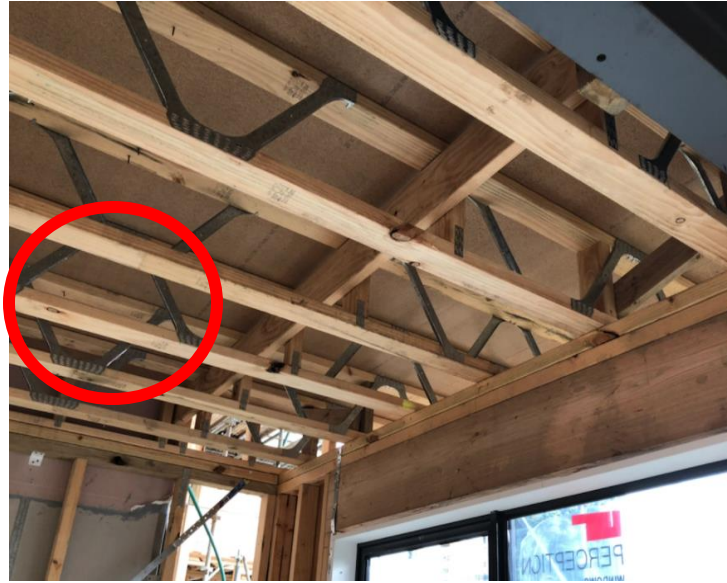
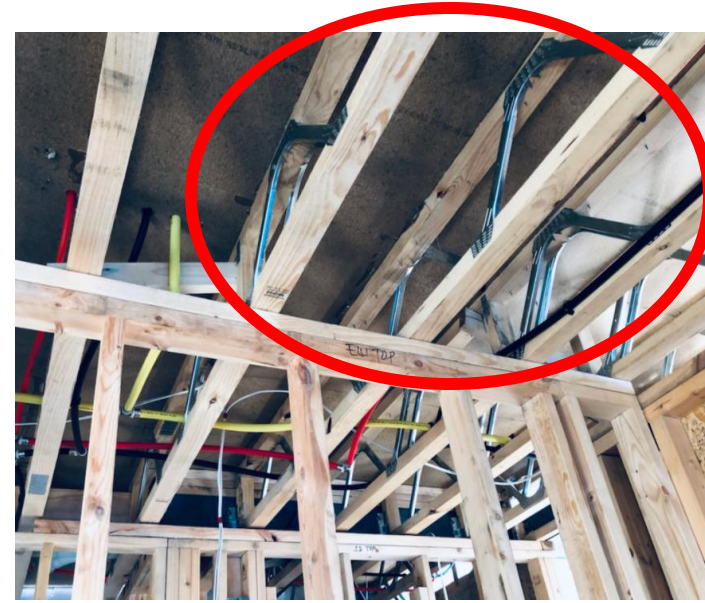
- The manufacturers installation guides must be followed so that they are installed the correct way up.
- Posi Struts require the web starts at the top chord at each support point unless clearly identified otherwise.

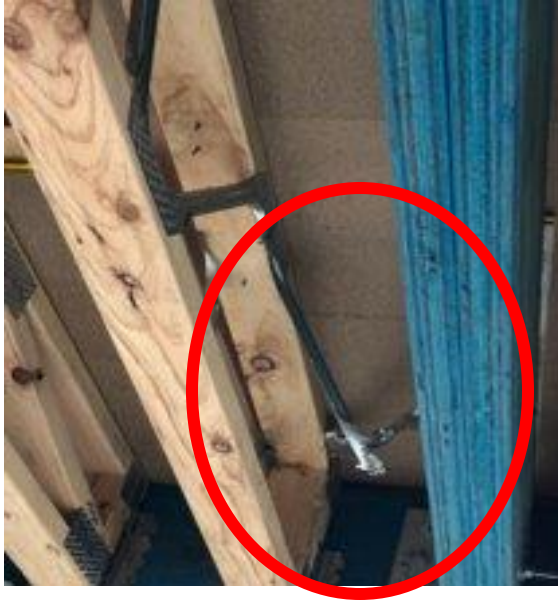
- Web of Posi Strut was damaged which required replacement

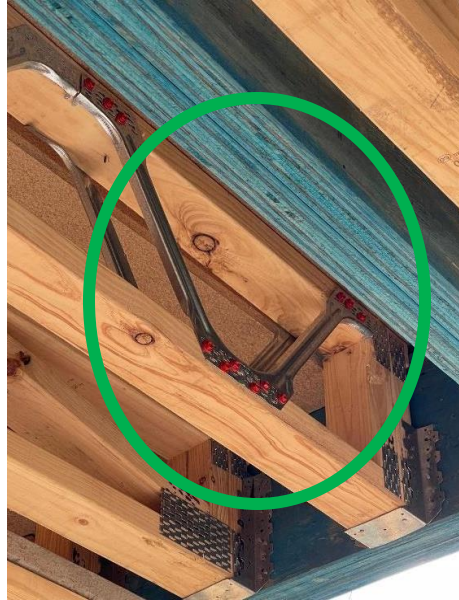
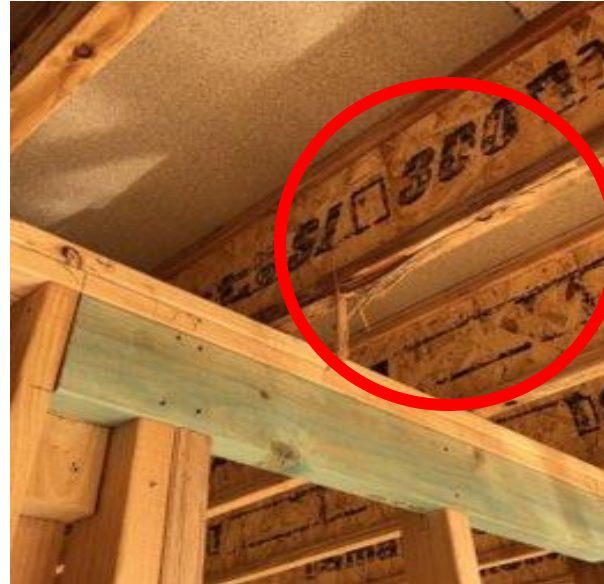
- Flange of Smart Joist was damaged. Materials should be good and suitable for their purpose for which they are used.

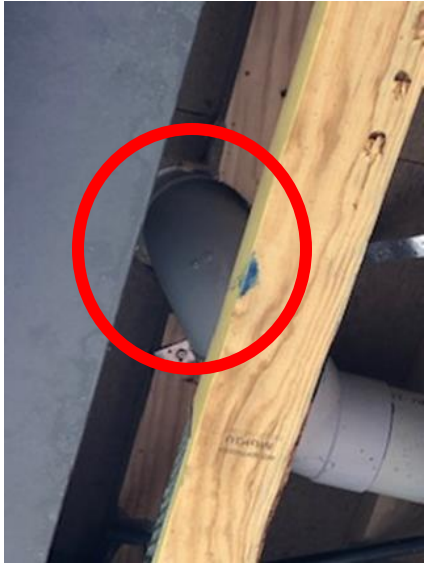
- Timber floor joist has top-chord and web notching to allow for plumbing pipe

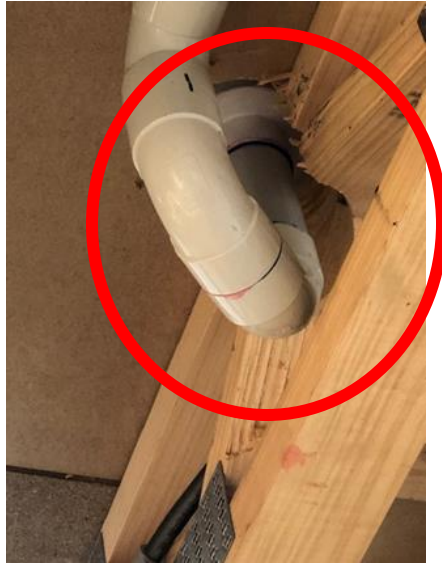
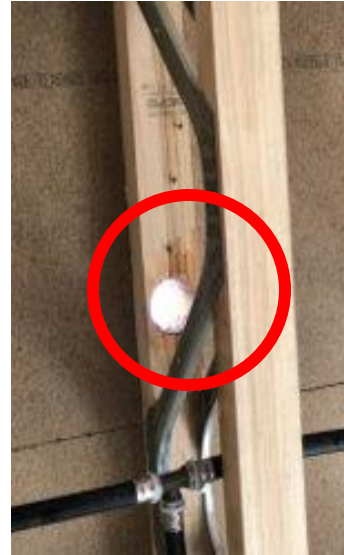
- Posi strut was notched resulting in a rectification design provided from the manufacturer.

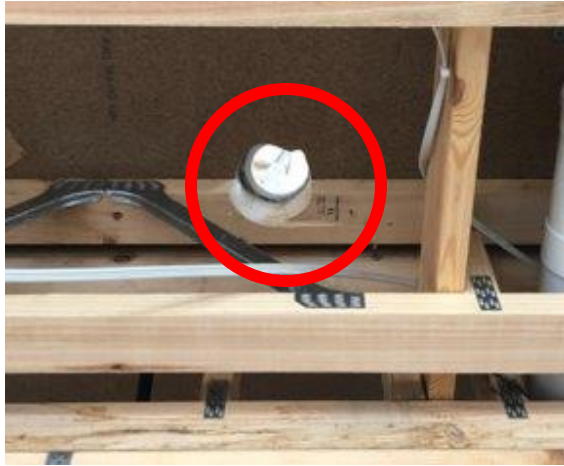
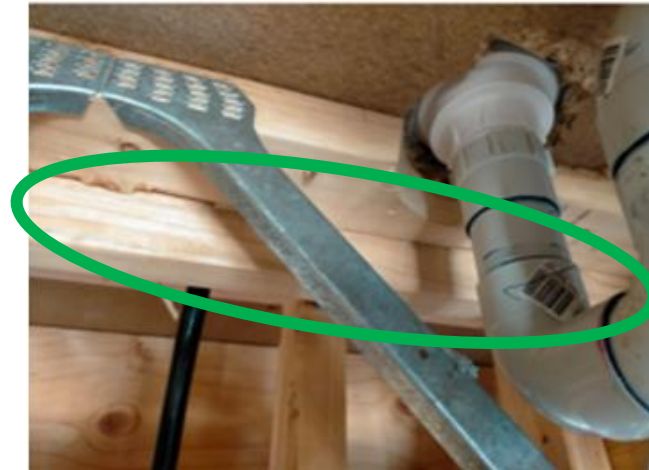
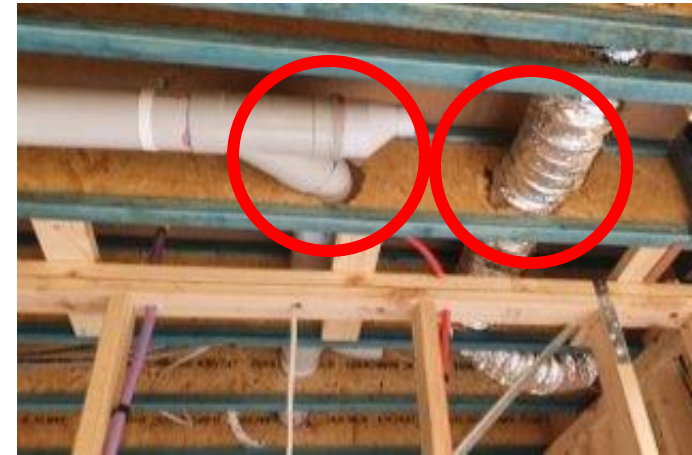
- Posi strut was penetrated resulting in a rectification design provided from the engineer

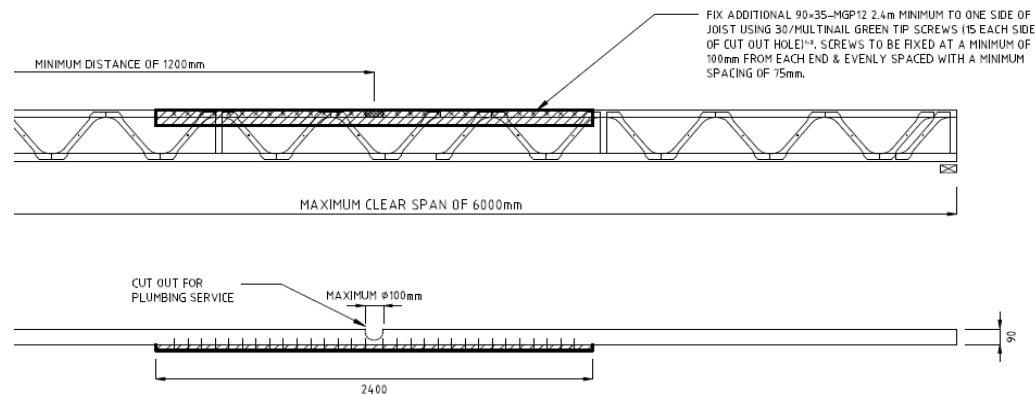
- E-Joists require cuts are neat and not within 5mm of the flanges.
- E-Joists require spacing of holes to be two times the width/diameter of the hole or 300mm (which ever is greater)

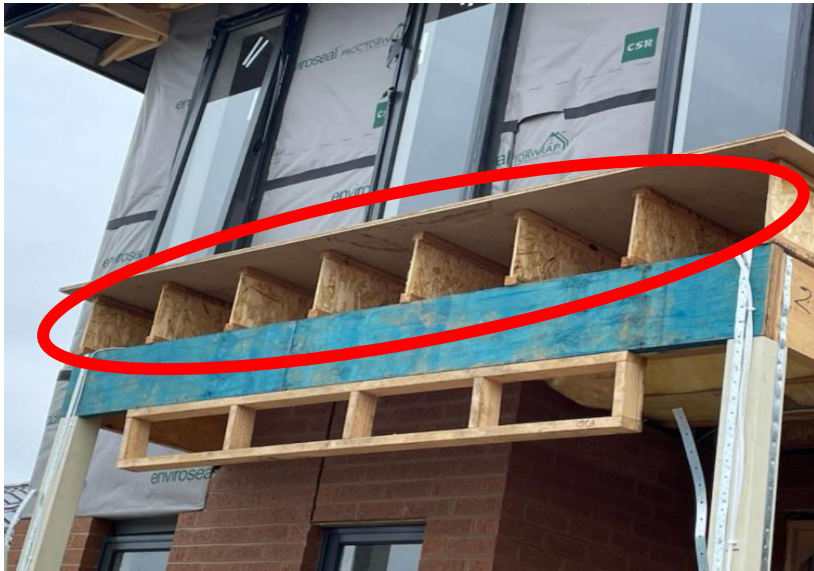
- Blocking not installed to end joists.
- Blocking to be installed at maximum 1.8m centres.

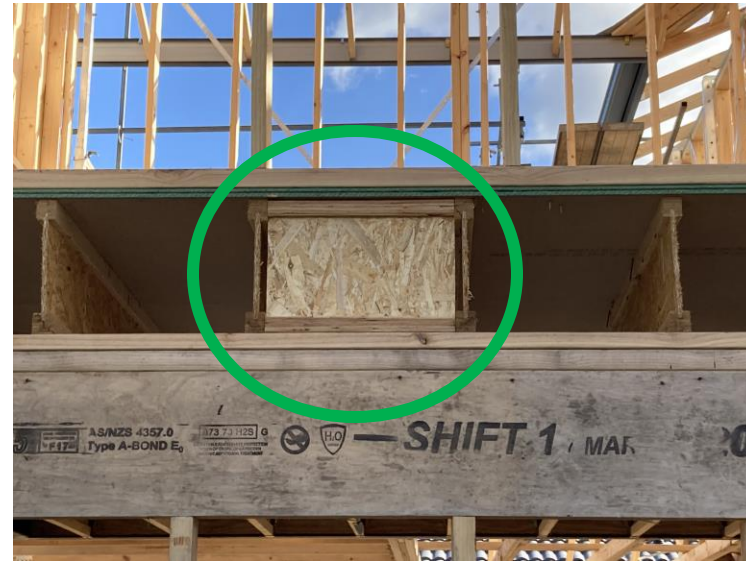
- Blocking provided at 1.8m centres.

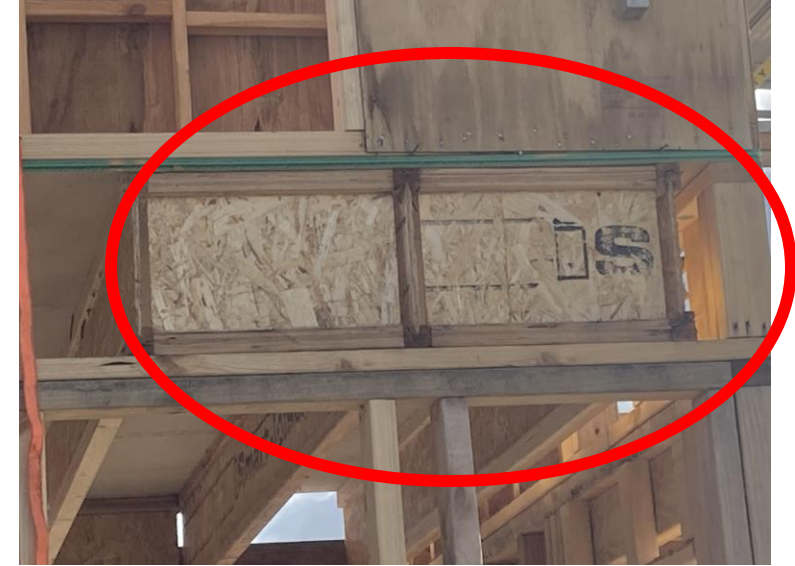
- Blocking provided but bracing straps to complete the tie down have not yet been provided for the braced wall.

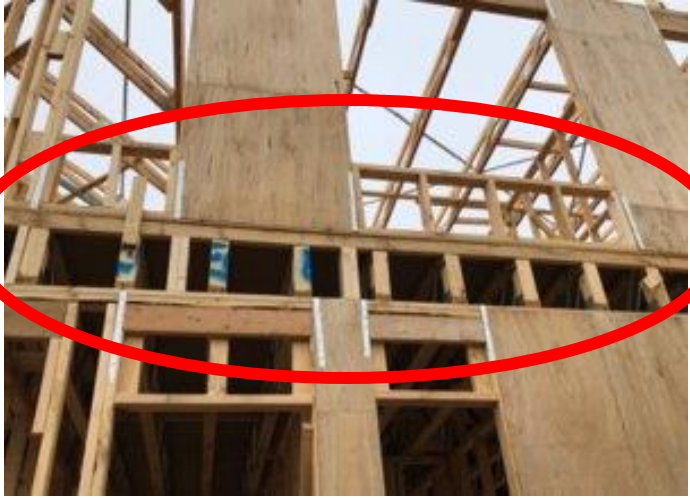
- No end support bracing provided.
- Timber diagonal blocking required at 1200 centrs.

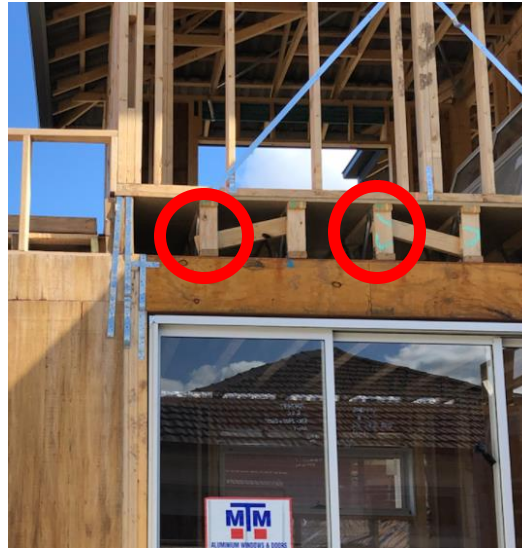
- Timber diagonal bracing provided at 1200mm centres however no Trip-L-Grips were not installed. Required to have at least one per braced panel.

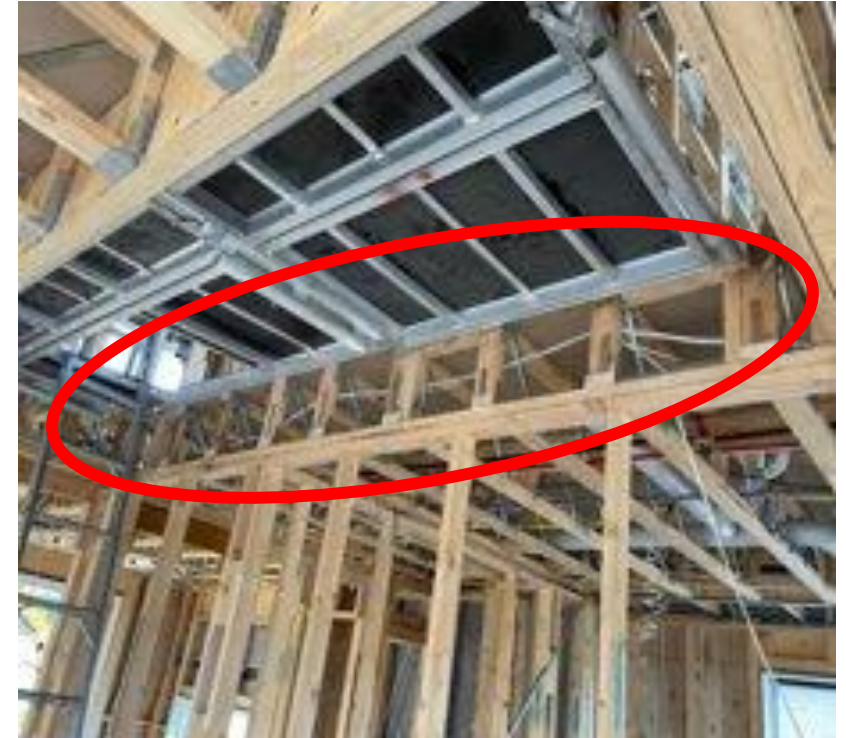
- No internal end support bracing provided
- Trip-L-Grips are required if using speed brace or diagonal timber bracing.

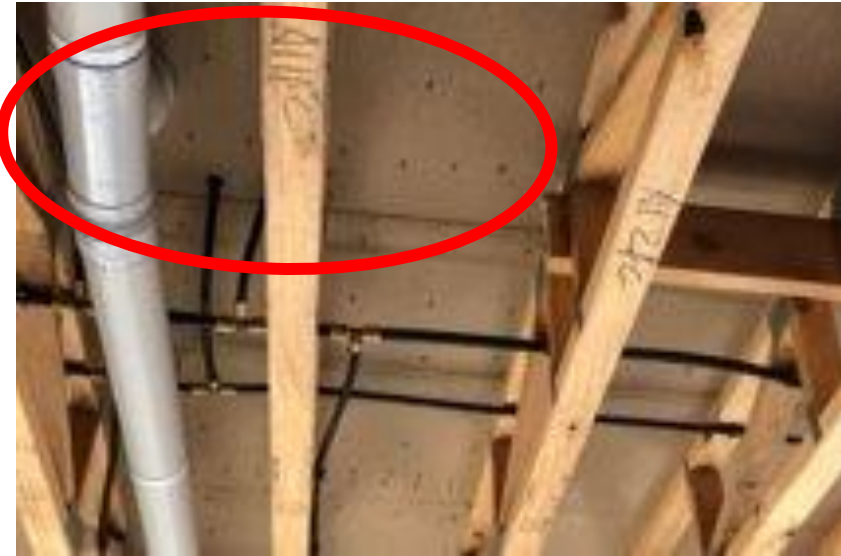
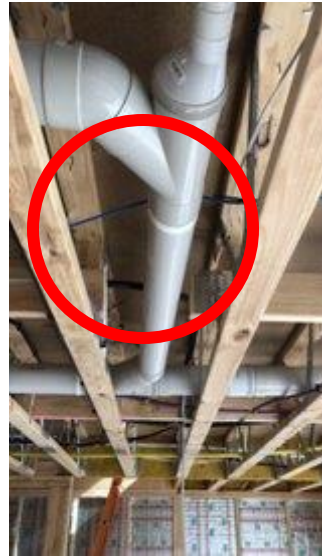
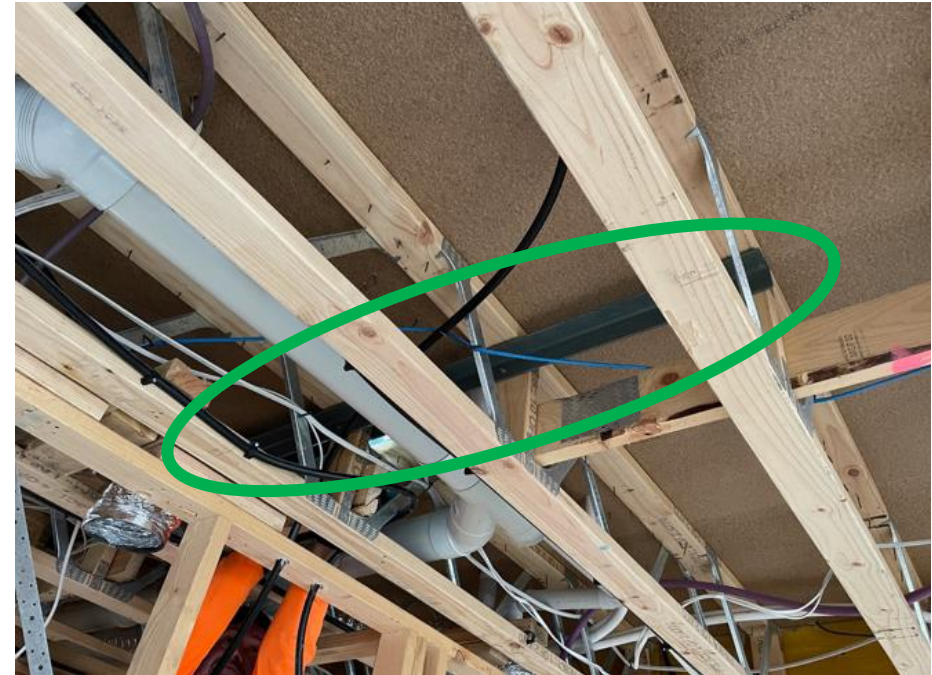
- Inspection identified strongback had been cut to allow for plumbing pipe

- Metal L-Bracket installed across 3 joists as per engineers rectification design and certification process

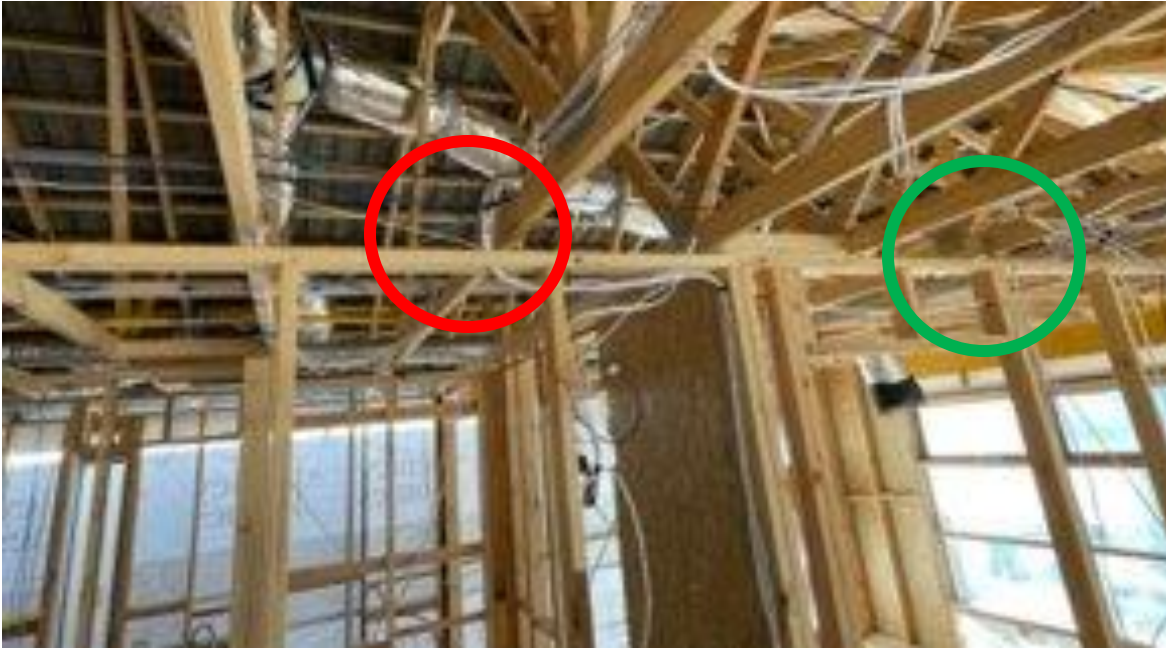
- Slotted L-Brackets not installed at 1.8m centres (internal non-loadbearing).

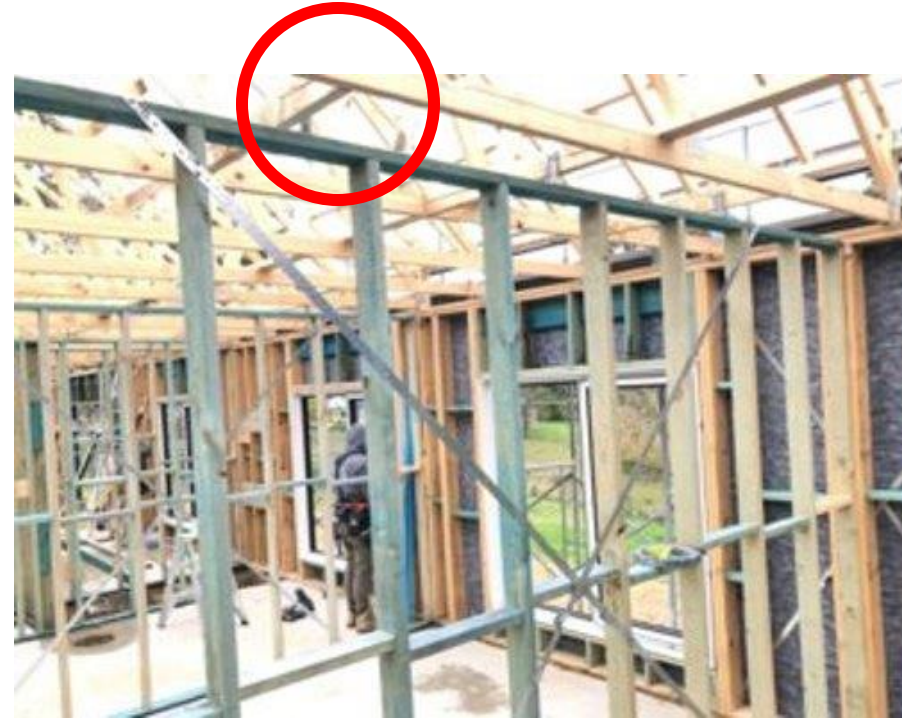
- No shear blocks installed to internal non-loadbearing braced wall.
- Refer to Table 8.22 for various methods

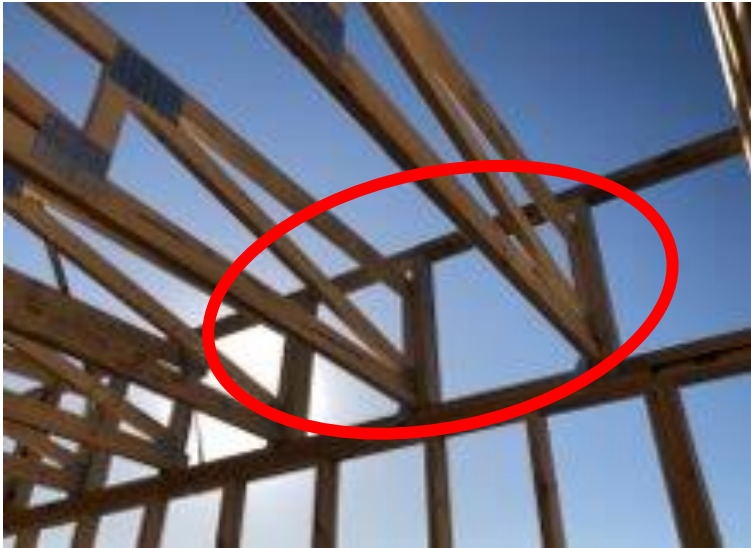
- No bracing to the ends of cut-off/half trusses

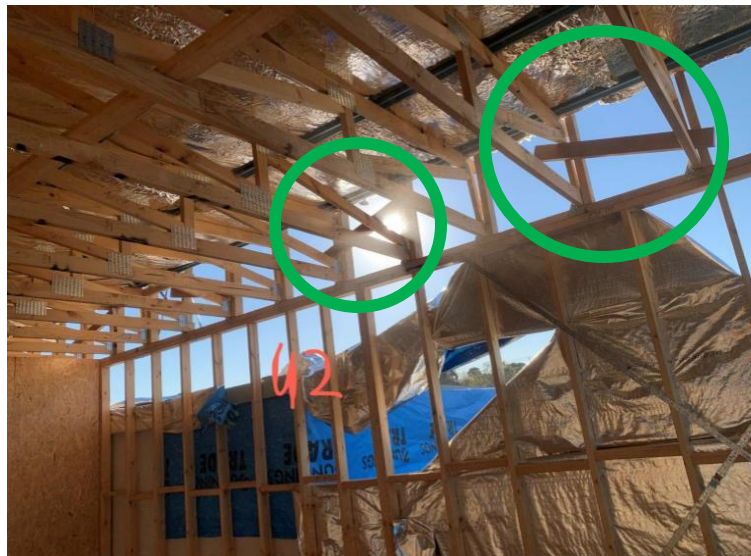
- Timber diagonal bracing installed to cut-off/half trusses
  - Speed bracing installed to half trusses
  - Blocking and fixing not provided as per manufacture's details

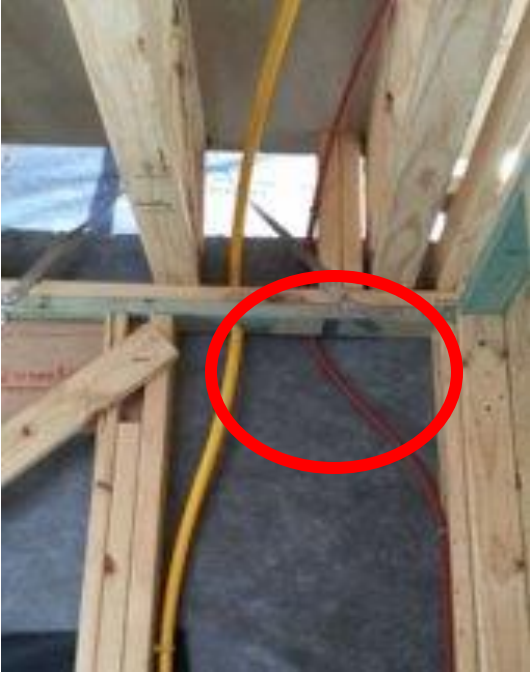
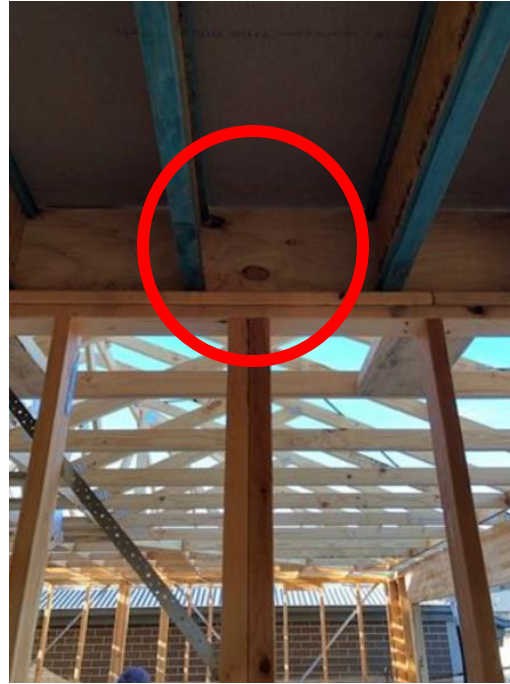
- Blocking not provided with double studs to transfer the concentrated loads through the structure.

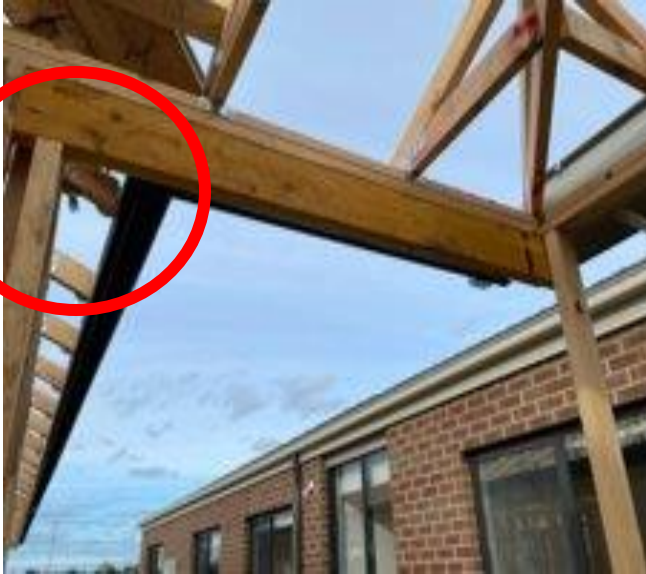
- Double studs/jamb studs required to ends of lintels

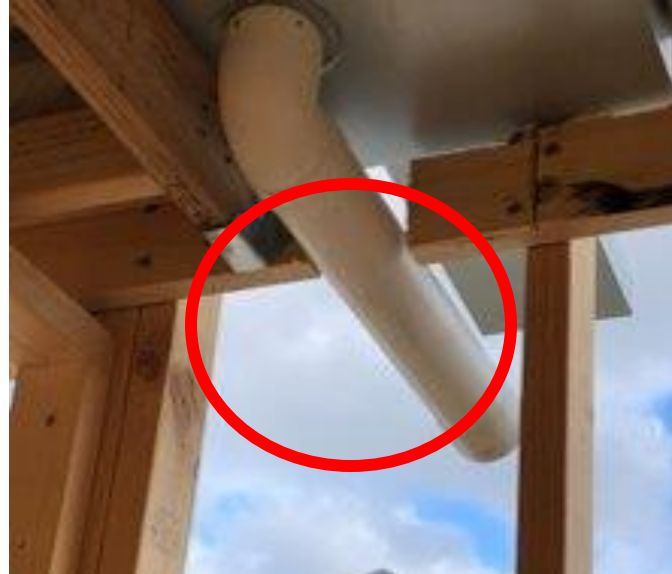
- Waling plate cut.

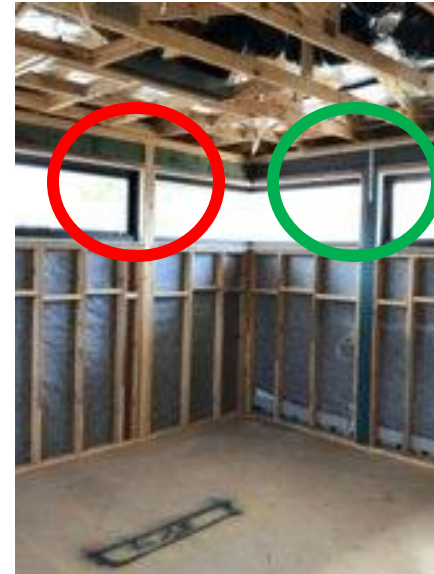
- Tie downs at jamb studs.
