# Proactive Inspections Program

## Activity report

January - March 2021

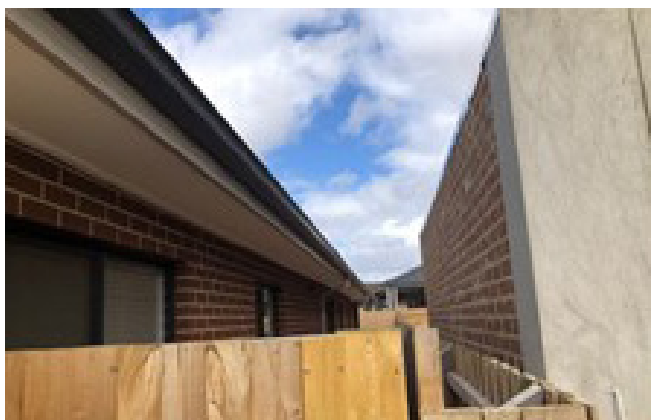
A proactive inspection of a new single storey dwelling revealed the garage wall had been constructed on the allotment boundary in lieu of a required setback of one metre in contravention of the Victorian Building Regulation 82. The dwelling on the adjoining allotment had a north facing windows located within 3m of the boundary.

A medium risk letter was sent to the builder and RBS and building permit documents requested from Melton Council. On receipt of the building permit documents it was apparent that the draftsman, who was also the builder had provided false information to the RBS, noting on the plans the habitable room windows as non-habitable. The RBS issued a building notice to the builder/draftsman who is under investigation for a breach of Section 246 of the Building Act (1993).

**Garage wall constructed on the allotment boundary.**

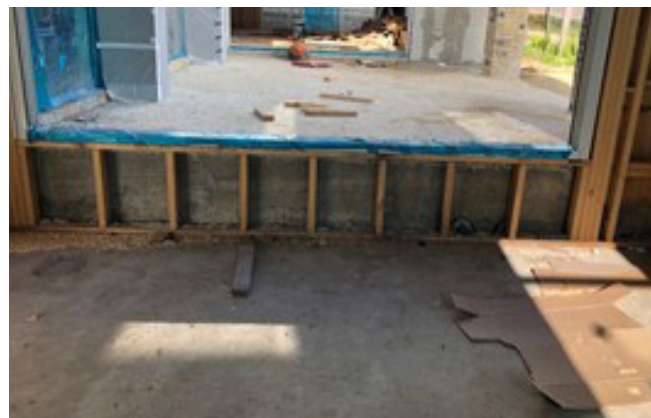
Uncovering this issue was particularly significant as the RBS had carried out

the mandatory frame inspection and the non-compliance was not identified, (the final inspection was also unlikely to have identified the issue). As a result of the PIP inspection and subsequent medium risk letter sent to the RBS and builder, a performance solution was formulated and approved by the RBS.

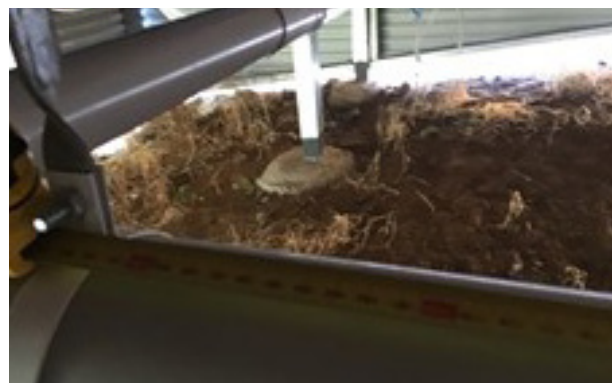
A proactive inspection of a single storey dwelling, in the Shire of Indigo, observed multiple sanitary drainage issues (among other non-compliant plumbing work) which included, a suspended sewer without the appropriate support, a below ground stormwater drain without the appropriate bedding/side support material, an above ground PVC stormwater pipe unsupported at the appropriate intervals, and the fitting used for the installation of the storm water drain was not fully inserted. A VBA notification of medium-risk plumbing activity (due to the high number of non-compliant items) sent to the builder, prompted the rectification of the items by the plumber. The VBA closed the matter after receiving notification from the builder that the plumber had rectified the items.

**Suspended sewer without the appropriate support.**

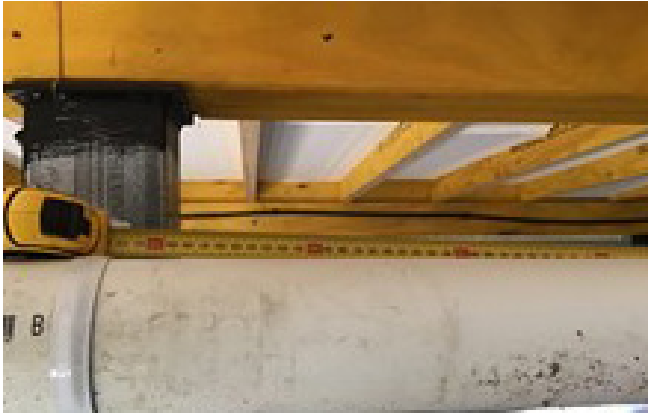
**Above ground PVC stormwater without support at appropriate intervals.**

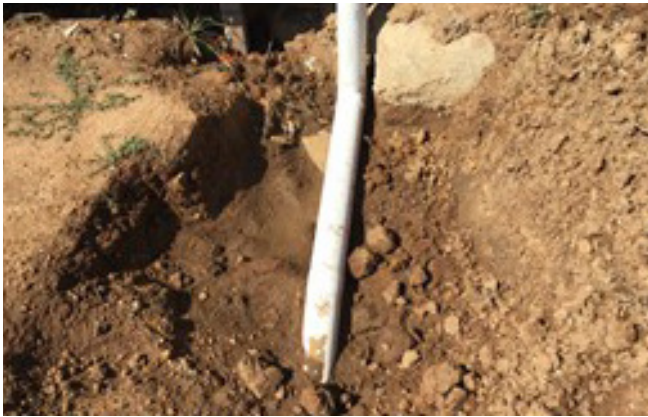
**Below ground stormwater drain without the appropriate bedding/side support material**

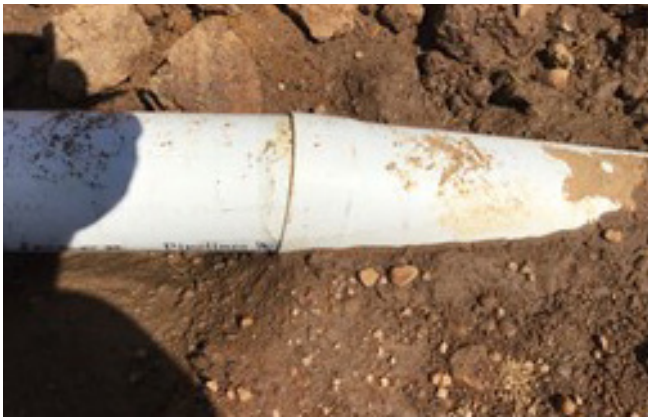
**Fitting used for the installation of the stormwater drain has not been fully inserted.**

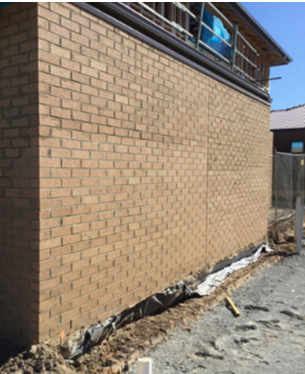
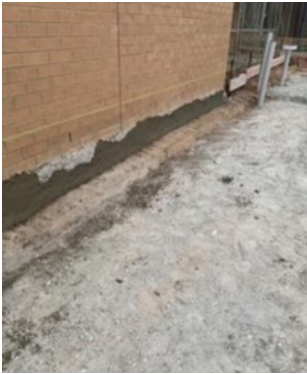
A proactive inspection of double storey dwelling observed a masonry garage wall (positioned on the boundary of the adjoining property), that was not supported with a minimum of 150mm edge rebate depth, contrary to AS 2870-2011 and structural engineer’s design. The RBS was contacted on the same day due to the seriousness of this issue and acted promptly to partially rectify the item and to complete a variation to the building permit so that the rectification work could commence. The VBA closed the issue upon receiving evidence of the building permit variation from the RBS, the photographs detailing the partial rectification work and an undertaking from the RBS to ensure the matter was brought into compliance.

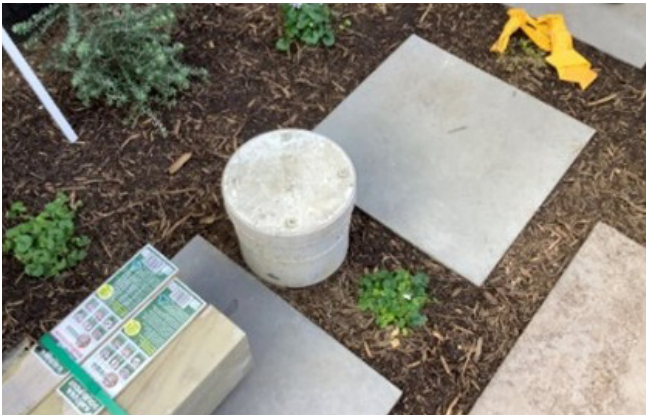
A proactive inspection of a new three-storey apartment complex found multiple plumbing issues, which included ground floor fixtures that were not protected against a surcharge from the main sewer, expansion joints used without fixed supports, drains installed above ground through brick walls without the minimum 25mm annular space around the drain and hot water service clearance from the gas line is less than 100mm. A VBA notification of medium-risk building activity, sent to the builder and RBS, prompted the rectification of the items by the plumber. The VBA closed the matter after receiving comprehensive photographic evidence of the rectified work.

**Unprotected plumbing fixtures**

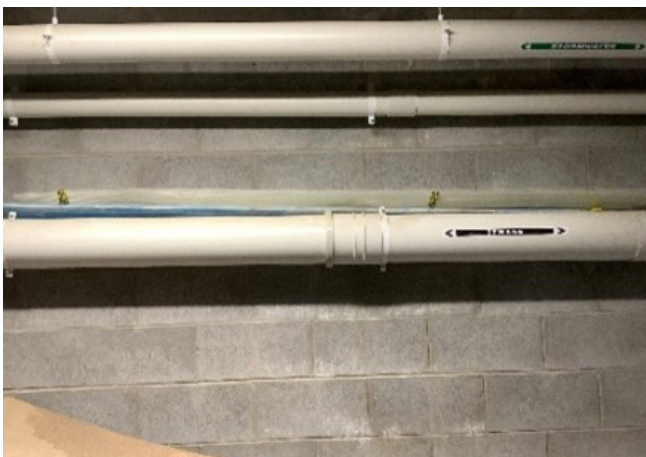
**Expansion joints used without fixed supports**

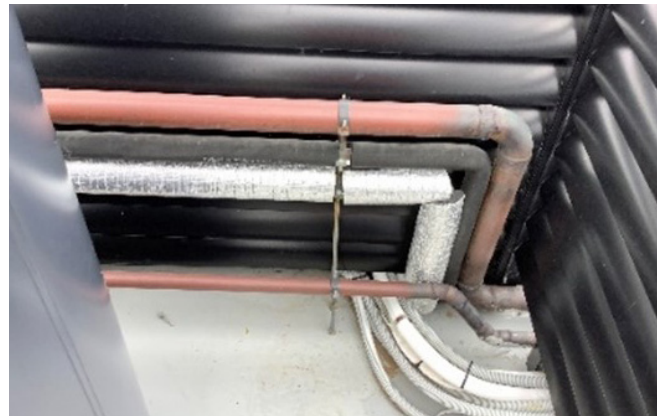
**Hot water service clearance from the gas line is less than 100mm**

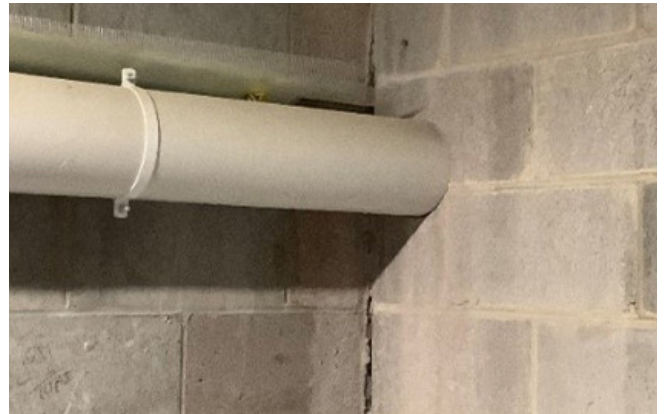
**Drain through brick wall without the 25mm clearance**
