# Proactive Inspections Program Activity Report

JANUARY - MARCH 2022

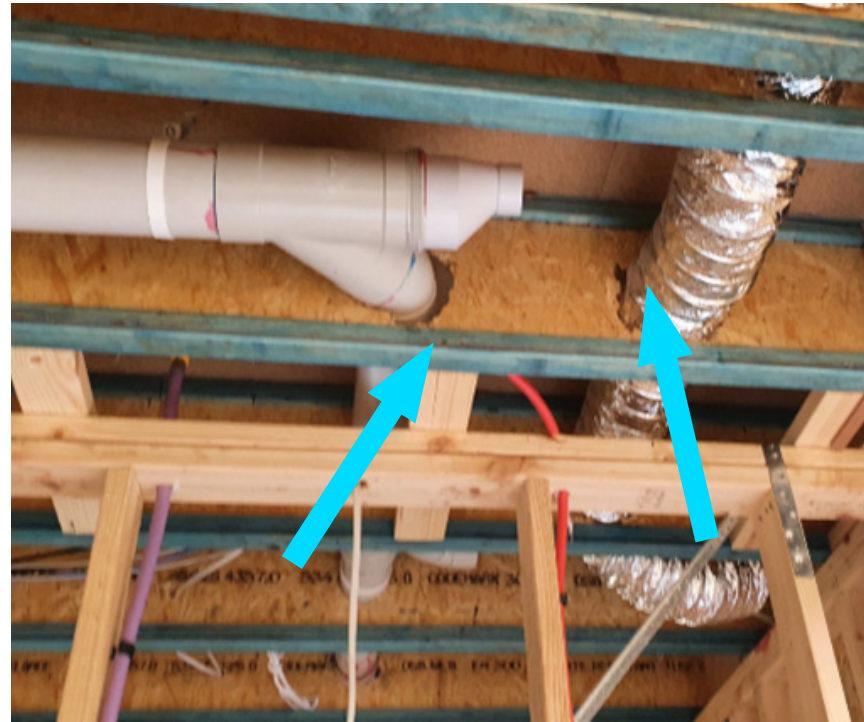
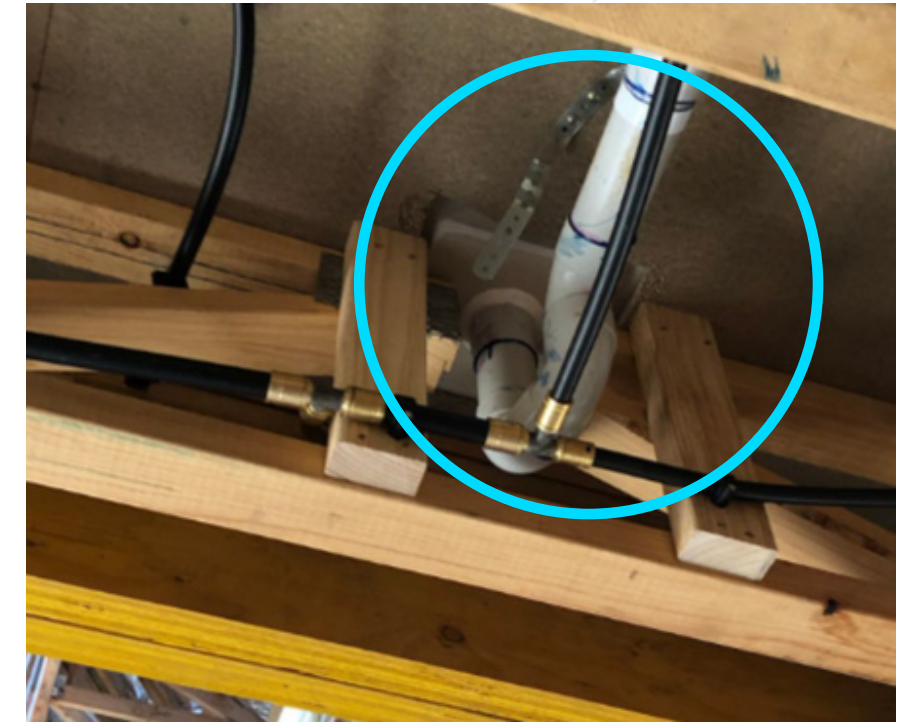
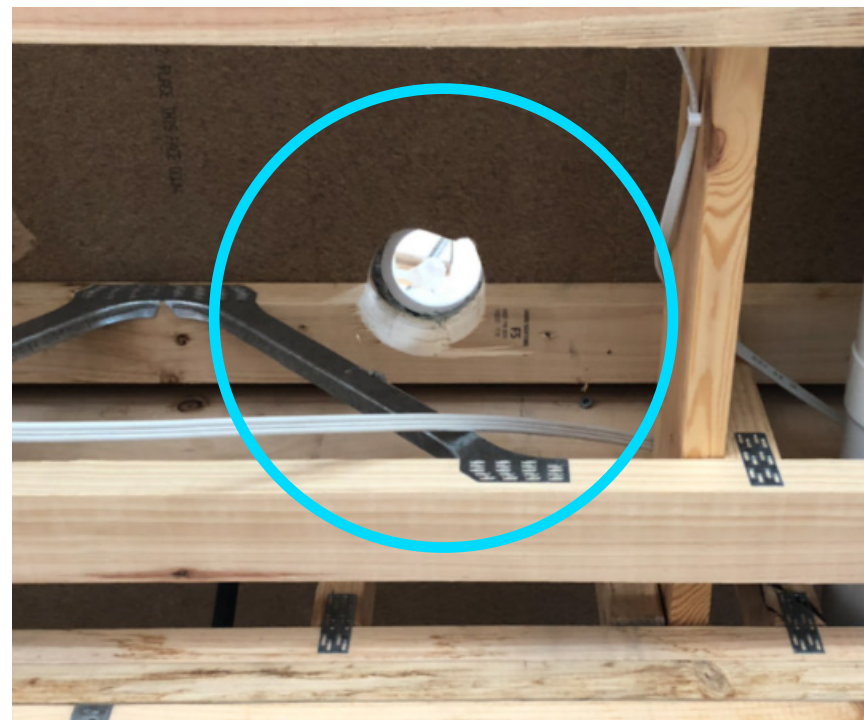
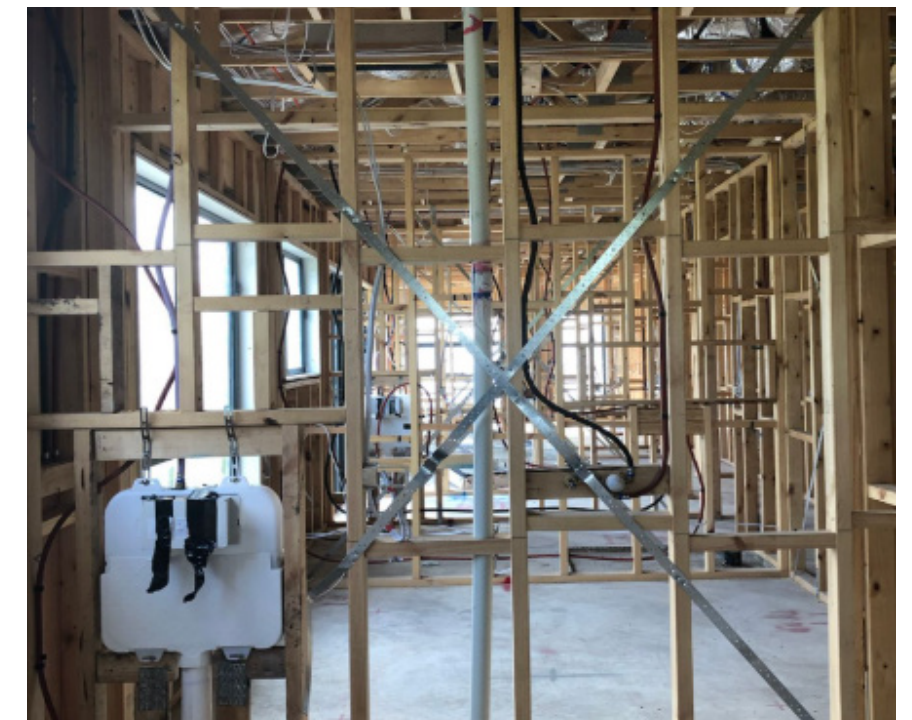
To reduce these issues from reoccurring, the targeted education of trades is required, especially electricians and plumbers. Improved planning at the design stage will assist in negating some of these issues arising. For example, a wall brace unit could be moved from an internal bathroom wall to facilitate the installation of a vent pipe.

The VBA will only close these matters once they have received confirmation the rectification work has been inspected and approved by the RBS.

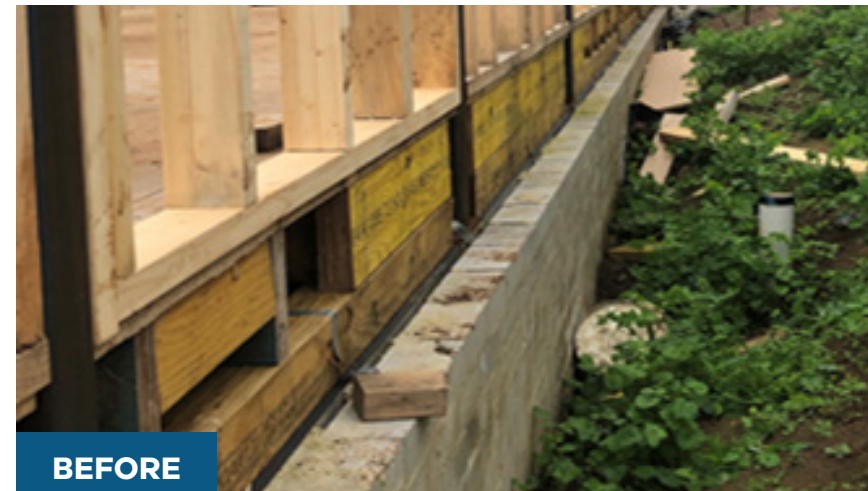
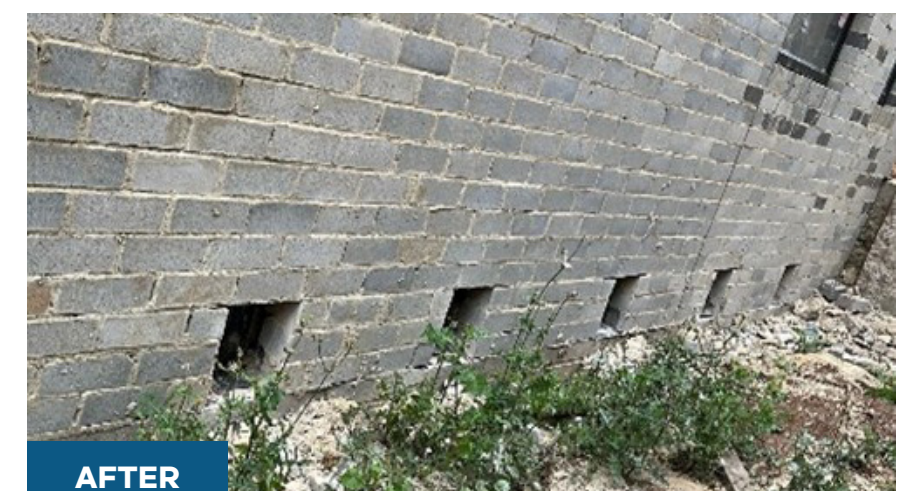
#### *Insufficient subfloor ventilation*

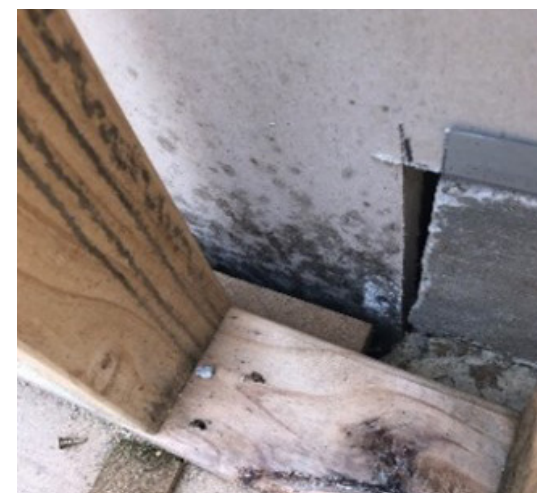
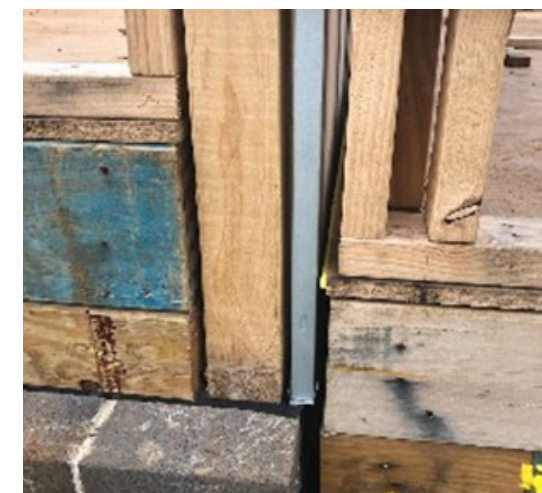
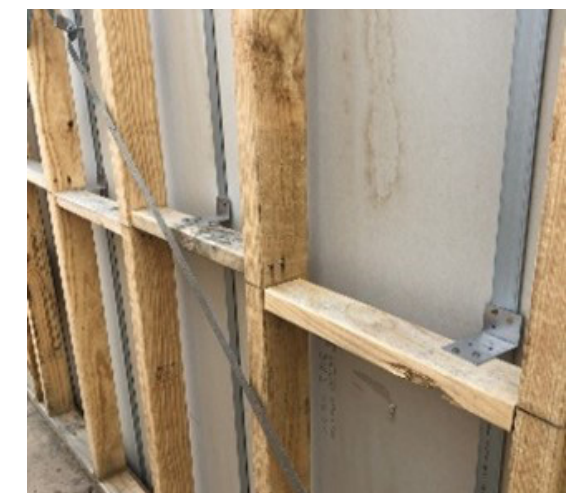
#### *Installation of the fire rated separating wall not in accordance with the manufacturers requirements*

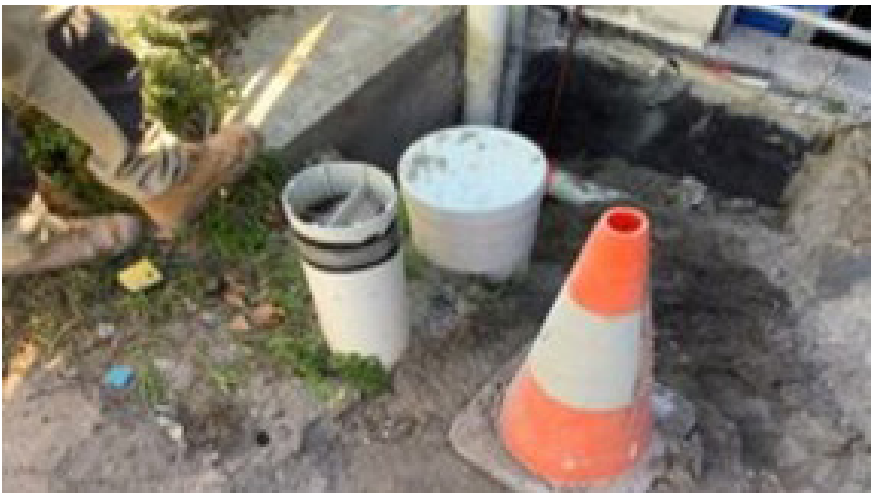
Non-compliant positioning of Reflux Valve

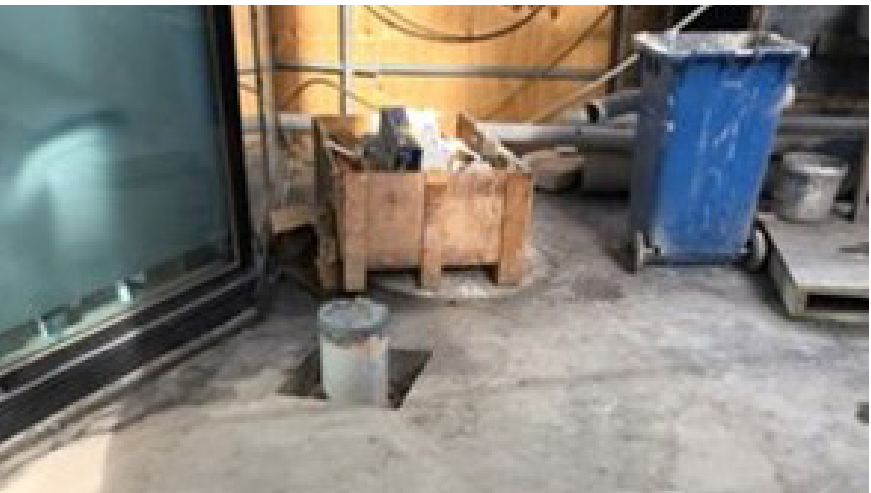
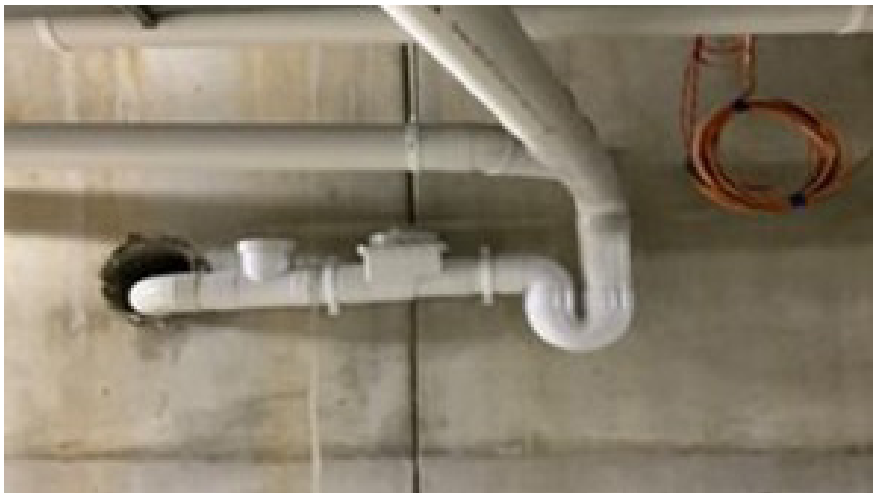
No Overflow provision to protect ground floor fixtures

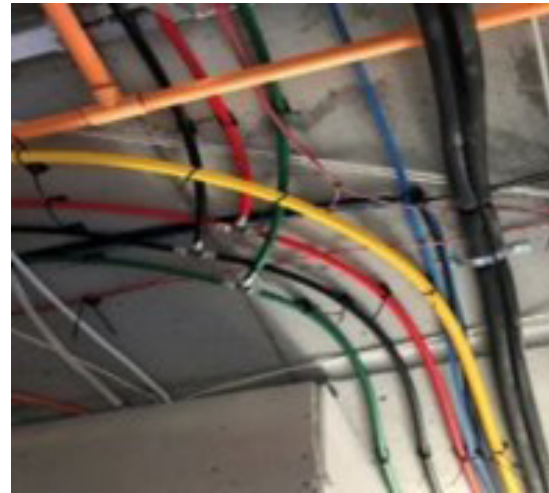
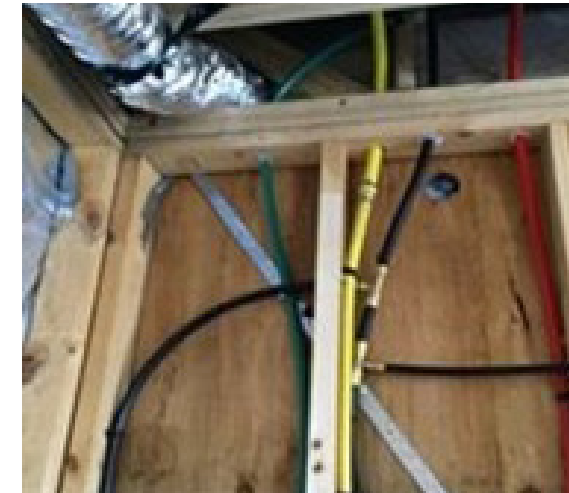
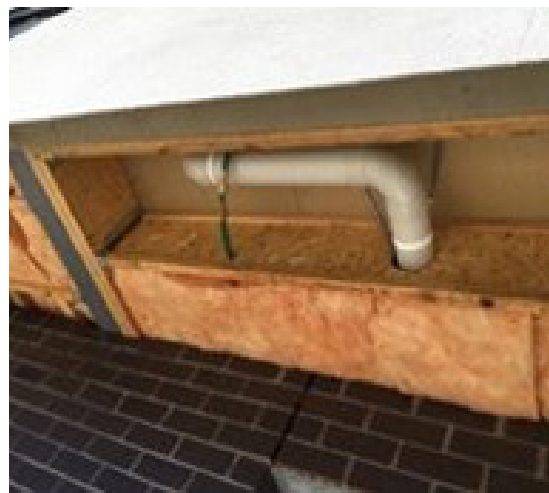
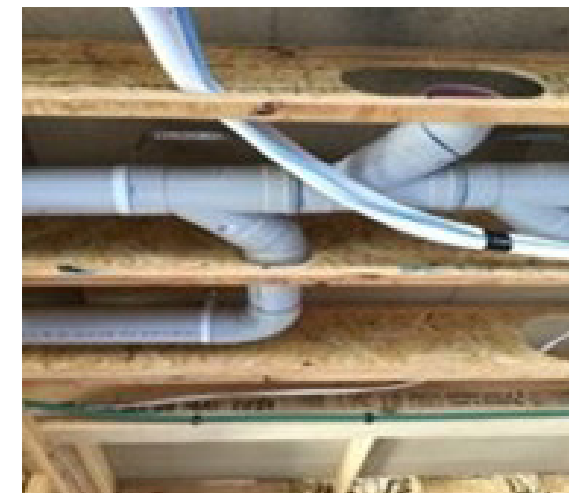
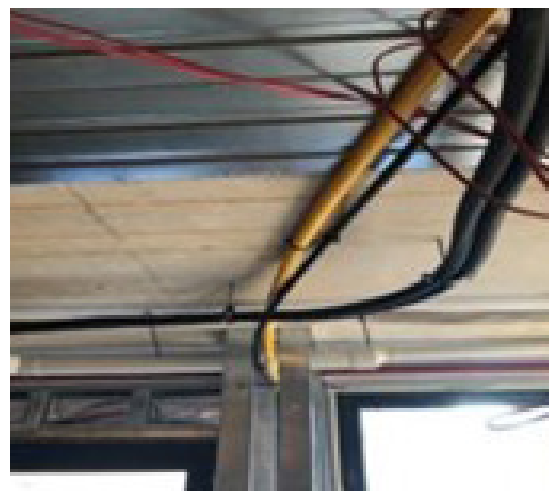
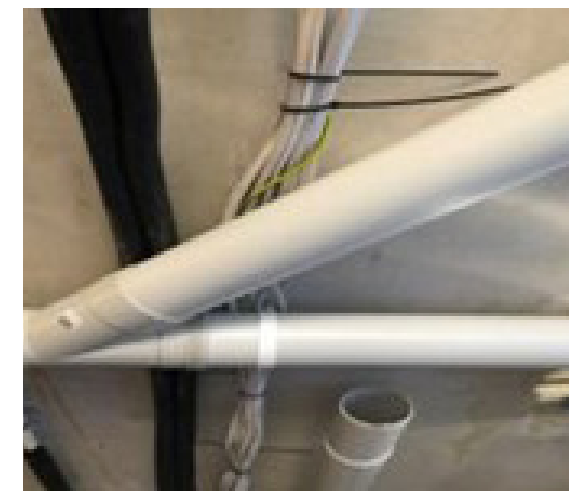
Insufficient separation of services is consistently observed during proactive inspections of Class 2 buildings due to the limited space in common areas to run services through and multiple trades being involved in their installation at various stages of the construction.

The VBA will ensure the services are reinstalled to meet the appropriate separation requirements between services. Building practitioners are also encouraged to consult with the affected trades prior to installation of their services to ensure that the services are installed to their correct compliant location to achieve separation.
