# Rendered expanded polystyrene clad wall system AS 5113 external wall fire spread test

Fire test witness and review report

Report number: EP205417

Client: Victorian Building Authority

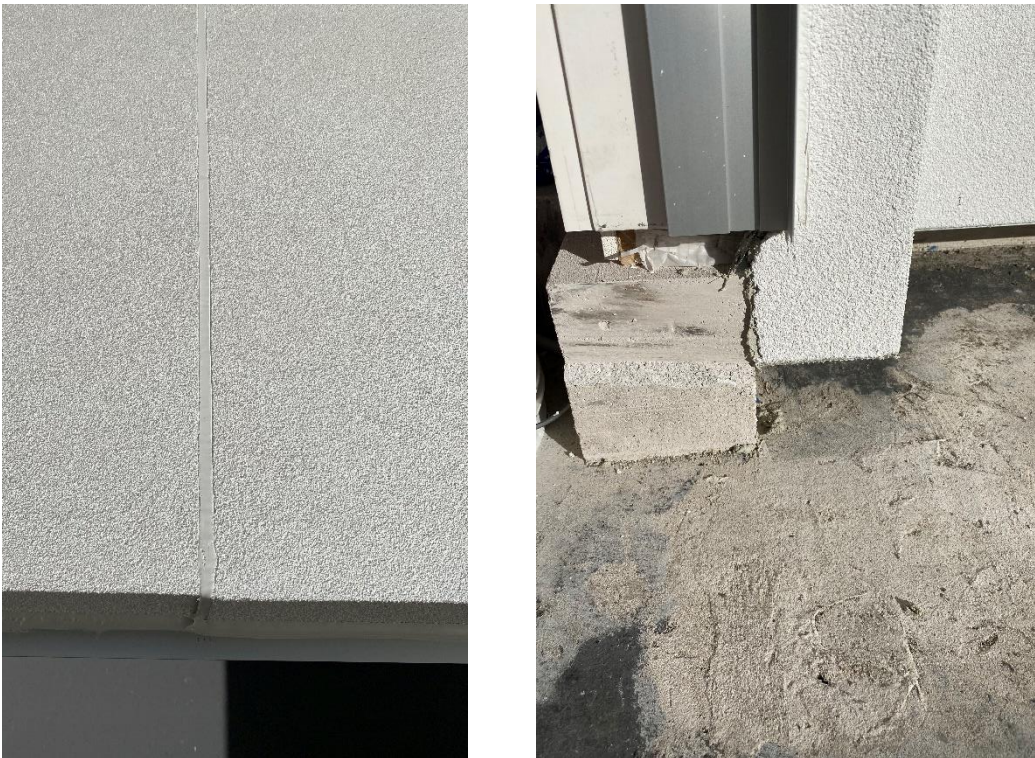
Figure 5. Vertical construction joint (left) and edge of combustion chamber (right) showing simulated timber window reveal and Hebel block simulating slab edge) during CSIRO inspection of completed construction at Warringtonfire.

7. The failure/opening of the rendered surface coincided with increased exposure of EPS and increased fire size. The initial point of failure of the rendered surface was the vertical expansion joint located centrally above the combustion chamber. This joint progressively failed firstly by sealant falling/burning out and eventually the render surface peeling away from either side of this joint. However the render layer also appeared to form cracks or openings at other locations away from this vertical joint, including around the upper perimeter of the combustion chamber, on the wing wall in the region of most severe crib flame impingement (between the combustion chamber and level 1) and vertically along the intersection of the wing wall and main wall above the combustion chamber. Based on witnessing the test and review of the available test data, CSIRO is of the opinion that, if no vertical control joints had been included in the tested specimen, it would have been likely to have resulted in similar fire spread behaviour, however the onset of significant fire spread may have been marginally delayed. This opinion is based on:

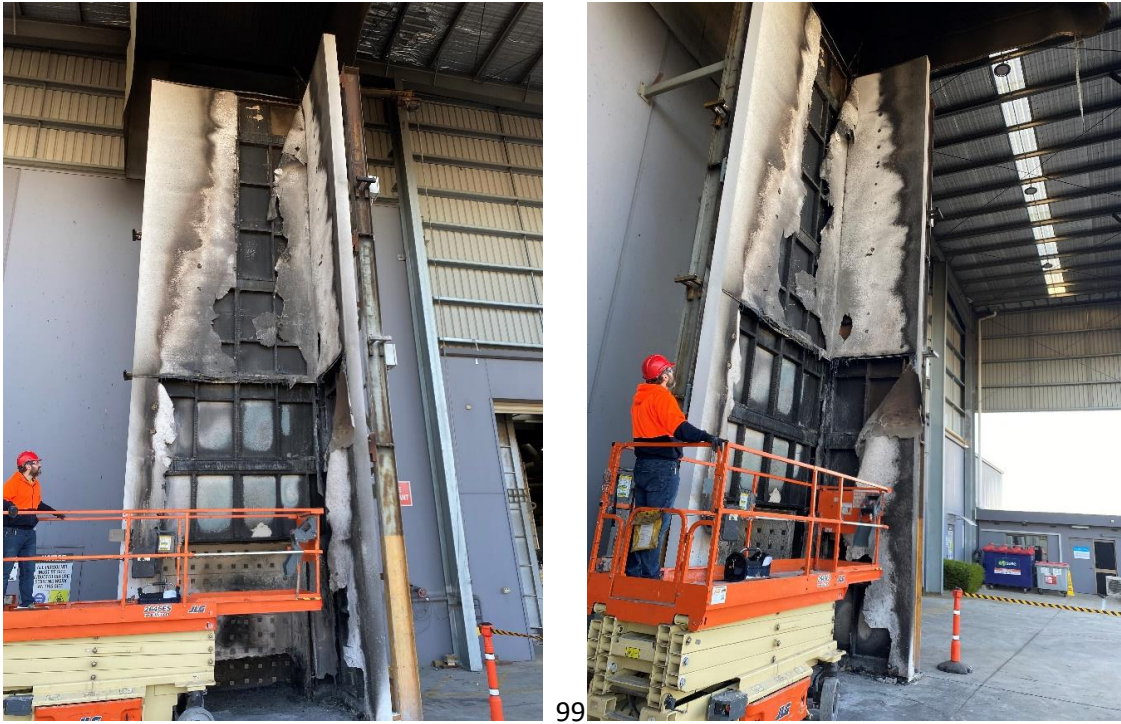
Figure 9. Post-test external rendered EPS wall system prior to any deconstruction. Main wall (left) wing wall (right)

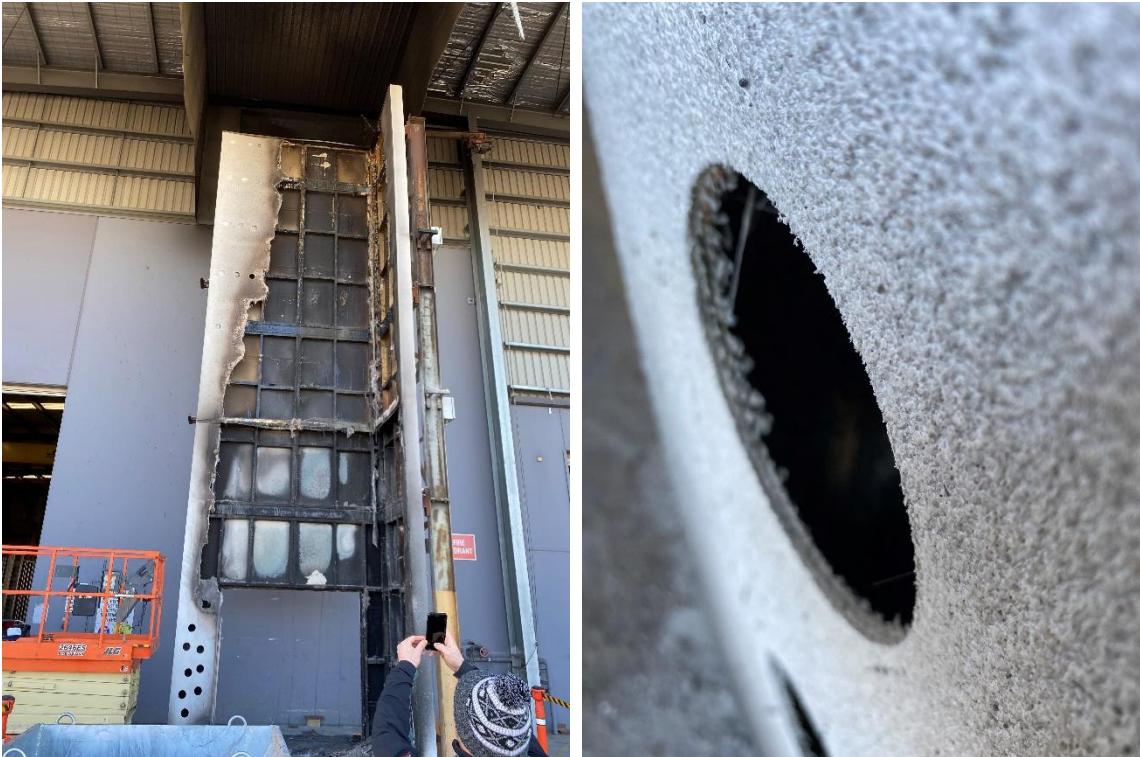
Figure 13. Post-test wall system showing render thickness hole saw samples. Right photo shows close up hole saw sample on left side of combustion chamber with EPS behind completely melted/burnt away.
