Building Documentation Audit

Volume 2 - Class 1 &

Volume 1 - Multi-Disciplinary Audit

March - August 2024

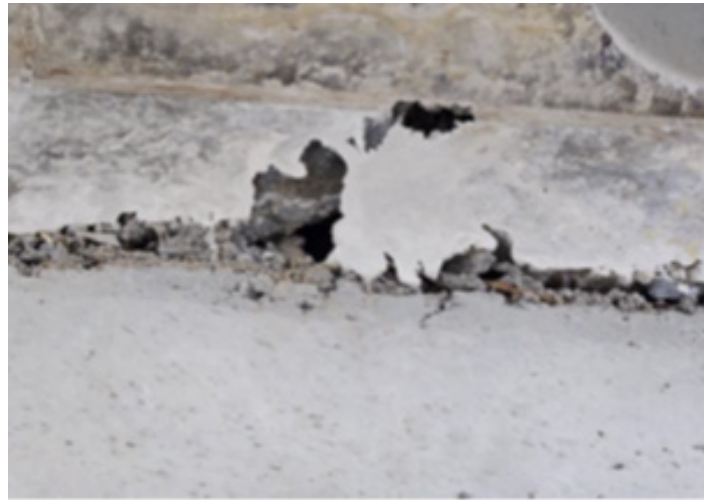
- honeycombing and air voids in shotcrete wall
- damaged concrete surfaces and exposed reinforcement bars
- the spoon drain not constructed as per design documentation by the engineers

Figure 5: Honeycombing and air voids in shotcrete wall.

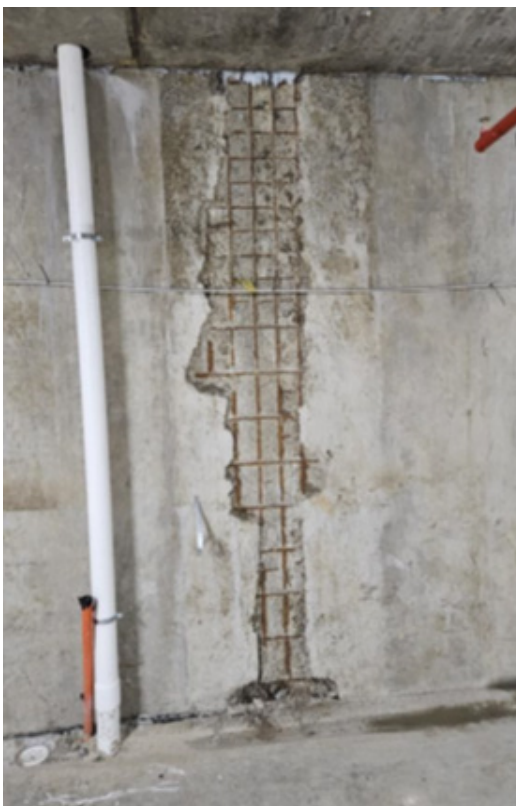
Figure 6: Damaged surface exposing reinforcement.

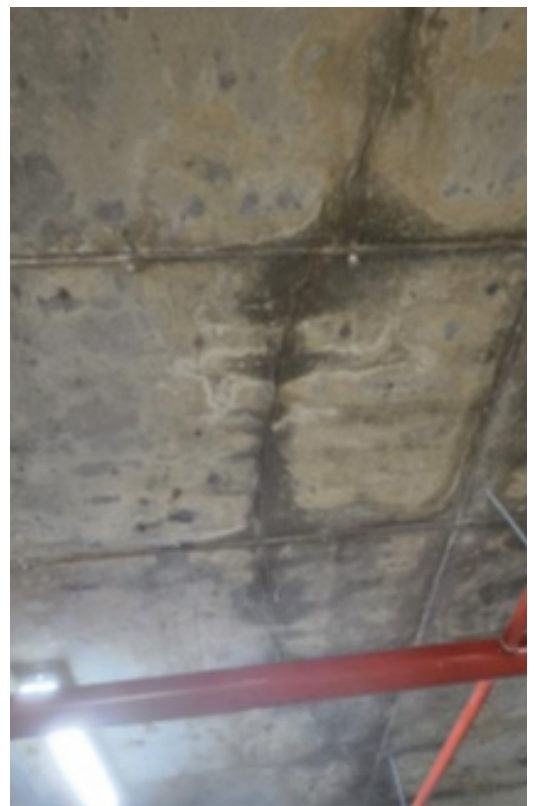
- water leakage across the shotcrete wall in the basement
- two cracks forming in the basement slab, in both the longitudinal and diagonal directions and dampness and water droplets were observed throughout the length of both cracks.

Figure 7: Crack forming in basement slab.

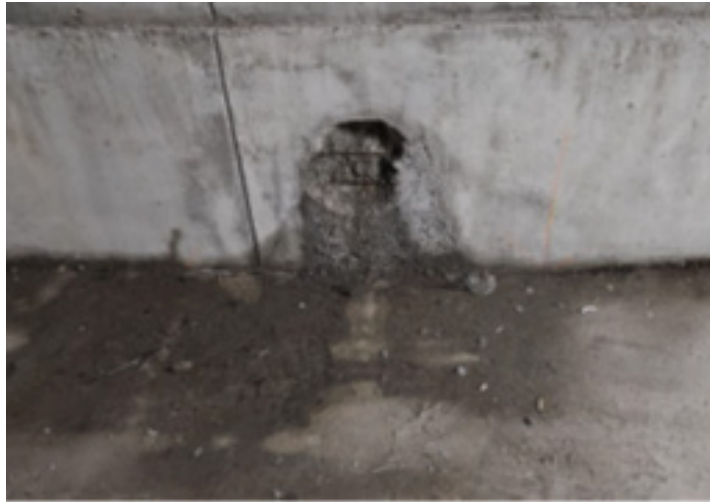
- exposed reinforcement bars and water leakage on the eastern edge of the ramp between basement levels.
- water ponding in basement,
- patches of honeycombing and exposed reinforcement bars in the Ground floor slab between

Figure 8: Exposed reinforcement bars and water leakage.

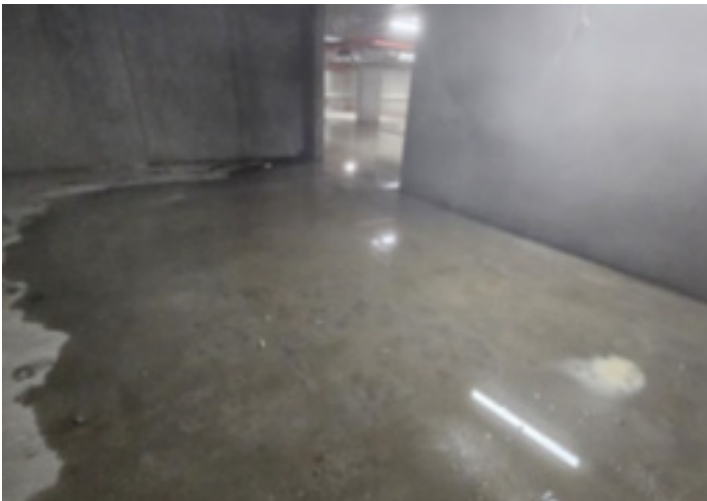
Figure 9: Excessive water ponding.

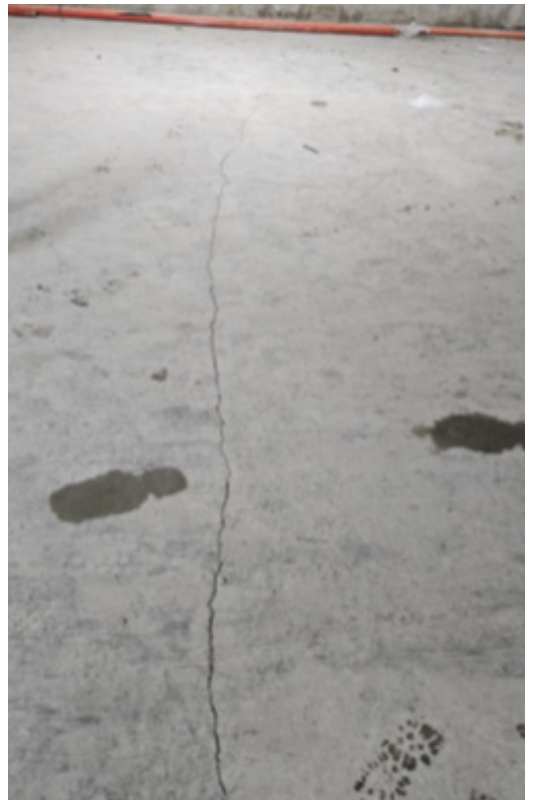
- crack forming in basement slab running the full length in longitudinal direction with dampness and water droplets on either side of the crack
- voids at the connection of the slab and wall/shotcrete walls at several locations throughout the Basement, ramp and Ground Level slab

Figure 10: Crack forming in basement slab.

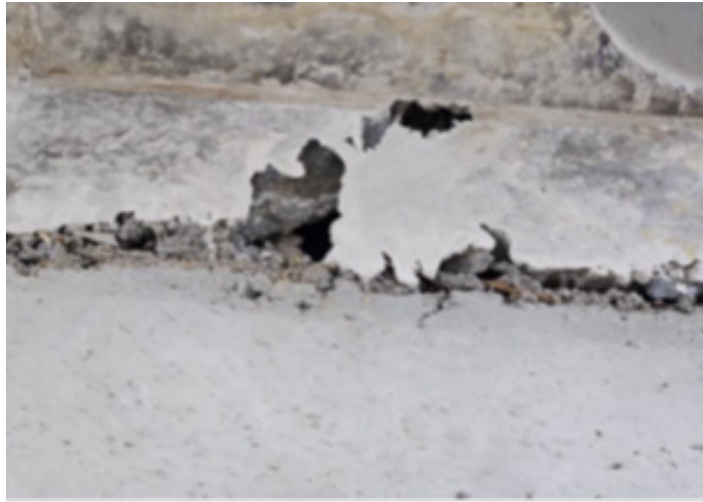
Figure 11: Honeycombing and exposed reinforcement bars.

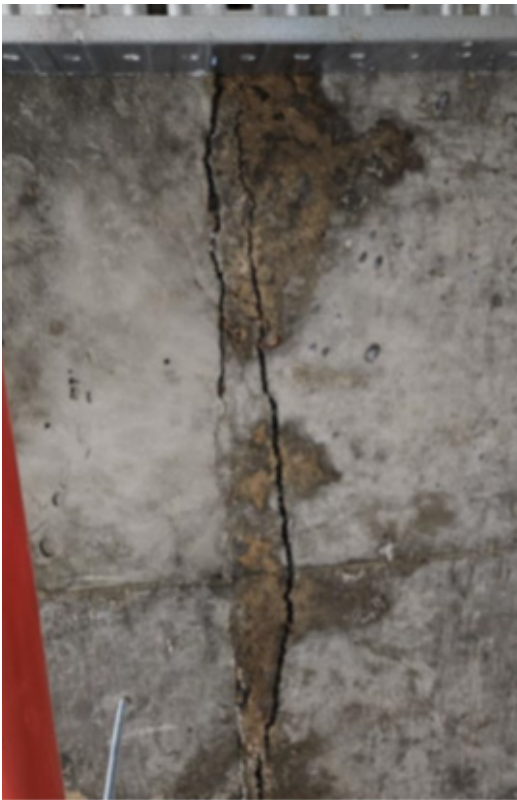
- several cracks forming at the soffit of Ground floor slab at Temporary Movement Joint
- 30-40mm gaps were present at the intersection of several Lift shaft and stair core walls at Basement 2 level to Level 4

Figure 12: Cracks forming in soffit.

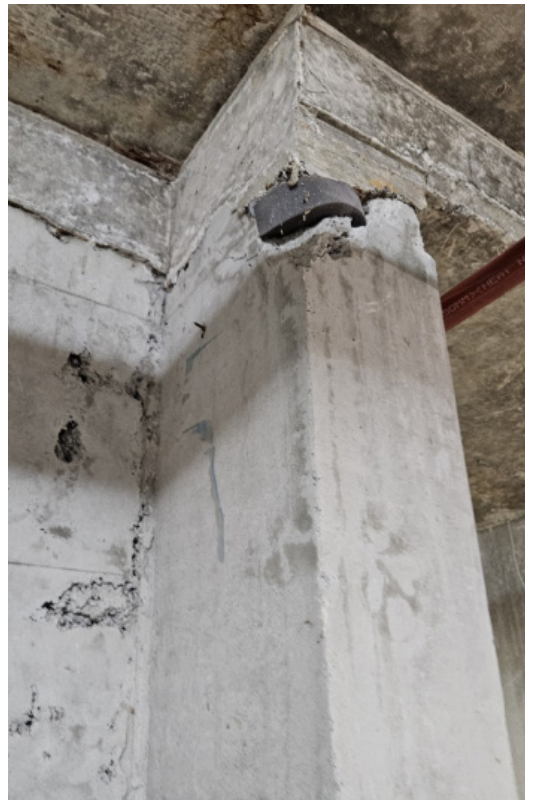
- damaged surface and discontinuous reinforcement in the in-situ wall at Ramp.

Figure 13: Damaged surface at ramp.

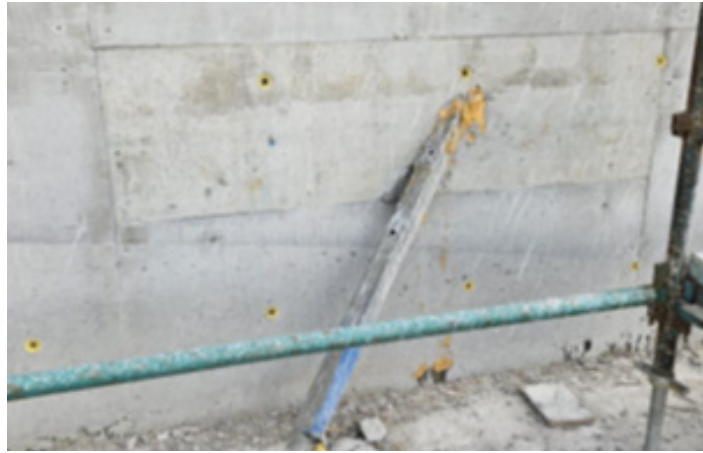
Figure 14: In situ wall with temporary prop cast in.

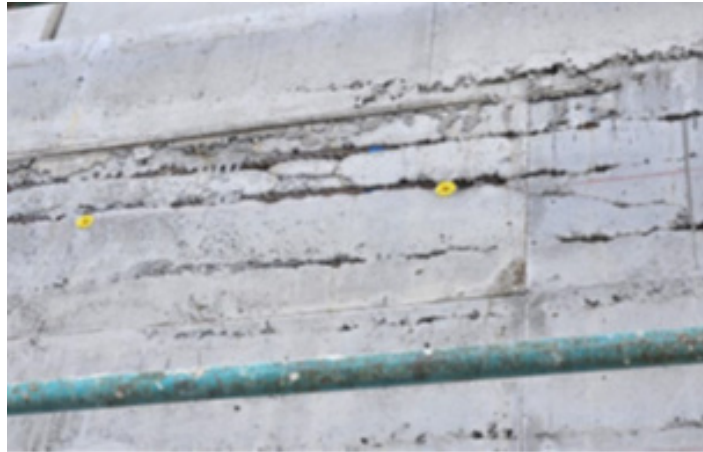
Figure 15: In situ wall with exposed reinforcement and honeycombing.
