# Reaction-to-fire report

A reaction-to-fire test of a non-loadbearing external wall system in  
accordance with BS 8414-2:2015+A1:2017

Product: Rendered expanded polystyrene clad wall system

Job number: RTF190234

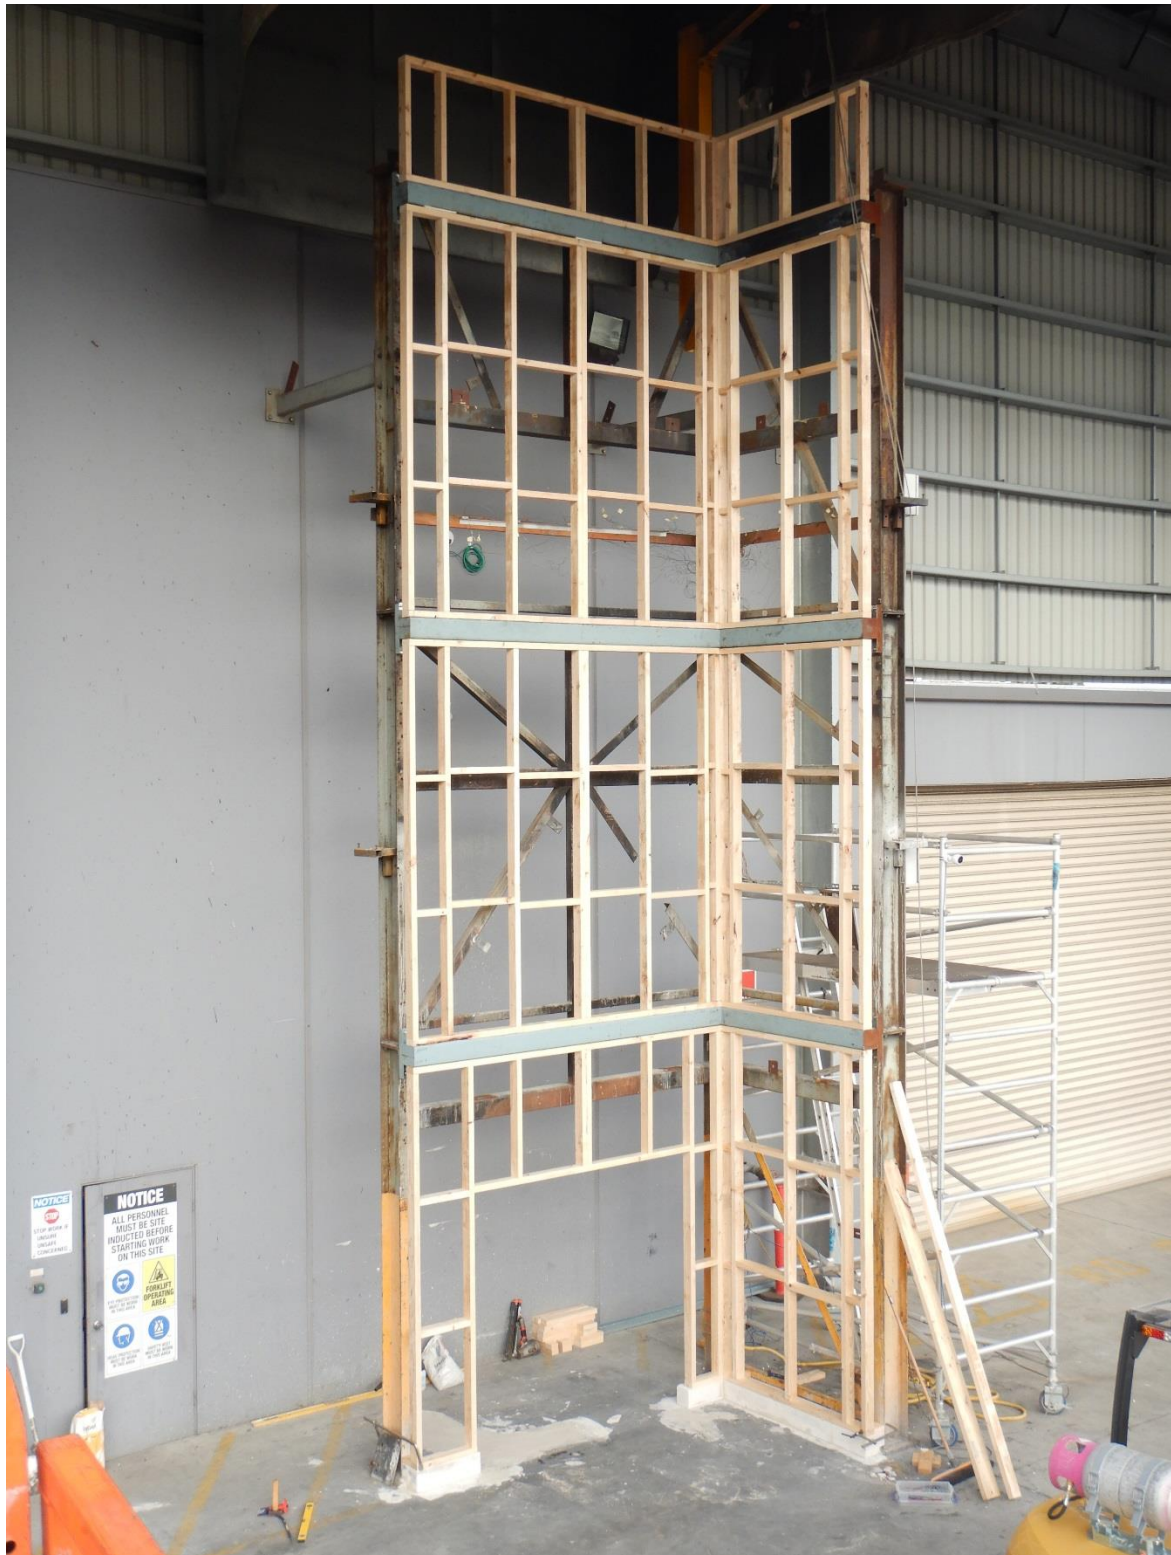
Figure 24 The timber framing during construction – back blocking not present at this stage.

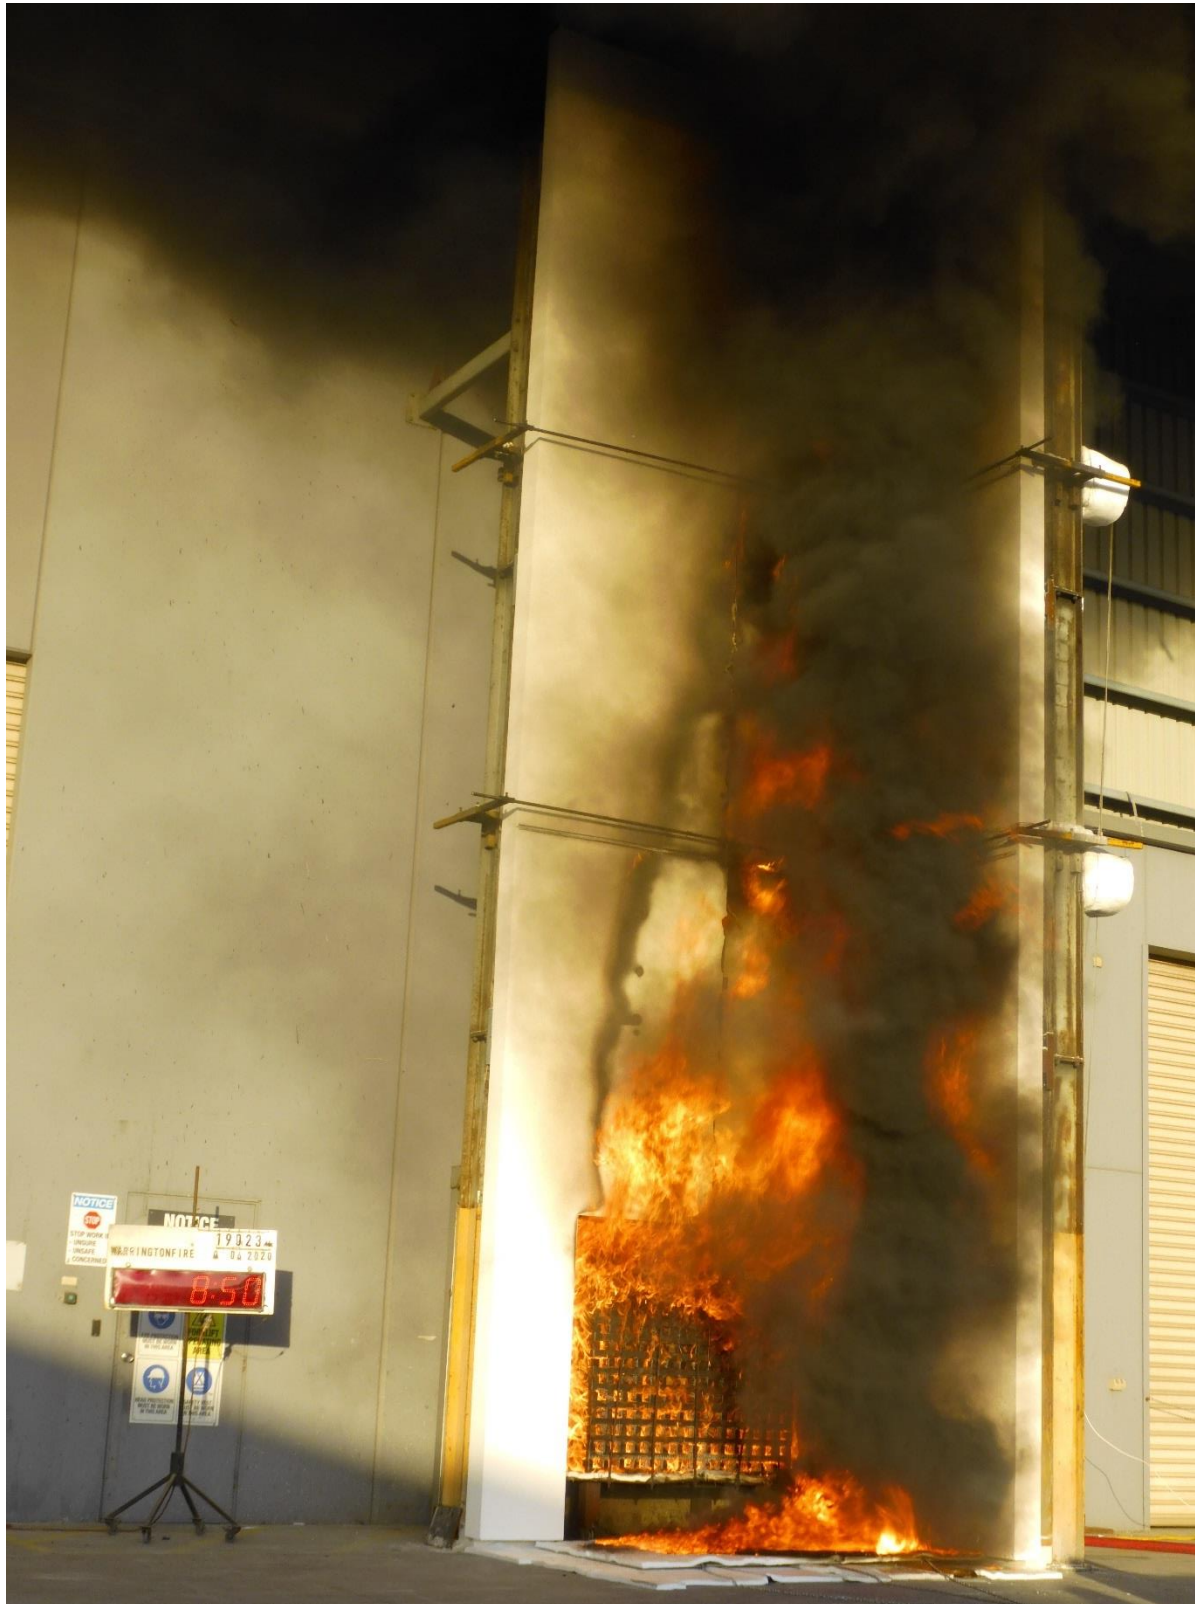
Figure 37 The external wall system during the test – 8 minutes 50 seconds after crib ignition

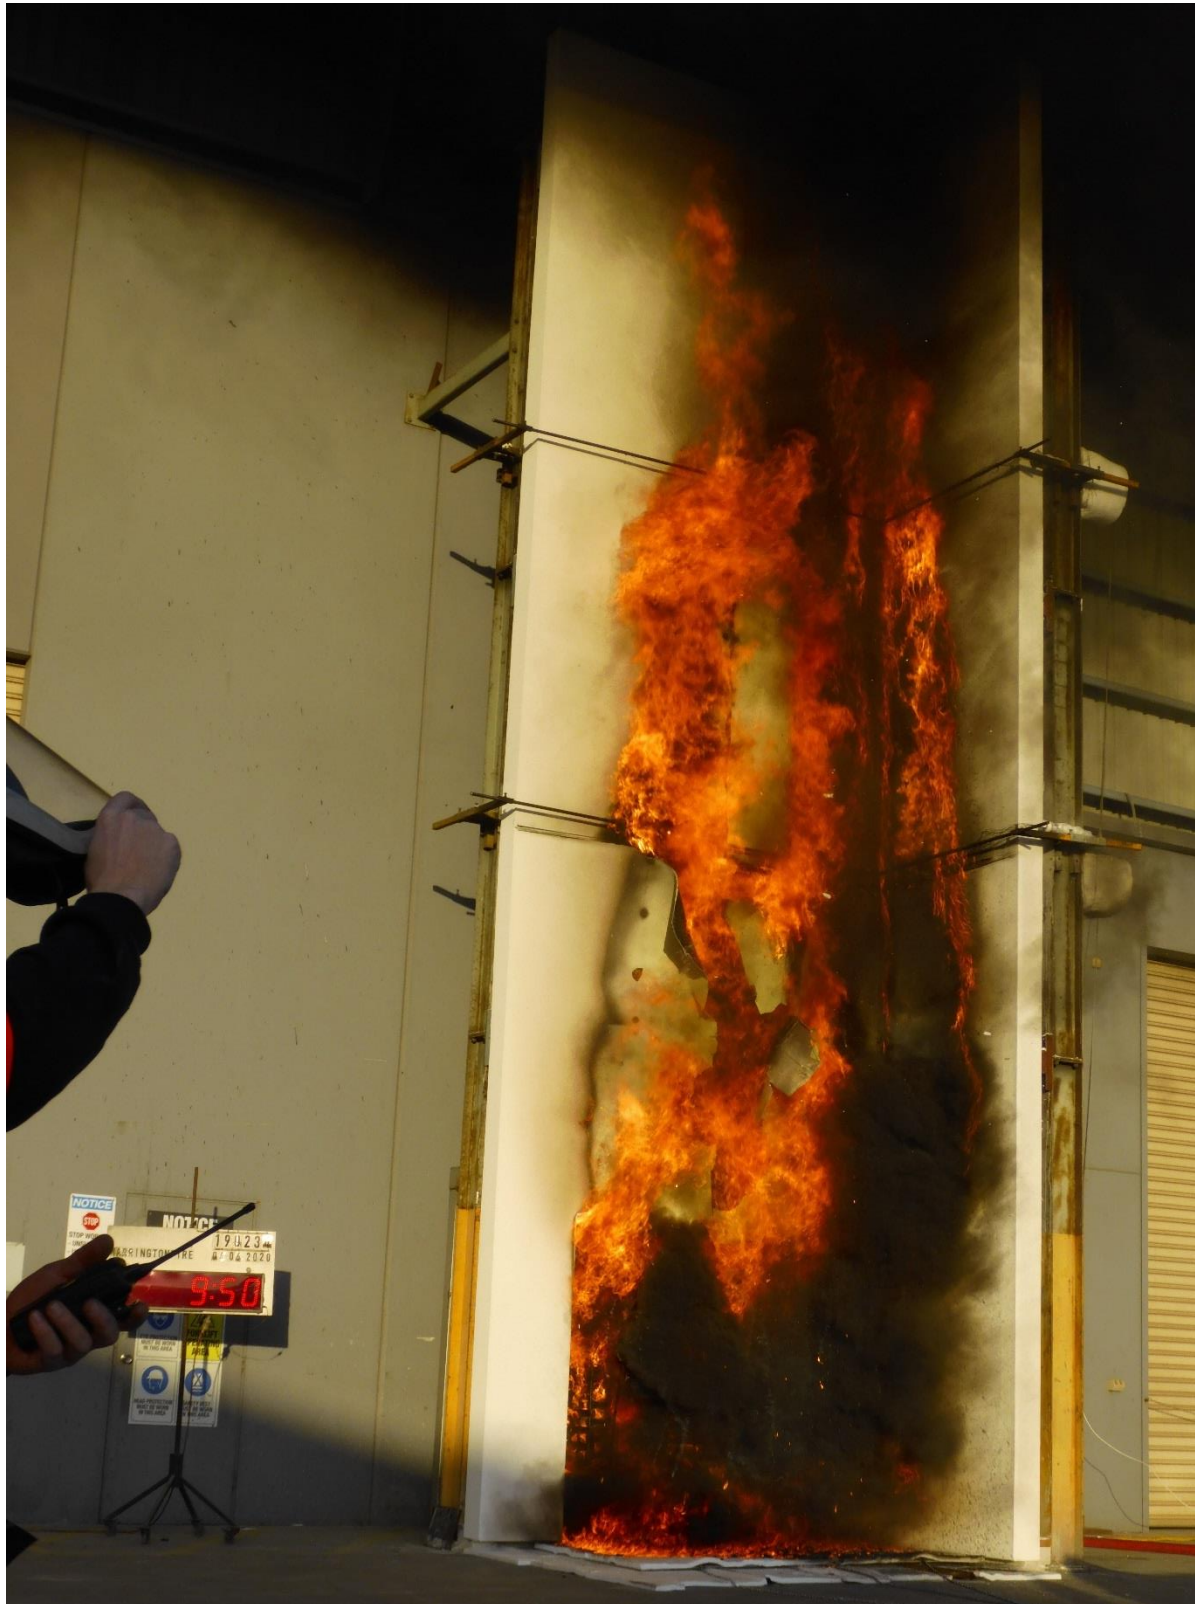
Figure 38 The external wall system during the test – 9 minutes 50 seconds after crib ignition

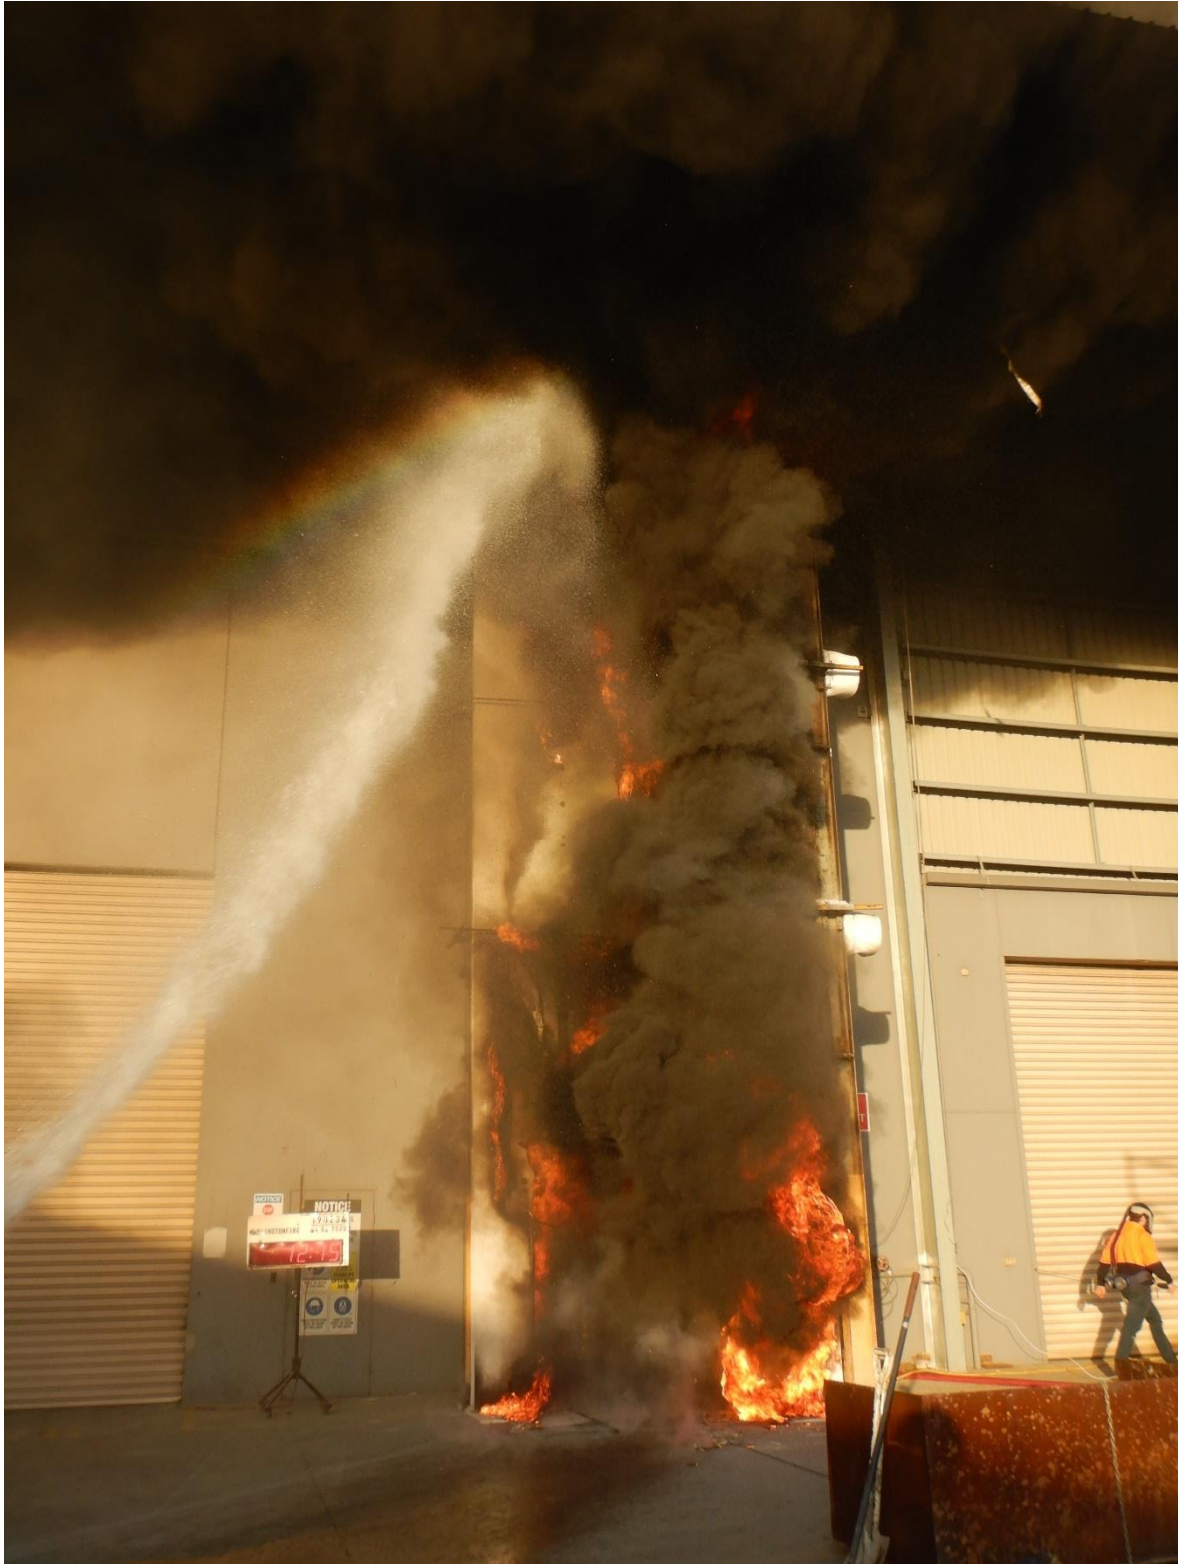
**Figure 40** The external wall system at the end of the test.
