# Literature Review on Fire Safety of Exterior Insulation Finish Systems and Insulated Sandwich Panel as External Wall Systems

Author: Nathan White, Neythra Weerakkody, Joe Sam Abraham  
Proposal number: FE2925

Document Number: EP192002  
Date: 29 September 2020  
Revision: Revision G

Client: Victorian Building Authority (VBA)

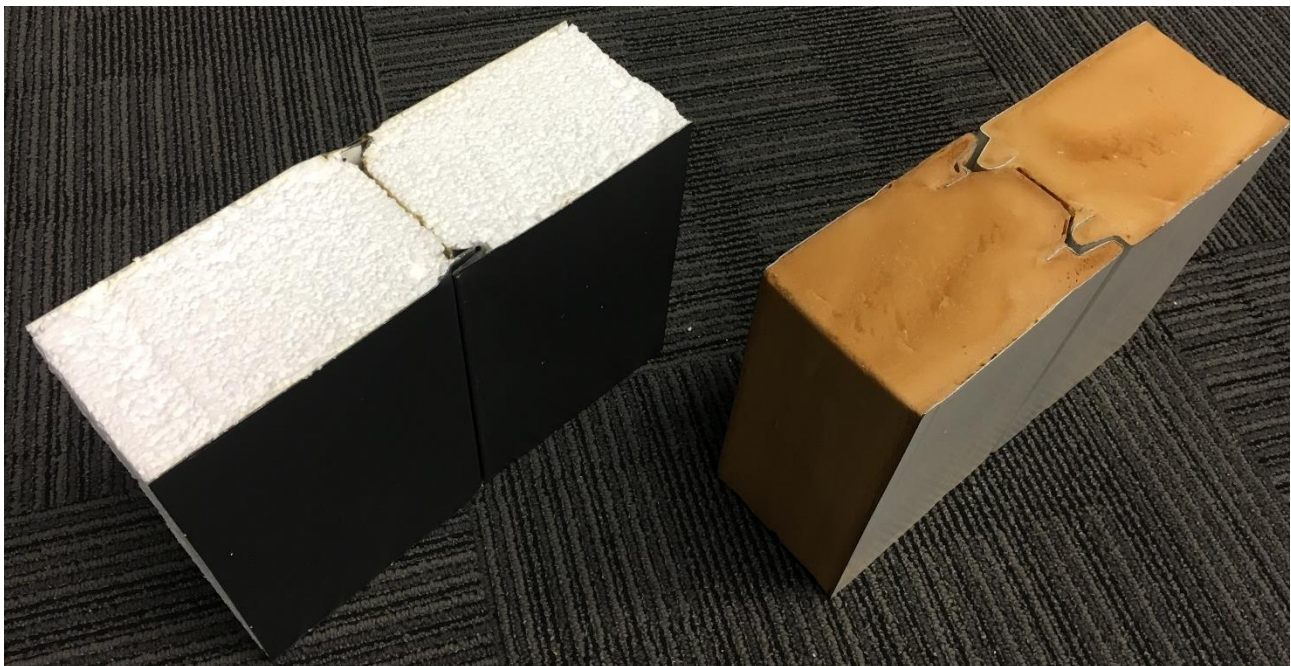
By far the most common type of ISP's used in Australia are steel faced with either an EPS, EPS-FR (EPS with fire retardant) or PIR (Polyisocyanurate) core. This literature review mainly focuses on steel faced ISP's with foam polymer insulation cores.

**Figure 2. Typical ISP with interlocking slip joints, EPS core (left), PIR core (right). Photos by CSIRO**

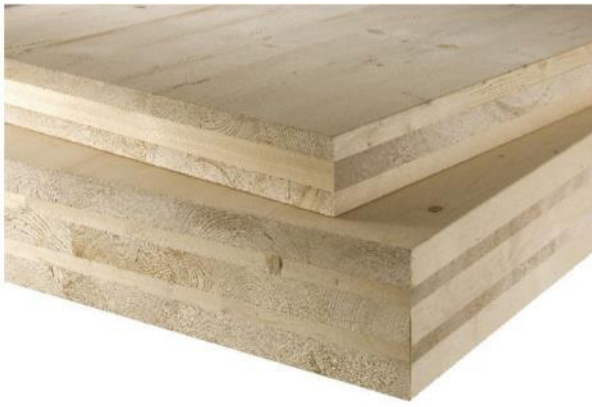
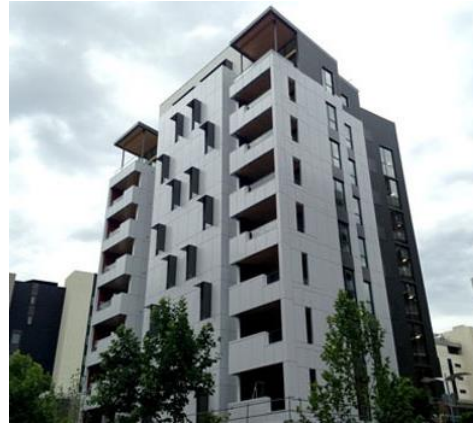
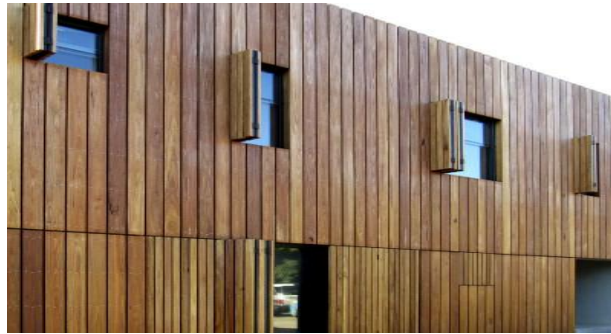
**Figure 5. Typical CLT Panels (left), Forte 10 storey residential CLT building in Melbourne (right), Typical hard wood cladding (bottom).**

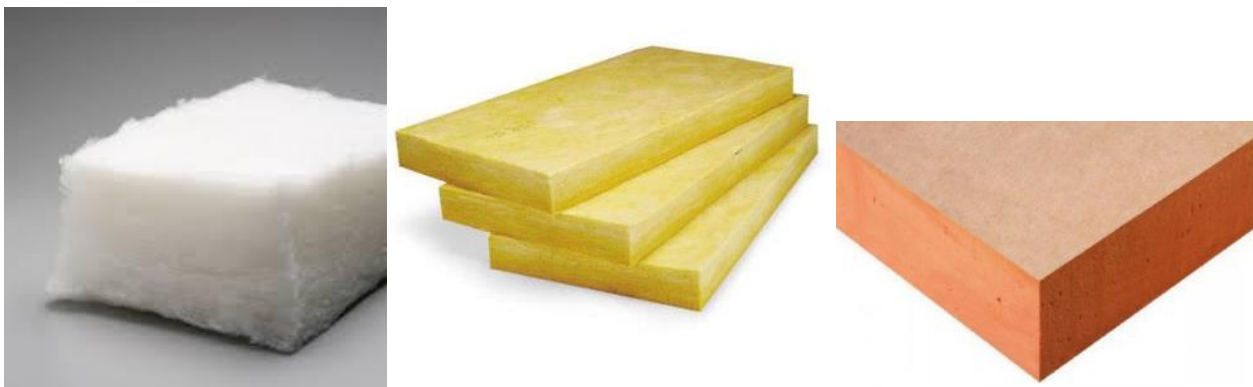
Figure 7. Polyester blanket insulation (left), Fibreglass insulation (centre) Phenolic foam insulation (right).

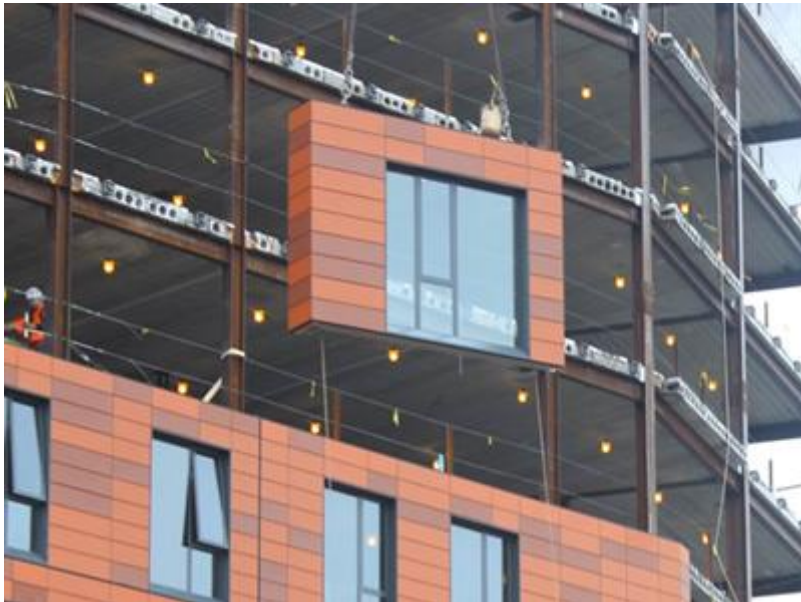
Figure 9. Unitised façade panels

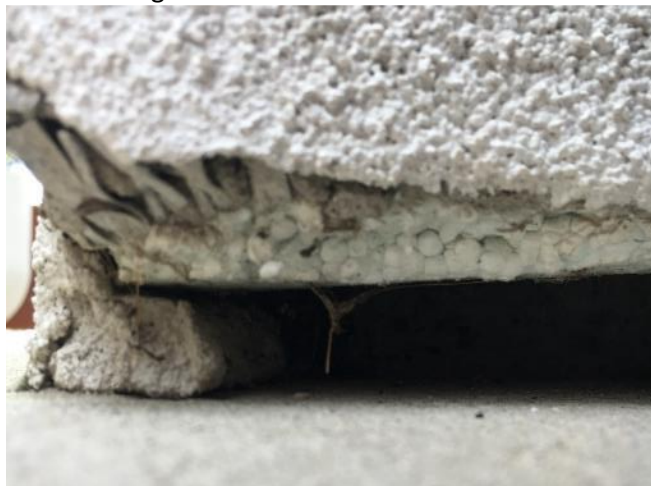
- Typically, the bottom of an EIFS wall cladding at surrounding ground level or surrounding roof surfaces is stopped short to provide a clearance gap to reduce moisture ingress. The bottom edge of this gap is often not finished with render. Visual inspection of this location can be difficult, but a finger can be used to feel/probe the bottom edge, or a mirror or mobile phone camera can be used to view the hidden layers. In some cases, a plastic or metal channel with weep holes may be installed along the bottom edge.

Figure 17. Example of bottom edge of EIFS exposed (photos by CSIRO)

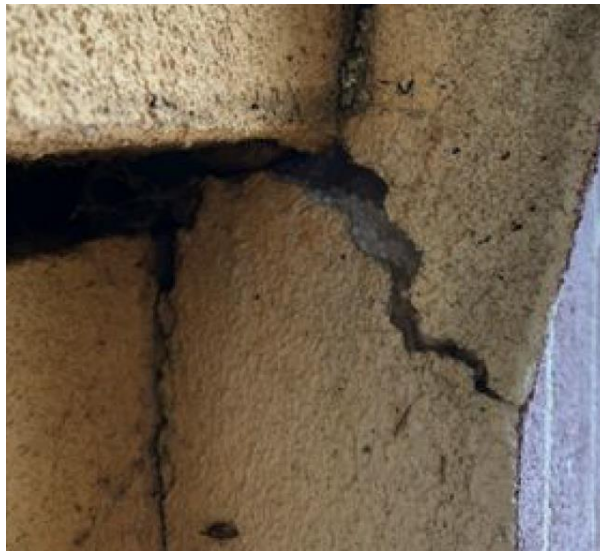
- Inspect the wall for any damaged render which reveals the core materials behind. Often damage occurs at areas prone to impact such as corners or at grade areas where there is movement of occupants or materials such as bins. Damage also occurs at stress concentration areas such as panel joints at edges of windows and doors.

**Figure 18. Damage to EIFS system with inappropriately thin render systems and poor maintenance (example photo extracted from ARP building audit report).**

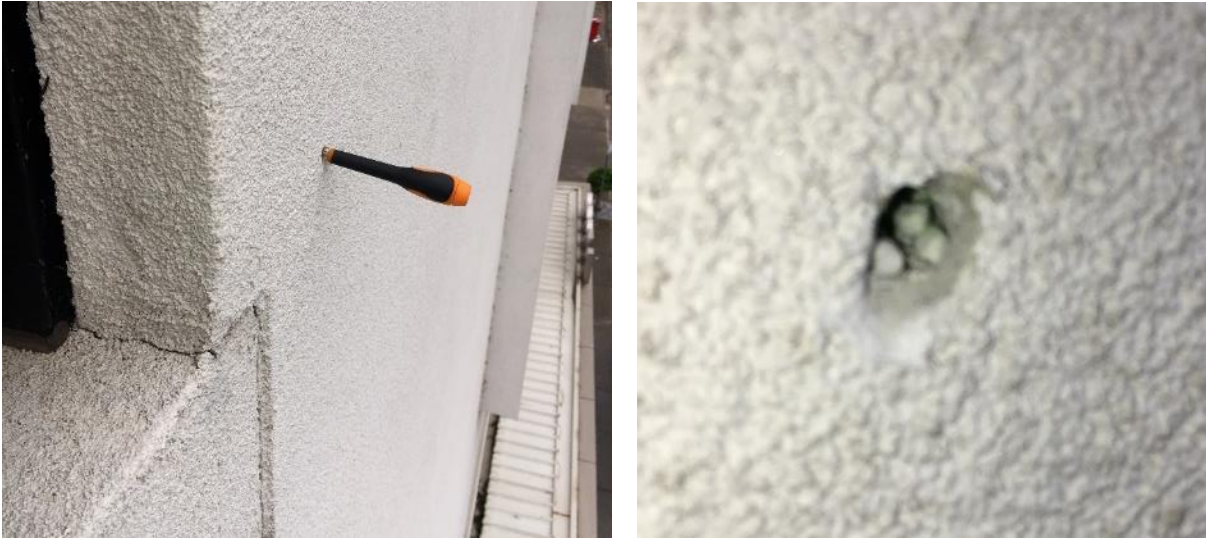
- When there is a transition into a new façade wall cladding system; such as EIFS to brickwork, if there is flashing present this can sometimes be moved to reveal the core materials.
- Penetrating the render with a sharp pointy metal probe can determine if the render has a solid (concrete/masonry) substrate or if it is EPS with minimal damage. Once the probe is removed EPS may be able to be visually confirmed. However thick renders can be difficult to penetrate and initially appear like compressed cement sheet. Aerated concrete and QT may also be penetrated with a probe but provide more mechanical resistance than EPS.

**Figure 20. Probe used to penetrate EPS EIFS system render. In this case the render was ~ 5-6 mm thick and felt like compressed cement sheet based on external knocking only and was initially difficult to penetrate with probe. Thinner renders will have a different feel and be easily penetrated. (Photos by CSIRO)**

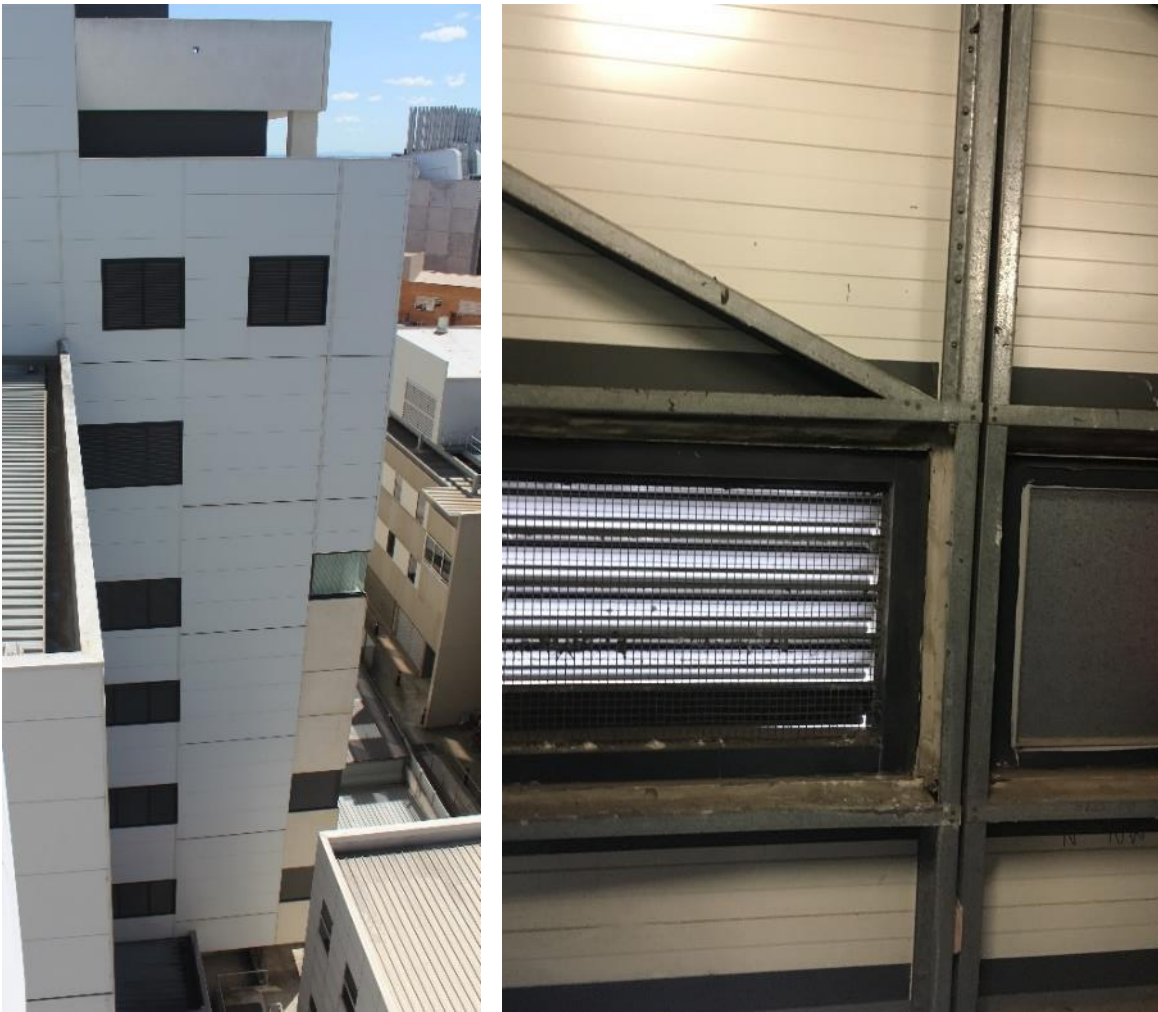
**Figure 21. Example of ISP with PIR core as external wall on multi-storey building viewed from exterior and interior within plantroom. (Photos by CSIRO)**

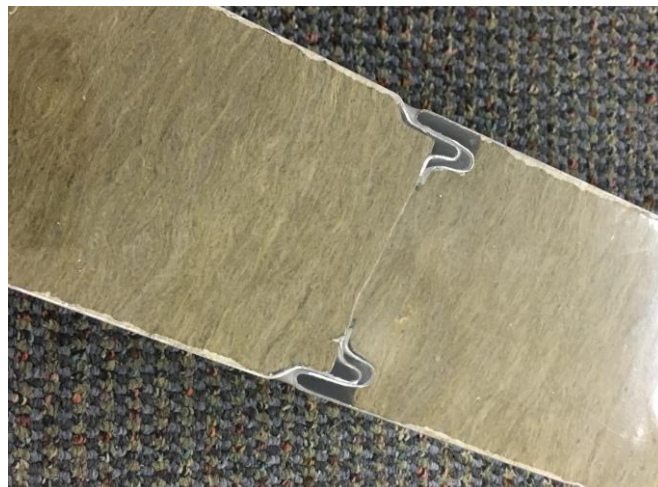
Mineral wool can be prone to moisture ingress. Manufacturers specify denser mineral wool for increased water repellence however inclusion of this material in external walls generally requires careful encapsulation or protective membranes.

**Figure 23.** Example of Mineral Wool Core ISP. Photo by CSIRO

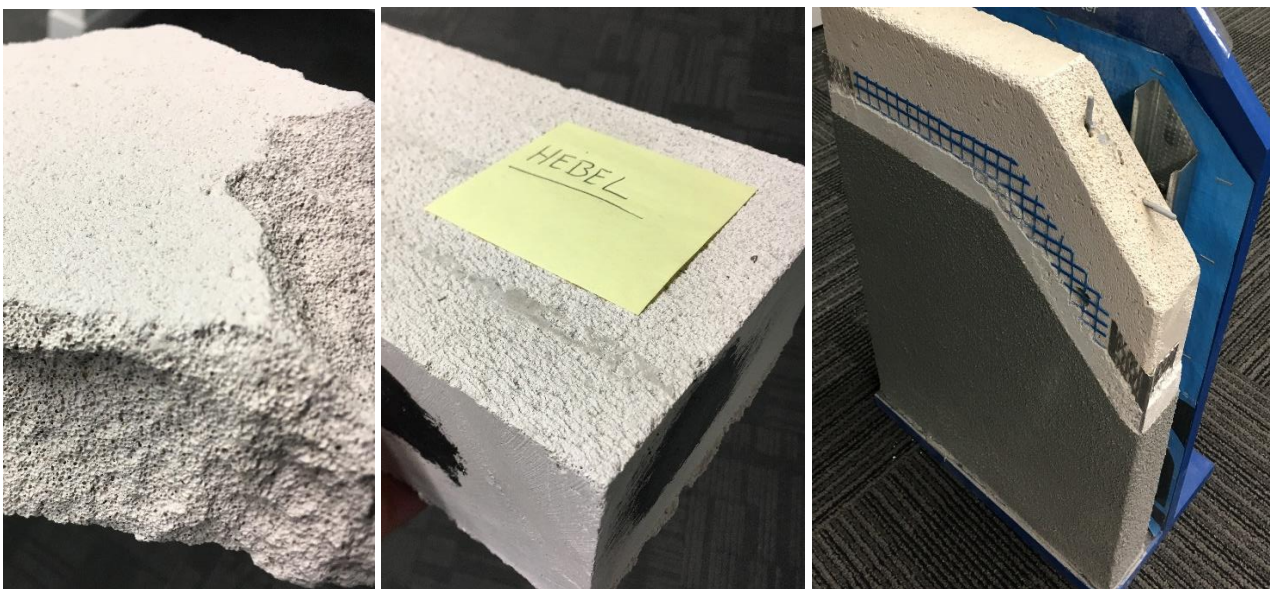
AAC is also used in some steel faced ISP systems. "Speedpanel" is an example of such a product in Australia. Speedpanel is mostly used for internal fire-resistant walls and shafts but can be used as an external wall system. 51 mm thick speed panel achieves an FRL of -/60/60 and 78 mm thick speed panel achieves an FRL of -/240/240.

Figure 24. typical AAC structure (left), Hebel block (centre), Typical AAC EIFS installation (right), all photos by CSIRO.

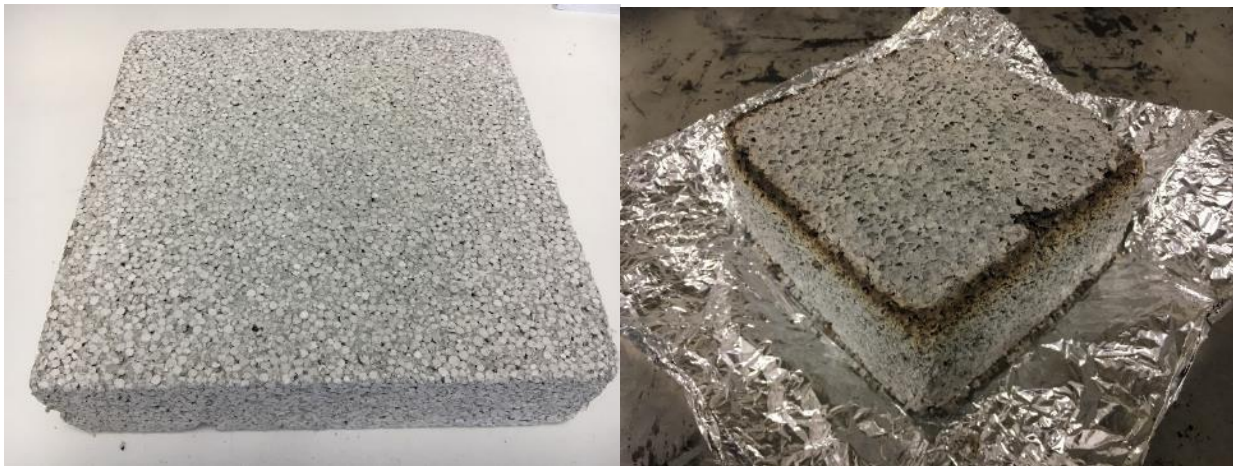
**Figure 26. Compolcrete prior to cone calorimeter test (left) and after cone calorimeter test (right) – All photos by CSIRO**

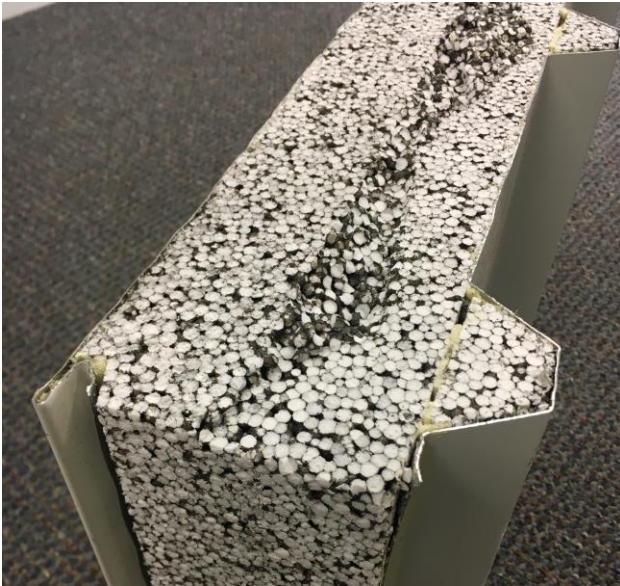
Figure 27. Example of EPS in phenolic resin matrix, Photo by CSIRO

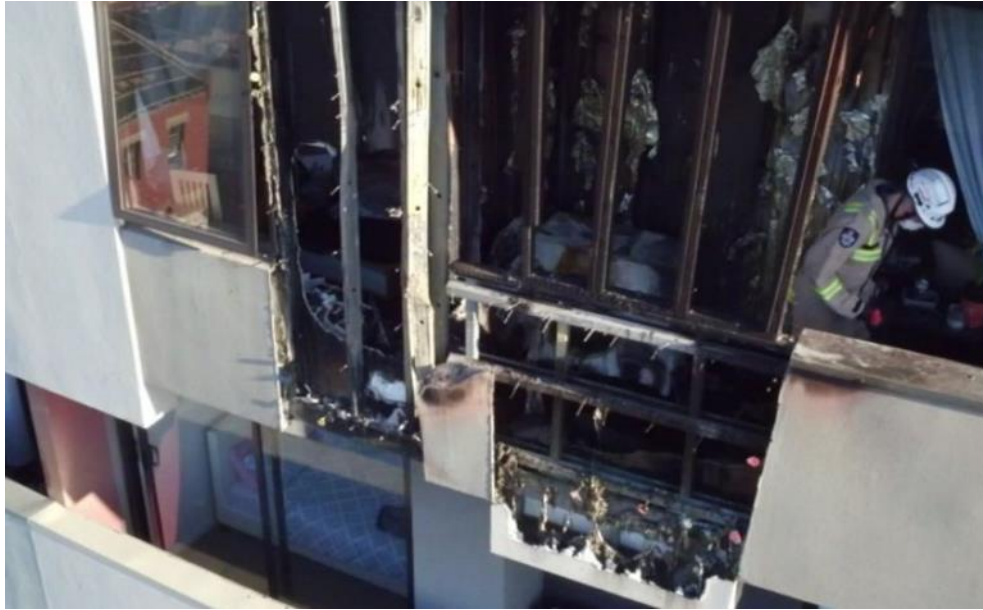
In March 2017, a fire developed on the cladding of a Class 2, apartment complex consisting of 105 apartments, retail tenancies and nine offices tenancies. The building is clad with a combination of EPS EIFS and aluminium composite cladding. The fire was believed to be started by a faulty air conditioned unit<sup>[74]</sup> on the balcony of one apartment and spread mainly via the EIFS to another apartment on the next level above. The Municipal Building Surveyor (City of Moreland) has ordered that additional sprinklers be installed on each balcony within 3 months and all flammable cladding to be removed around fire hydrants and hose reels within two months. The overall cost of repair is estimated to be \$2 million.

Figure 31 - Photo of Anstey Square Complex after fire spread from one apartment to the next<sup>[74]</sup>

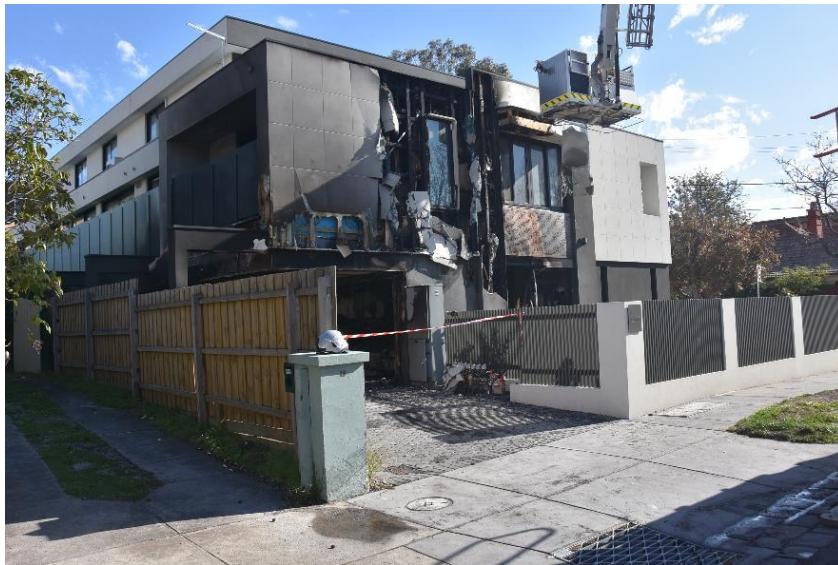
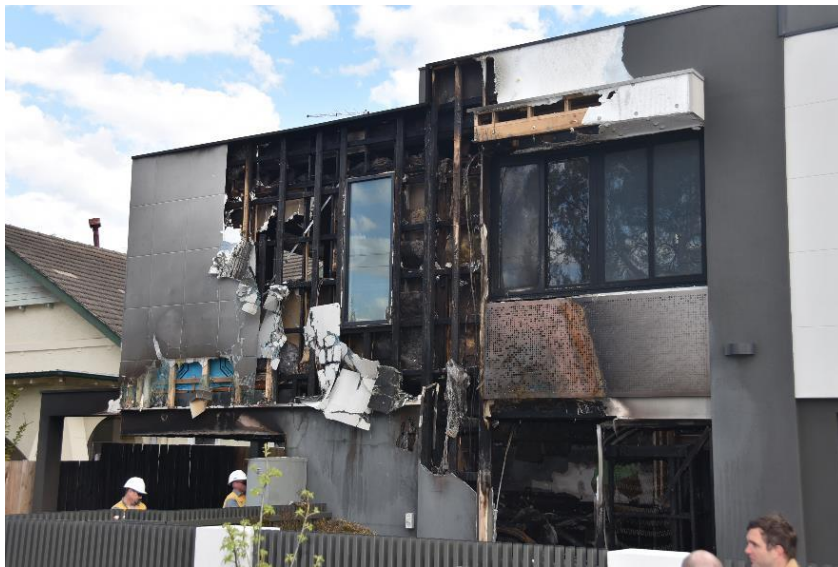
On the 27<sup>th</sup> of September, 2017, fire fighters were called to a fire within the garage of a two-storey unit. The fire spread onto the cladding of the building consisting of expanded polystyrene. The fire was caused by a leaking gas bottle stored in the boot of the car. MFB spokesmen David Rankin stated that fire fighters did an aggressive internal attack on the fire wearing BA units, taking 30 minutes to control the blaze. The two storey unit fronts onto Hughenden Street and adjoins a block of three storey units, however the post incident damage was confined to the front of the two-storey unit only. One occupant suffered burns to face and hands. Based on news article descriptions and photos this appears to be a Class 1 townhouse (attached) building.

**Figure 33 - Post fire damage to street frontage shown on two storey unit (Photos provided by MFB)**

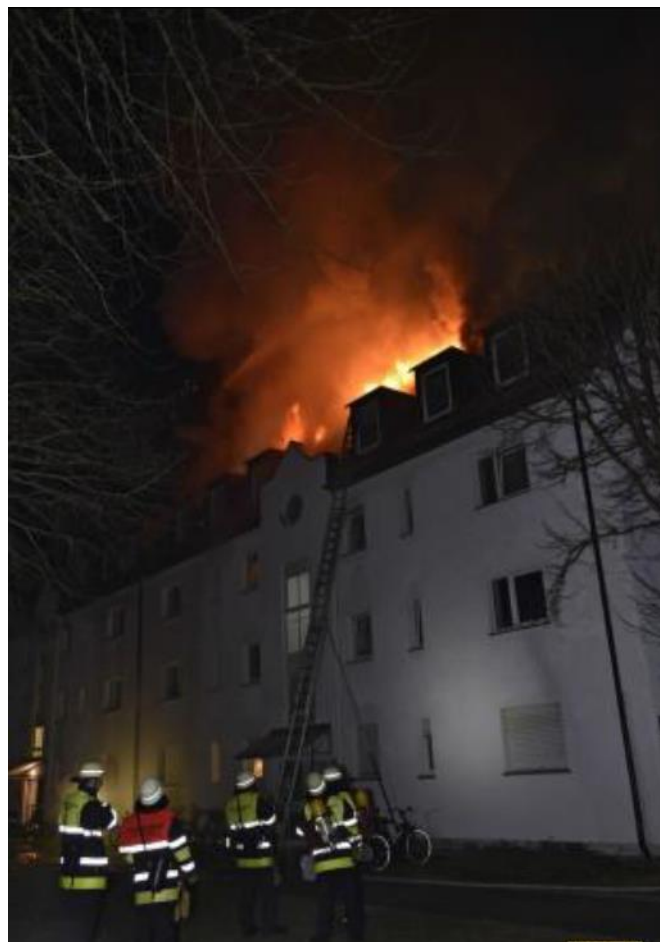
- On New Year's Eve night 2016, a fire initiated on a balcony and then quickly spread to the EIFS façade over two storeys and then into the roof truss.
- The insulation thickness was approximately 100mm thick.
- The fire caused four injuries however one person became a fatality a few days after the fire due to the injuries sustained during the incident. Estimated damage ~€200,000.

**Figure 34. Unterbiberger Straße, Munich EIFS fire 31/12/2016. Note photo appears to be taken from opposite side of building from fire start area. <sup>[75]</sup>**

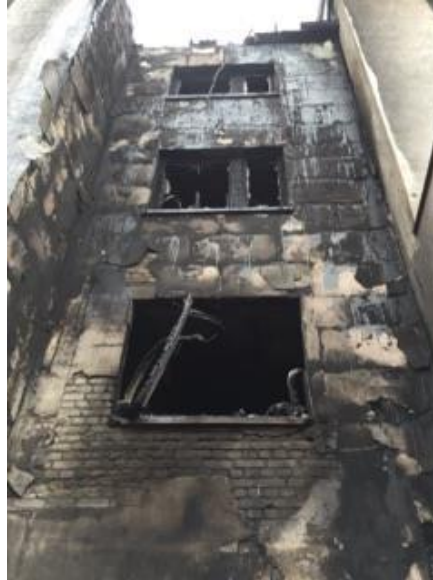
- On May 17, 2016, a fire was initiated by an overturned candle within a ground floor apartment. The fire spread to the EIFS via a ground floor window and then spread on the EIFS to the top of the building with fire spread into apartments on levels above via broken windows.
- The fire spread to the top of the building and the EIFS façade was completely burned.
- It was concluded that the EIFS façade system significantly enhanced fire spread.
- The building had no sprinkler protection.
- Three fatalities (one adult, three children) and 28 injuries were incurred.

Figure 35 – ETICS Façade fire at Apartment building in Duisburg <sup>[75]</sup>

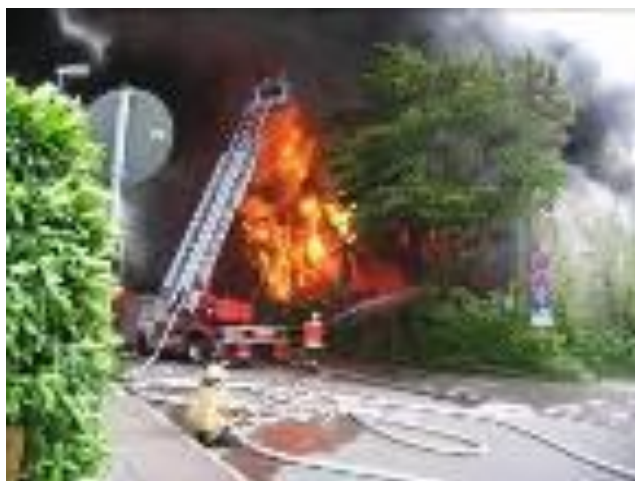
- Building of fire origin was building Class 3, special building less than 7 m height (as defined by MBO). Based on fire incident description it appeared to be a public assembly/hall type building.
- On the 31<sup>st</sup> of May, a fire started due to sparks or heat source from construction igniting the insulation material. Based on description it appears that the building may have been either under construction or renovation at time of fire.
- No details are provided on the EIFS except that no cavity fire barriers were installed. The degree to which the render was installed is not stated.
- The hall appears to have been destroyed and two adjacent houses damaged by heat.
- Significant smoke production resulted in evacuation of several nearby buildings and surrounding parts of the city/town centre being closed for several hours.
- No fatalities or injuries. Estimated damage ~ €600,000.

Figure 36. Ditzingen EIFS fire 31/05/2012<sup>[75]</sup>

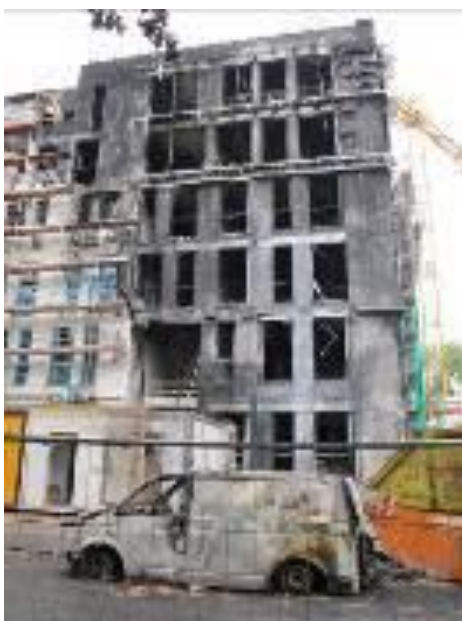
- The fire rapidly spread to the top of the building and horizontally over a substantial area of building exterior with fire damage to interior of building at all levels prior to fire brigade suppression. A large amount of smoke production was noted in the incident report.

- Cavity fire barriers were destroyed over a large area.
- No fatalities or injuries but damage estimated to be ~€1.5 Million.

Figure 37. Frankfurt EIFS fire 29/05/2012<sup>[77]</sup>

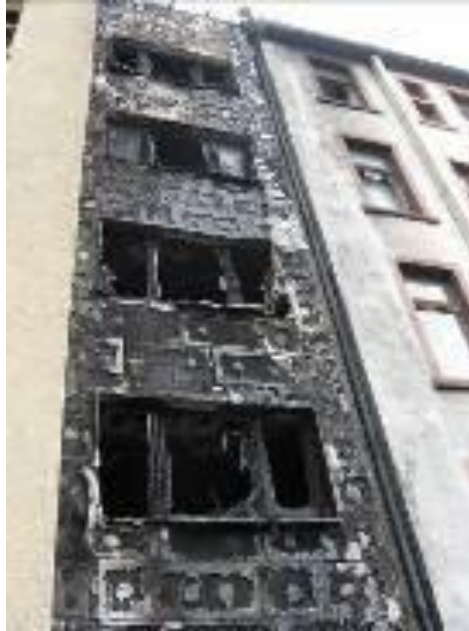
- On the 20<sup>th</sup> of March, a rubbish container/bin fire at the external base of the EIFS facade of a seven-storey residential building resulted in fire spread to the top of the building.
- Building class: G (defined by older version of HBO). EPS Insulation layer thickness ~ 60 mm.
- It is not clarified if sprinklers were installed and functioning within this building. It is not clarified if cavity fire barriers were installed within EIFS.
- The fire brigade had to rescue several people using rescue equipment.
- No Fatalities, 21 injuries and estimated damage of €500,000.

Figure 38. Frankfurt EIFS fire 20/03/2010<sup>[77]</sup>

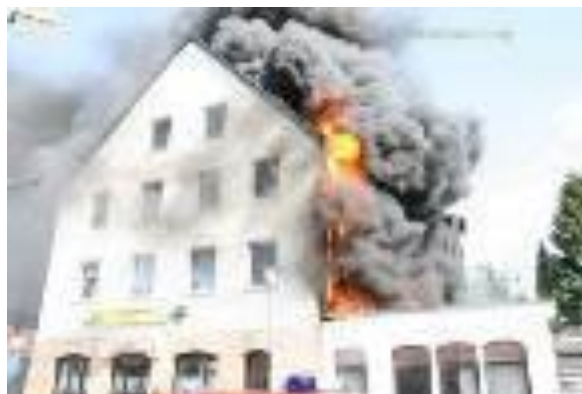
- On the 22<sup>nd</sup> of May, a fire was reported to have started due to works being conducted on the roof.
- Four storey apartment building clad with EPS EIFS. Details of EIFS not reported.
- Details of sprinklers not reported but building height would not require sprinklers.
- Fire rapidly spread on EIFS with some fire spread into apartments.
- One resident was rescued from apartment by acquaintances before the arrival of firefighters, and before fire rendered apartment untenable. Based on photo there was significant smoke production.
- No fatalities, one injury, estimated damage ~ €250,000.

Figure 39. Aachen EIFS fire 22/05/2009<sup>[75]</sup>

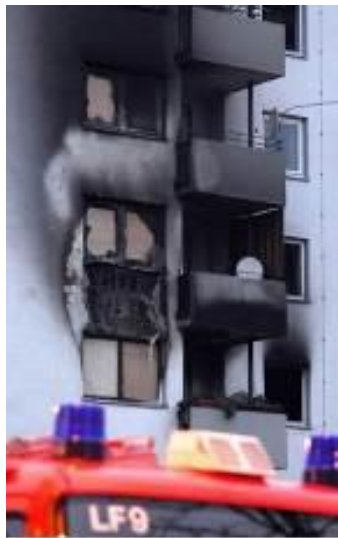
In the apartment of fire origin on the second floor there was one fatality and one injured person. However, there was a subsequent flashover in the apartment on the fourth floor resulting in four fatalities and two persons reported as injured with extensive smoke spread through the buildings and the fire stairwell. Several people were rescued by the fire department.

Figure 40. Cologne-Mülheim, Germany 24/12/2005<sup>[75]</sup>

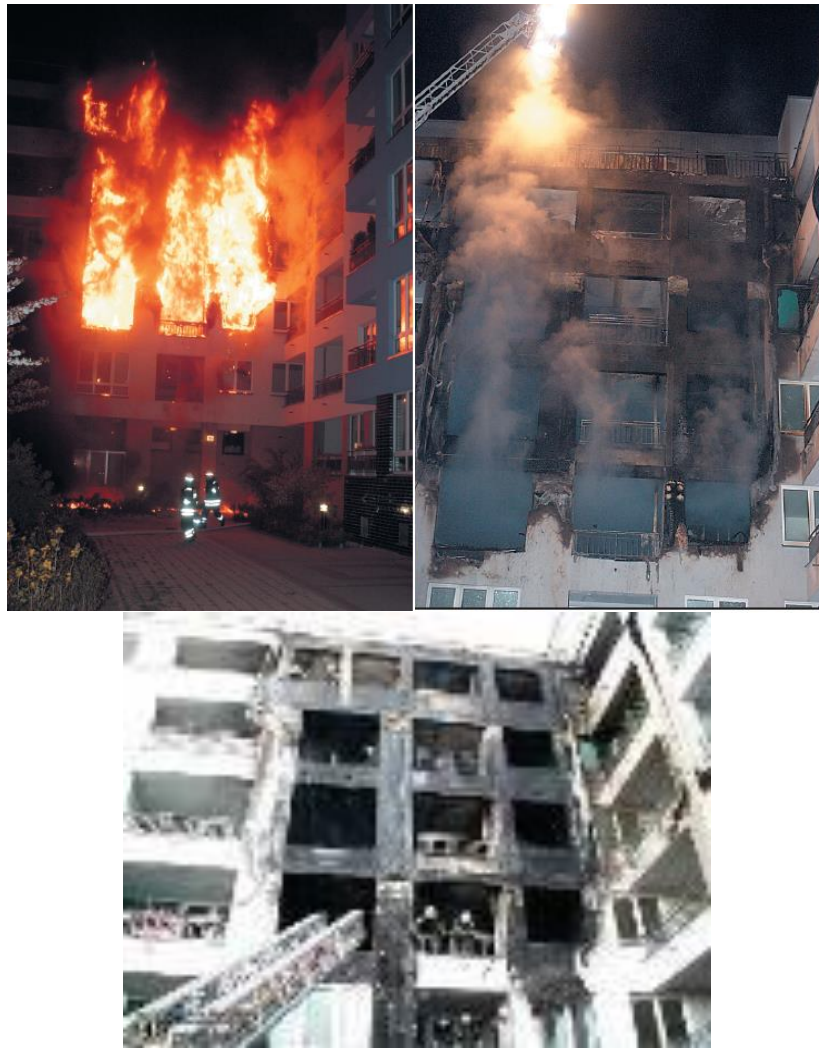
Figure 41 – The stage of the fire upon the arrival of the fire brigade (LHS) and Post fire damage (RHS and bottom)<sup>[77]</sup>

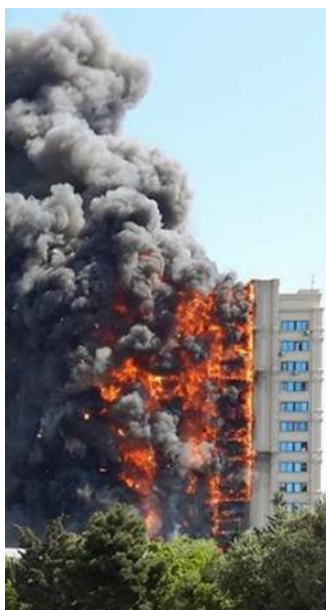
- Fire occurred at 10:00am on 19 May 2015 in a soviet style residential building consisting of 16 floors housing 200 apartments.
- According to tenants – fire began in first floor and swept through entire building within seconds.
- 15-17 fatalities with 63 injured.
- A refurbishment of the facade had occurred. The choice of cladding for this building is unknown, however there are claims in the media suggesting that either ACP or 'Styrofoam' facing (EIFS) was used on the façade.
- Those that stayed in place within non affected apartments did not suffer any injuries however those that attempted to escape the building were affected by the toxic smoke.

Figure 42 - Baku High Rise residence fire, Baku, Azerbaijan (2015)

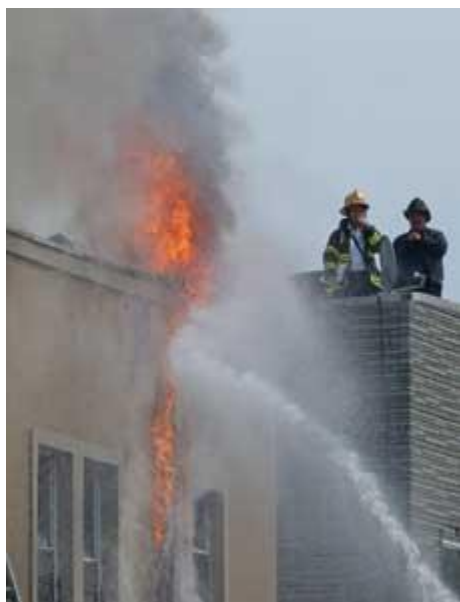
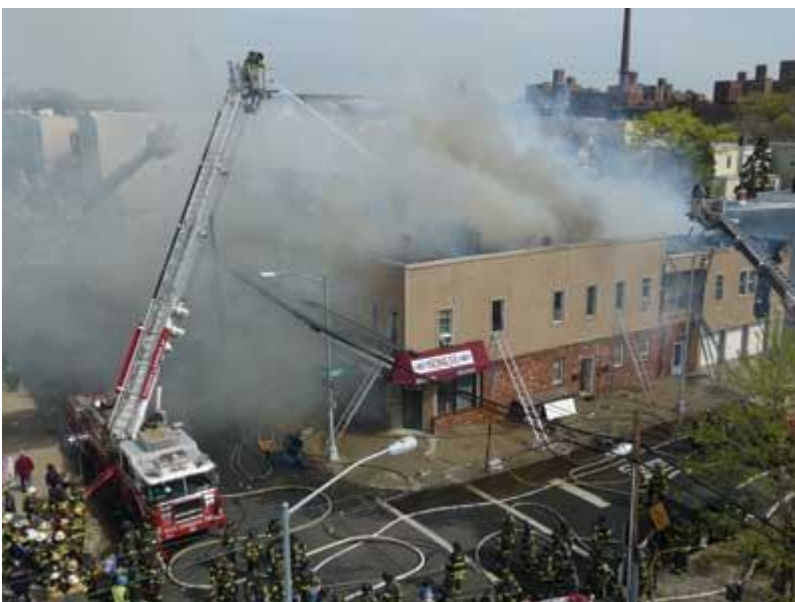
Figure 43 -Flames burn vigorously above the roof line of the EIFS-clad structure (left), View of opposite side of building (away from area of fire spread) <sup>[78]</sup>

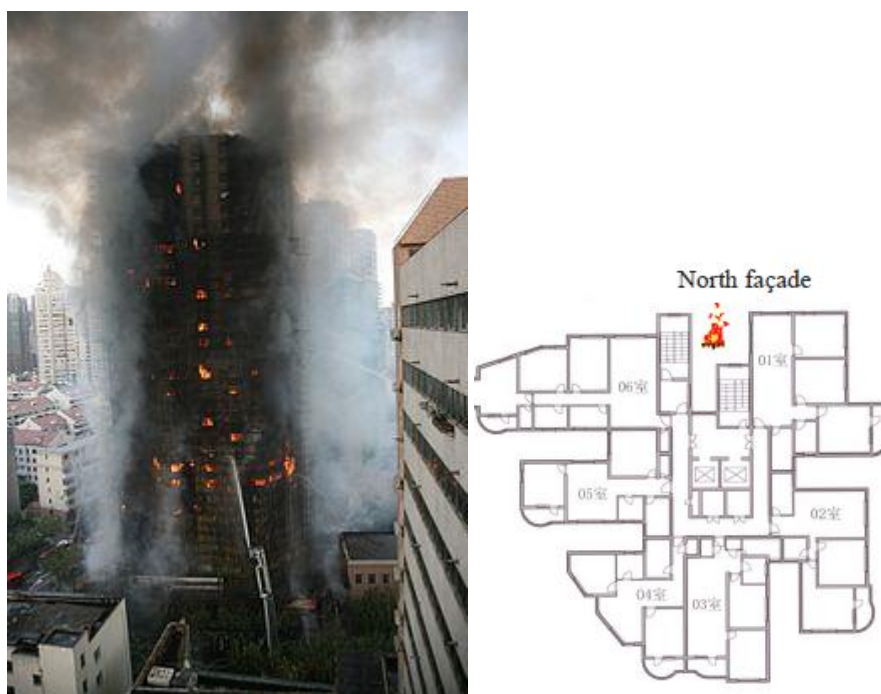
Figure 44 –Plan view of the building showing the outline of the external face of the building and location of fire.<sup>[79]</sup>

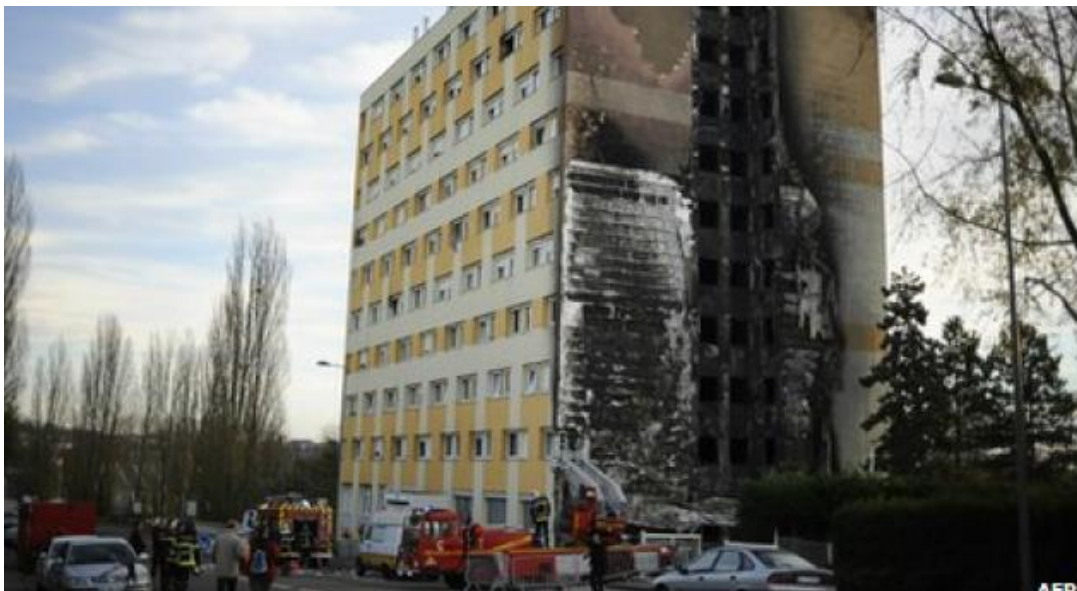
- On 14<sup>th</sup> of November 2010 a fire within an immigrant hostel resulted in seven fatalities and eleven injuries.
- Ignition source was an external garbage container at base of building that resulted in rapid fire spread.
- The building is believed to have been EIFS with EPS insulation and mineral wool barriers however no detailed fire brigade reports have been found.
- 130 occupants were evacuated. Some occupants jumped from windows.
- The significant smoke spread within the building prevented many occupants from escaping.
- It was reported that the wind was blowing flames against wall.
- From the image below, it seems that the fire spread is concentrated along the vertical ‘U-shape’ channel created for balconies.

Figure 45 – Dijon France Immigrant hostel post fire damage<sup>[80]</sup>

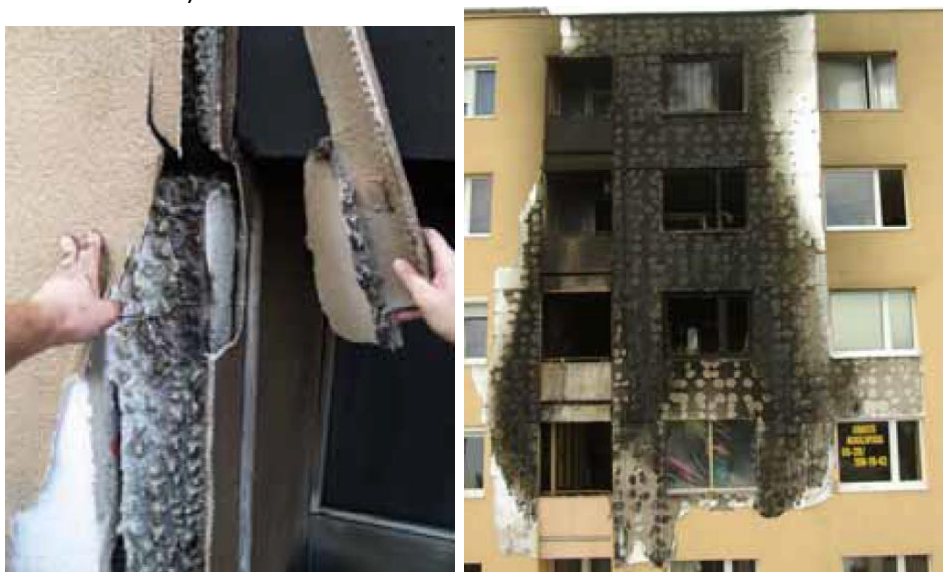
- On the 15<sup>th</sup> of August 2009, a kitchen fire started on the sixth floor resulting in vertical fire spread along the exterior of the 11-storey building.
- There were three fatalities.
- The building was built in 1986 but refurbished in 2007. The refurbishment included polystyrene based EIFS.
- Smoke spread internally through stair and mechanical shafts.
- An Investigation into the incident outlined the following issues:
  - The building was not constructed in accordance to industry requirements.
  - Use of polystyrene insulation.
  - Inadequate sticking or fixing of lamina to polystyrene sheets.
  - Absence of mineral wool insulation as fire propagation barriers (especially around window reveals).

Figure 46 – EIFS fire in Miskolc showing damage to cladding (LHS) and extent of damage to façade (RHS)<sup>[81]</sup>

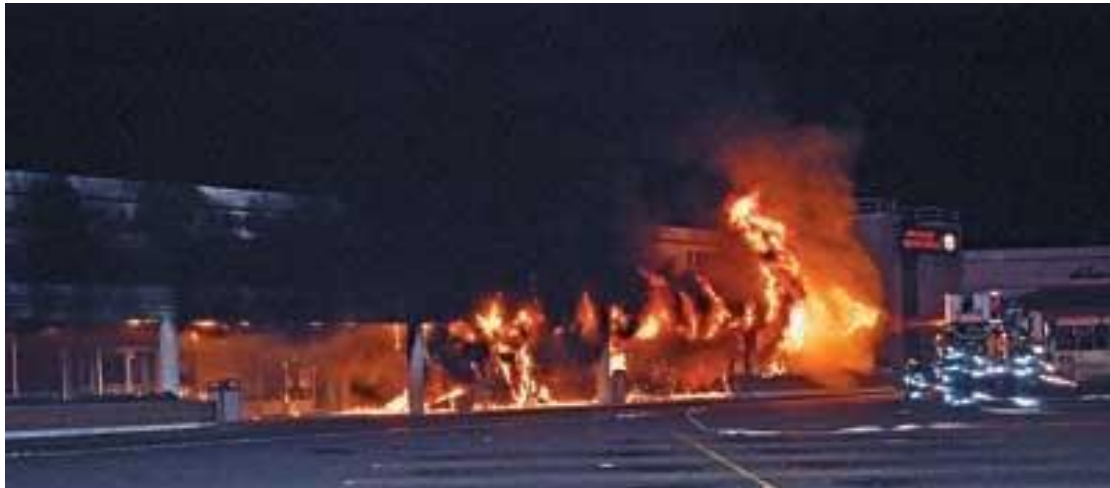
- The building was approximately 250 feet long and 100 feet deep.
- The cause of fire was arson. The arsonist broke the front window which exposed the fire to the EPS on walls and overhang.
- Flaming molten EPS showered on the front of the building. Firefighting operations (forcible entry, search and rescue, hose line interior attack, roof ventilation and ladder placement) were suspended until outside water streams were started.
- No injuries were reported however there was significant damage to all occupancies.

Figure 47 -Flames burn vigorously on walls and overhang

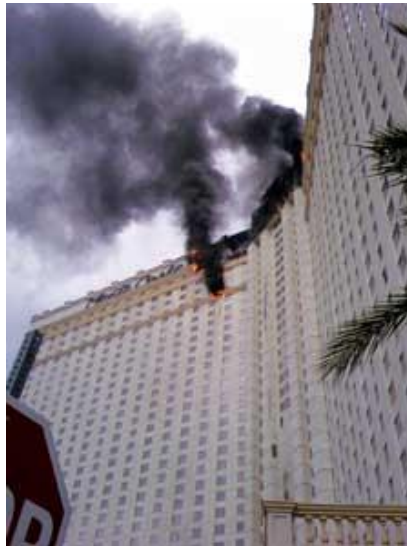
1. The main contributing material to the fire was the combination of materials in the decorative band at the top of the wall, the decorative band at the top of the 32nd floor (EPS with a polyurethane resin coating) and the undetermined materials in the medallions.
2. Flaming droplets and burning pieces of EPS and/or polyurethane caused ignition of the large decorative band at the 29th floor. This decorative band was composed of EPS and had a non-EIFS coating.
3. EIFS in the flat portion of the parapet wall was involved in the fire however was not the main contributor even though it appeared to have a non-complying thickness of lamina. As the fire progressed along façade made of the non-EIFS polystyrene (encapsulated in a polyurethane resin), it continued to involve the EIFS, but did not contribute significantly to the spread of fire.

Figure 48 – Monte Carlo Casino Façade Fire (2008)

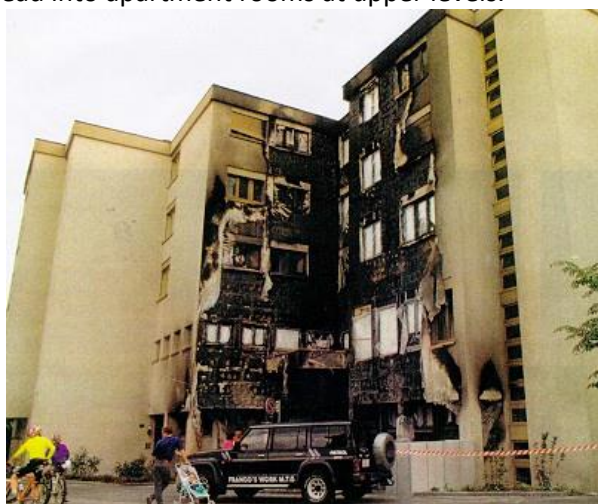
- The façade of a five-storey apartment made of 100mm EPS EIFS ignited from an external rubbish container fire.
- Fire spread vertically to the top of the façade and the heat generated from the fire caused windows to break causing fire spread into apartment rooms at upper levels.

Figure 49 - Munich EIFS fire 1996<sup>[78]</sup>

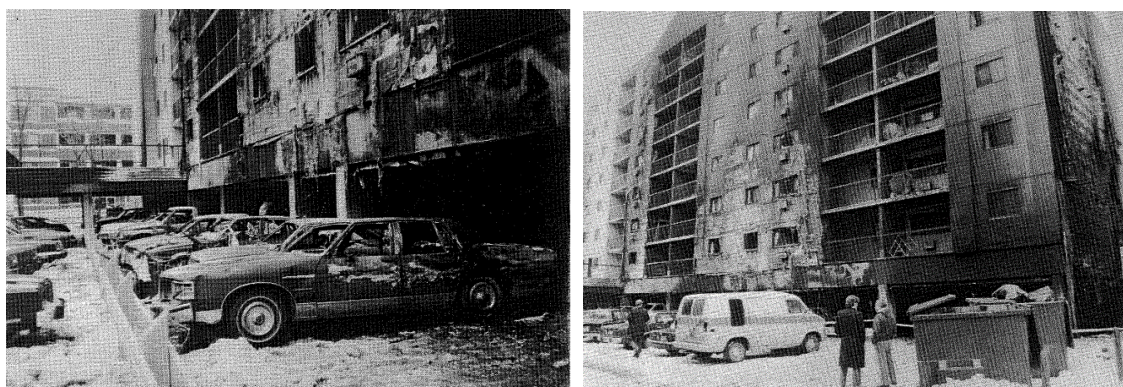
Figure 50 - Damaged cars outside east wall (LHS) and extent of damage to east and north walls (RHS) <sup>[82-84]</sup>

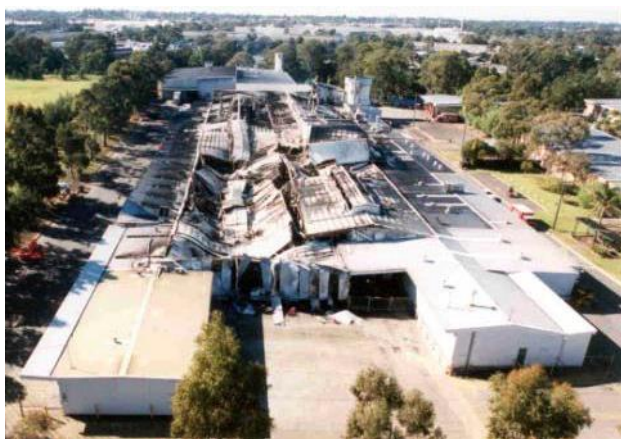
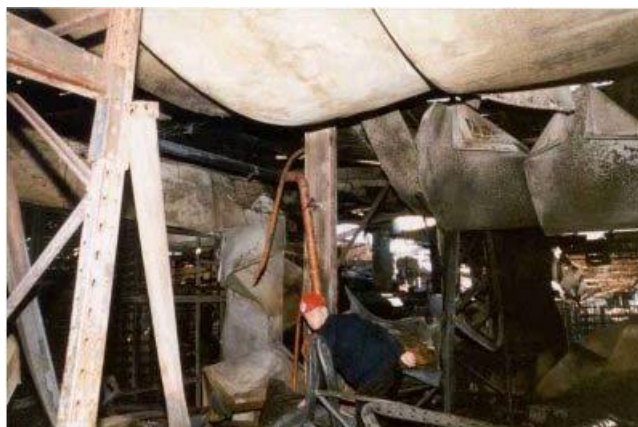
- Single storey large factory of 10,000m<sup>2</sup> with walls and some areas of roof constructed of EPS ISP.
- The building had no sprinkler protection, but it had a thermal fire detection system connected to fire brigade monitoring.
- On 2 June 2002, the failure of the gas fired heating system resulted in the ignition of polenta flour. The fire then spread to EPS ISP structure.
- The Fire Brigade had to conduct defensive firefighting due to poor water supply and rapid fire spread to EPS sandwich panels.
- The fire incident report highlights the structural collapse of the EPS sandwich panels as a governing factor from the switch from offensive to defensive.
- Fire caused destruction to most of the building with a total loss estimated to be \$100 million.

Figure 51 Tip Top Bakery fire 2002<sup>[87]</sup>

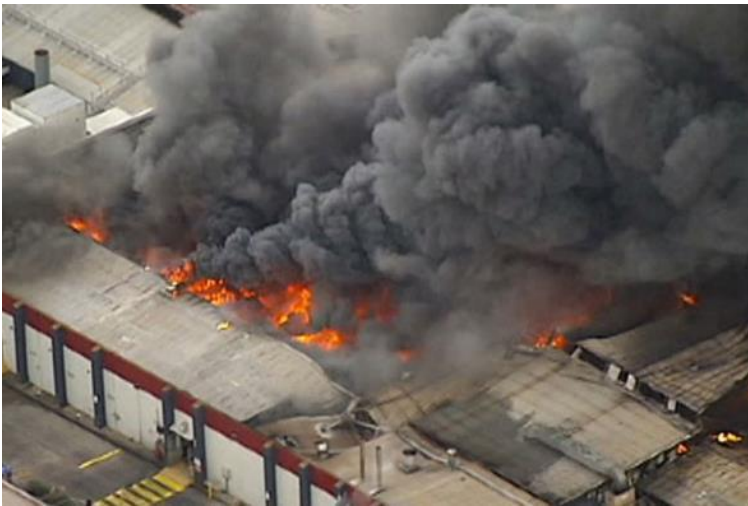
A new extension to the existing EPS cold store had been constructed from PIR. The fire burnt up to the PIR wall but did not penetrate, the PIR section was left largely intact.

Figure 52. Ingham Chicken factory fire, 2010<sup>[88]</sup>

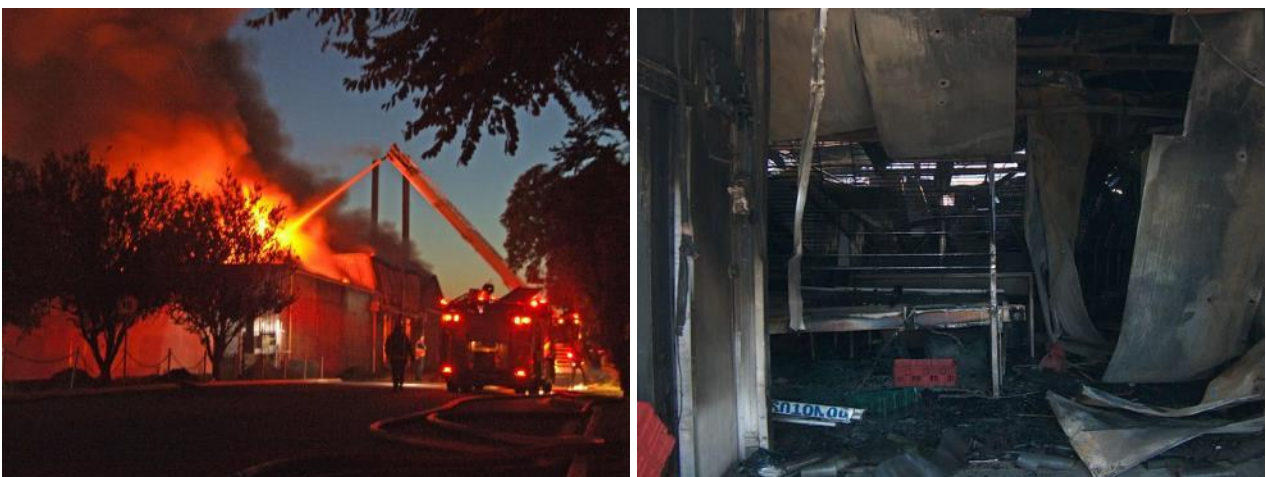
The Tegel Poultry Processing Plant in the Christchurch suburb of Hornby was destroyed by fire on 5 January, 2007. The total losses are estimated to be between NZ\$50m and NZ\$100m. The building was constructed of EPS ISP.

Figure 53. Tegel factory fire 2007 <sup>[90]</sup>

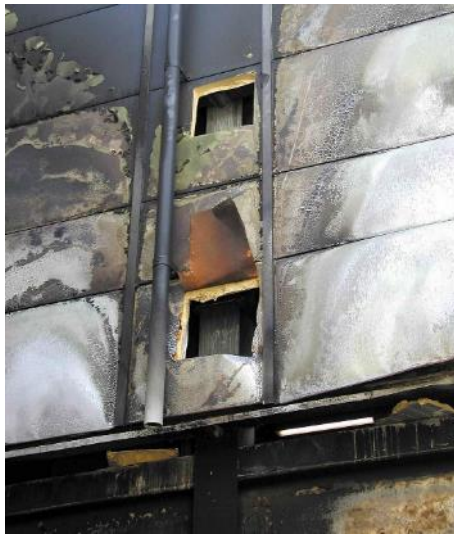
- The building had steel frame and all floors were concrete. First and second floor were clad with 70mm thick PIR Insulated Panels approved by LPCB to LPS1181 Part 1 2003 as Grade EXT-B.
- Direct flame impingement occurred on the cladding up to 10 m high from the ground floor.
- Post fire inspection holes cut to inspect steel columns revealed that the PIR core was unaffected except for surface char in area of flame impingement to steel skins.
- Fire did not spread to the levels above. There was damage to the metal skin of the cladding, but no fire spread or deep charring on the insulation of the wall panels.

Figure 54 – PIR Insulated sandwich panel post fire on Wharfedale Hospital, UK
