# Literature Review on Fire Safety of Exterior Insulation Finish Systems and Insulated Sandwich Panel as External Wall Systems

Author: Nathan White, Neythra Weerakkody, Joe Sam Abraham  
Proposal number: FE2925

Document Number: EP192002  
Date: 29 September 2020  
Revision: Revision G

Client: Victorian Building Authority (VBA)

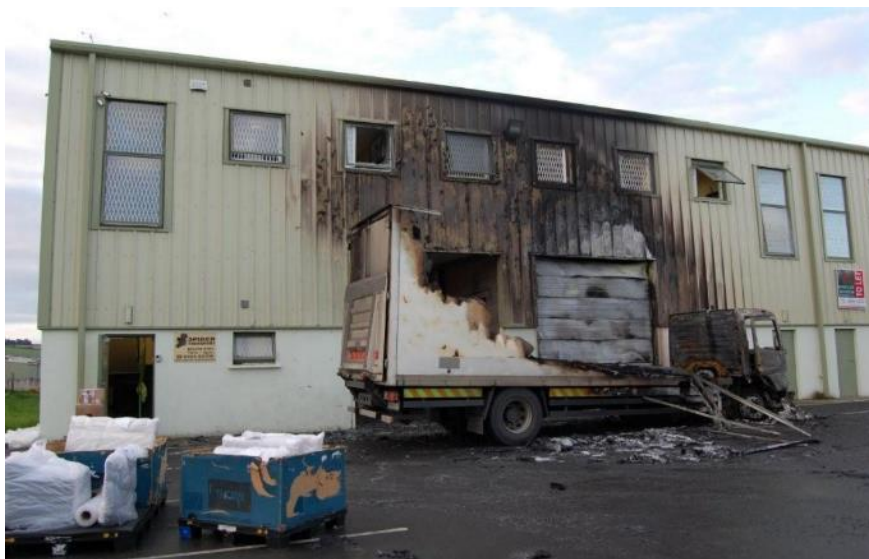
- The upper part of the wall was clad with ISP with PIR core. The sandwich panels complied with LPCB Grade EXT-B to LPS1181: 2003.
- Fire was started by arson by pouring flammable liquid into the cab area of a truck parked just outside the building ~1m away from external wall. The truck was destroyed in the fire.

- Flames from the truck directly impinged the ISP.
- The PIR ISP did not support fire spread on the external wall beyond the area of direct fire impingement from the truck fire. The ISP did not delaminate, or loose integrity and the fire did not penetrate to the interior of the building via the ISP, although some internal fire damage resulted via the roller door and broken windows.

Figure 55. Spider Transport fire<sup>[95]</sup>

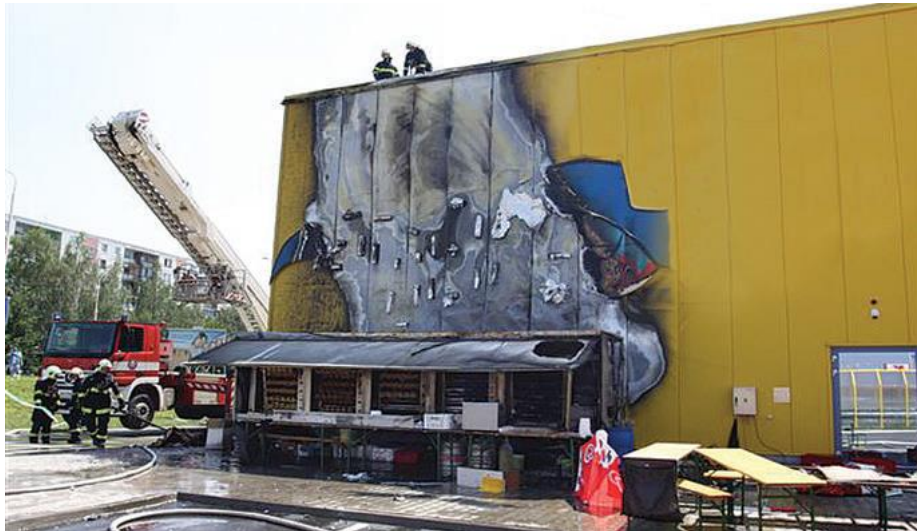
Figure 56 – PIR Insulated Sandwich panel post fire damage on Furniture Retail Warehouse, Slovakia

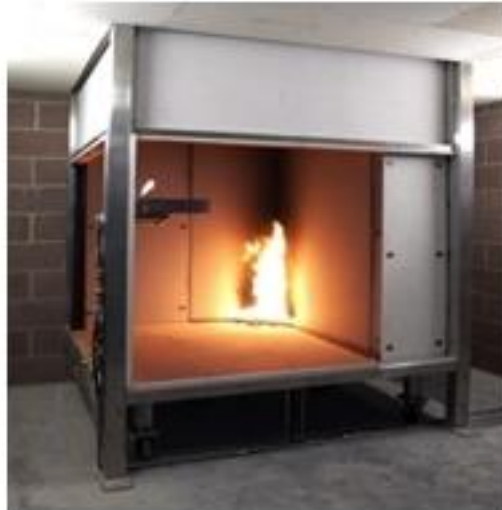
**Figure 69.** SBI test<sup>[127]</sup>

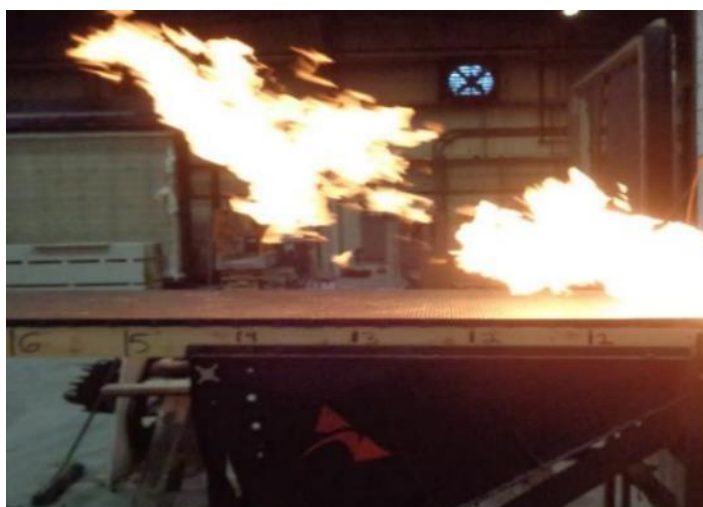
Figure 73. ASTM E-108 Spread of flame test

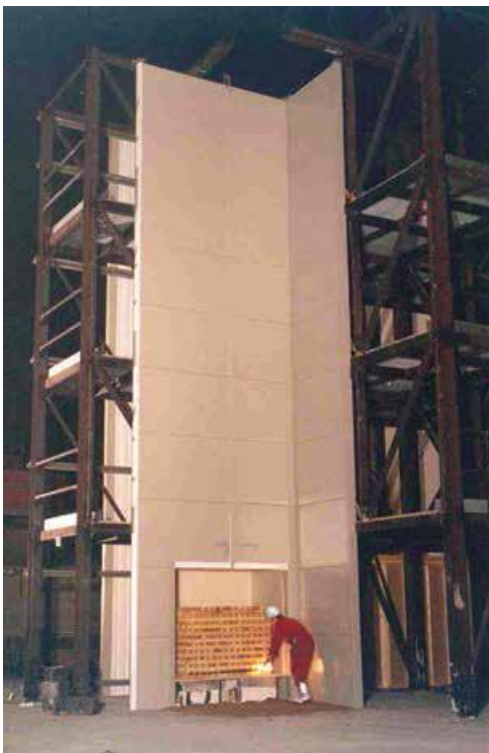
**Figure 80.** BS8414-2 test rig (from BRE report BR135<sup>[157]</sup>)

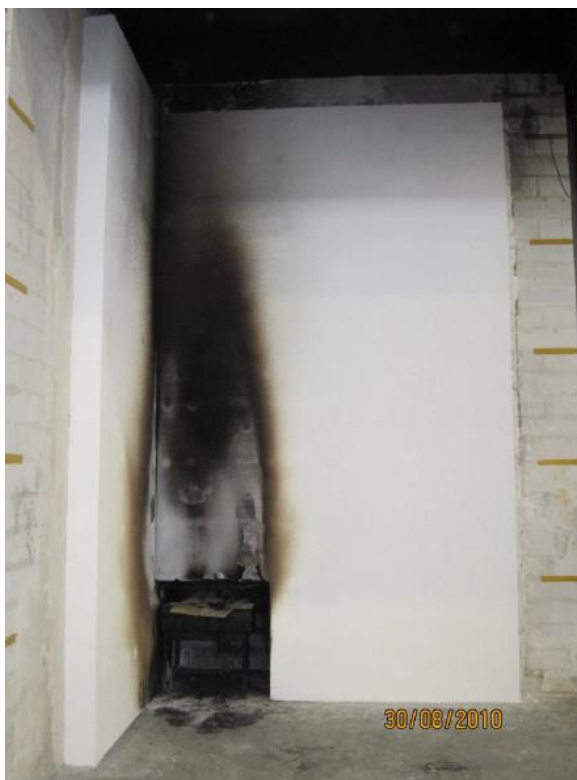
**Figure 81. DIN 4102-20 (Draft) test rig (From BRE Global<sup>[159]</sup>)**

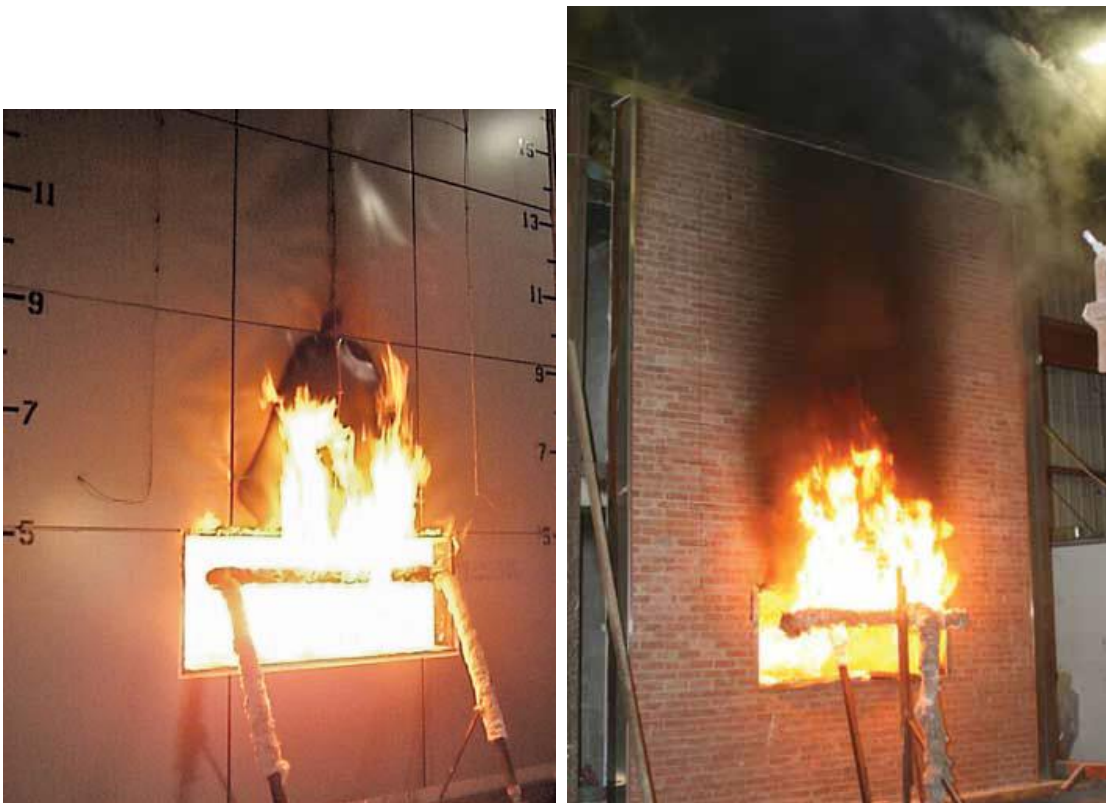
**Figure 83.** Front view of typical NFPA 285 test (from Hansbro<sup>[162]</sup>)

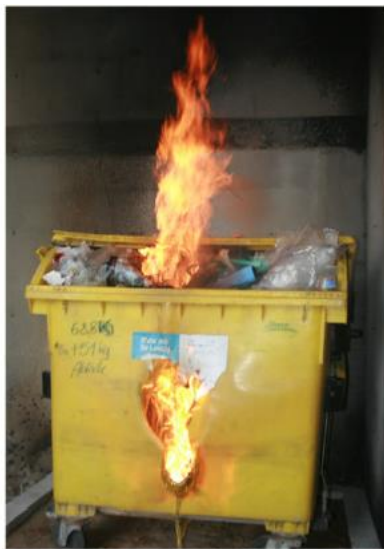
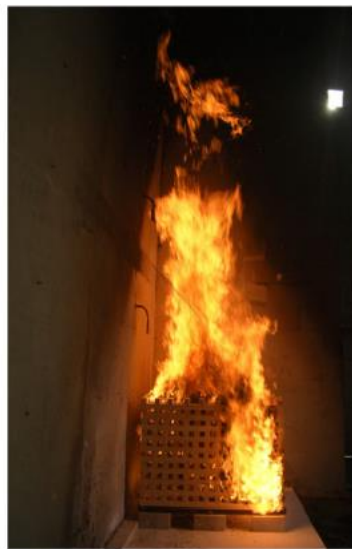
- Fire tests on large HDPE garbage bins with different rubbish contents resulted in:
  - For single bin – Maximum HRR in range 2.0-5.0 MW. Maximum flame heights in range of 2.5-3.0 m (short peaks up to 4 m).
  - For two bins – Maximum HRR of ~6.7 MW. Maximum flame heights in range of 4.0-4.5 m.
- Based on this a 200 kg wood crib was selected as a suitable larger ignition source. It had a maximum HRR in range of 2.8-3.4 MW and maximum flame height of 4-5 m (short peaks up to 7 m).

Figure 86. 200 kg crib dimensions, temperature profile and HRR against non-combustible façade<sup>[167]</sup>

- The 200kg crib was applied to a 9.7 m test wall with a main/wing wall façade arrangement made of an aerated concrete substrate.

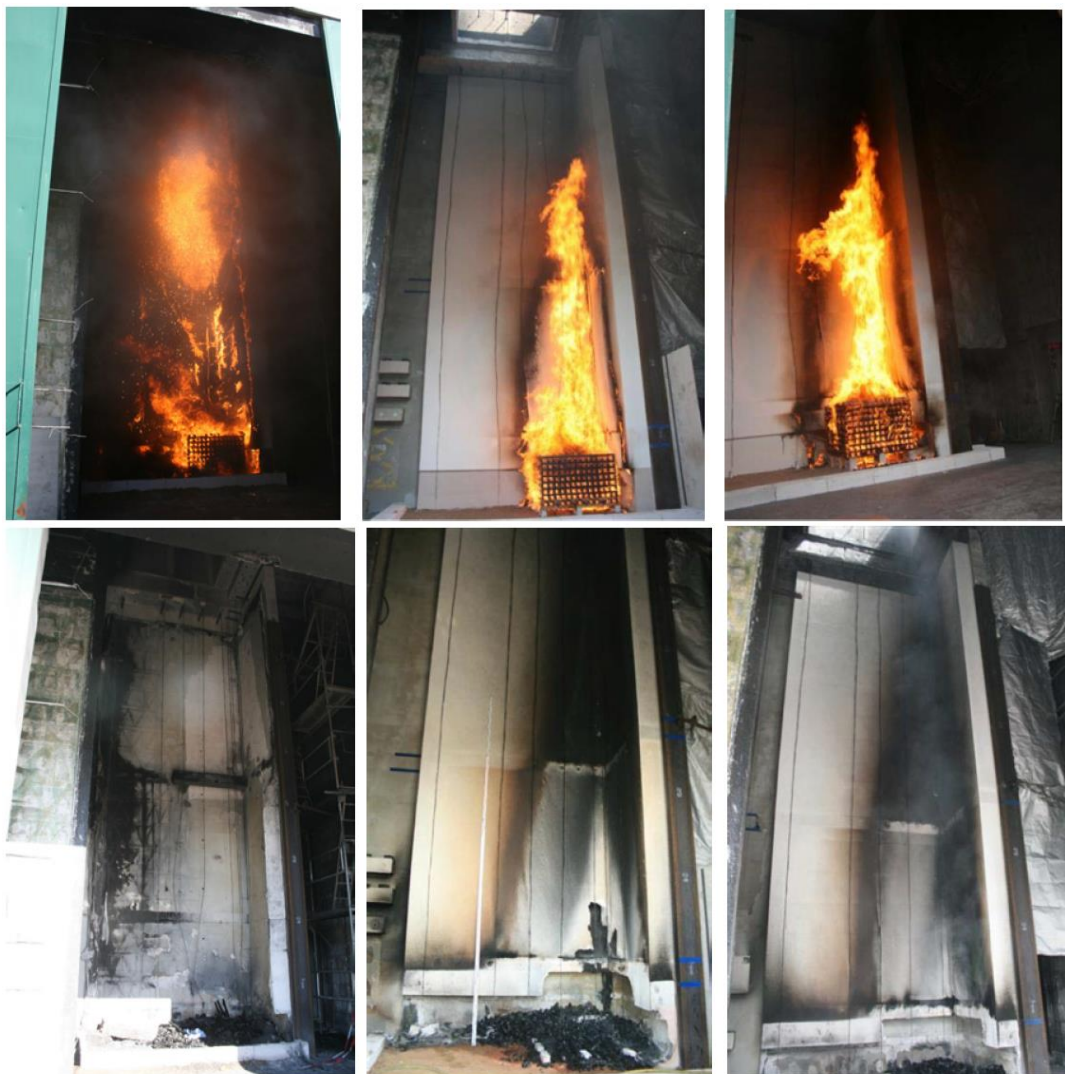
Figure 89. Test 1 at 15 min and post-test (left); Test 2 and 3 at 18 min and post-test (middle and right) <sup>[167]</sup>

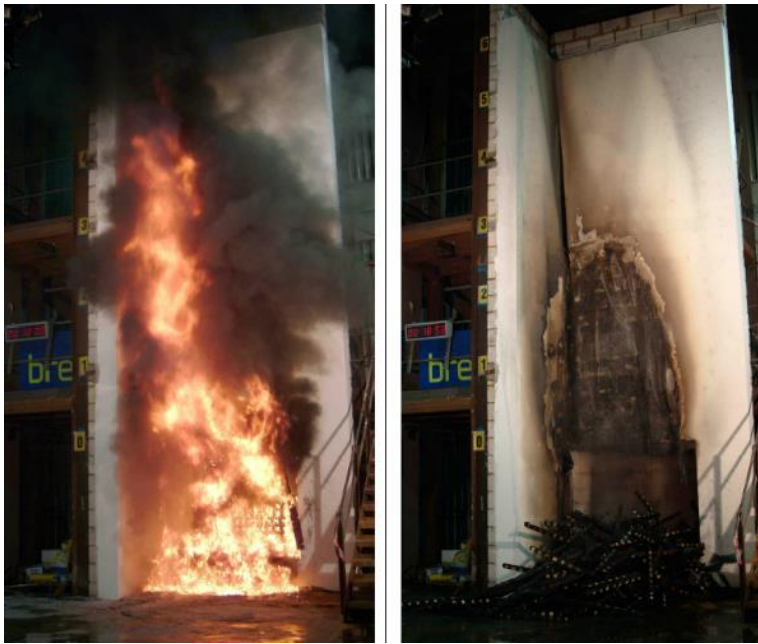
Figure 92. BRE BS 8414 test on 200 mm EPS with organic render resulting in BR 135 criteria fail before and after test suppression<sup>[159]</sup>

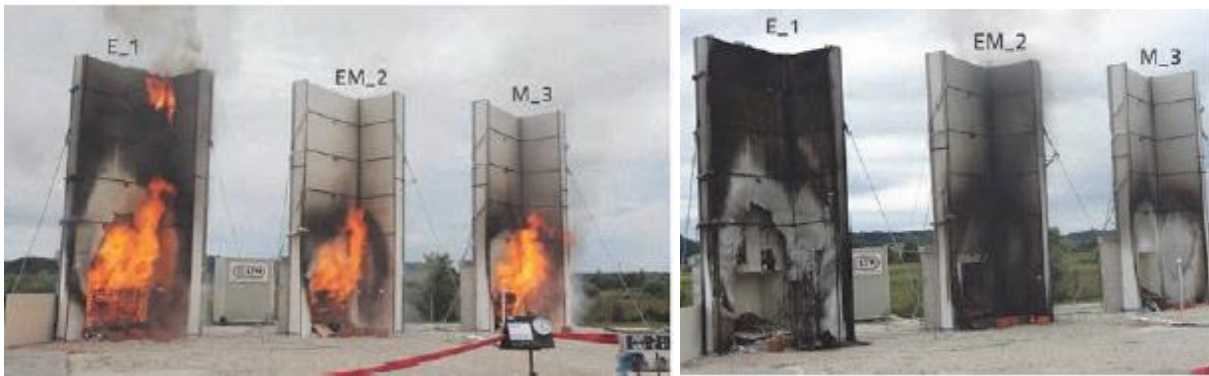
Figure 93. EIFS BS 8414 tests at 21 minutes and after suppression<sup>[169]</sup>
