# PROACTIVE INSPECTIONS REPORT

## Activity Report

FINANCIAL YEAR 2023-24

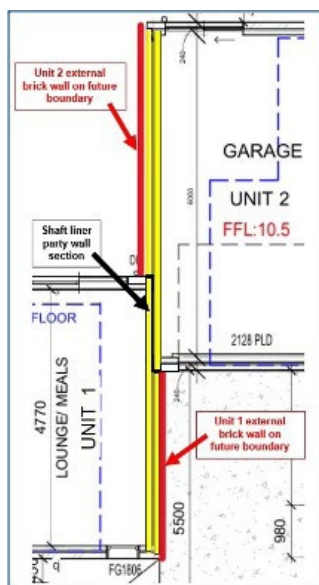
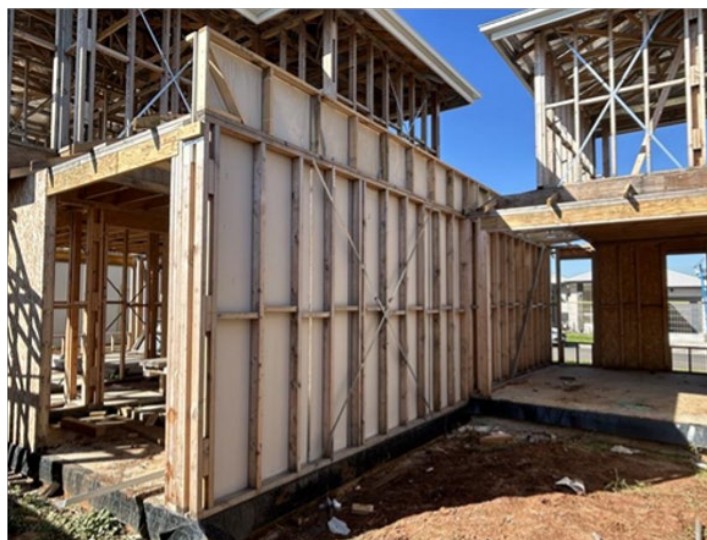
The approved amendment to the permit plans successfully achieved the required fire separation design by shortening the shaft liner to the area where the two buildings are directly adjacent. The front and rear sections of the shaft liner were replaced with external brick walls built along the proposed boundary at the front of dwelling 1 and the rear of dwelling 2. This revised design ensures consumer will not face significant property damage from fire spreading from the neighbouring building.

The future line of subdivision will zigzag, from the external face of dwelling 1 brick wall, step in through the centre line of the shaft liner section, then continue along the external face of the dwelling 2 brick wall.
