PRACTITIONER EDUCATION SERIES

# Proactive Inspections Program Findings: Buildings

# Common issues in timber framing

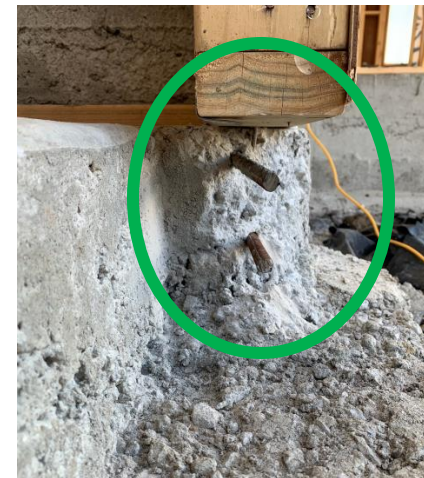
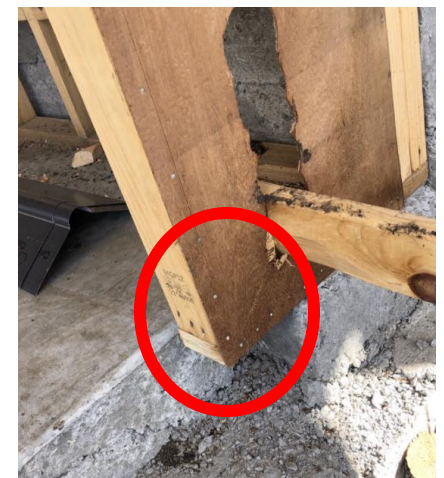
- Reinforcement starter bars into edge of concrete and bulk pour concrete

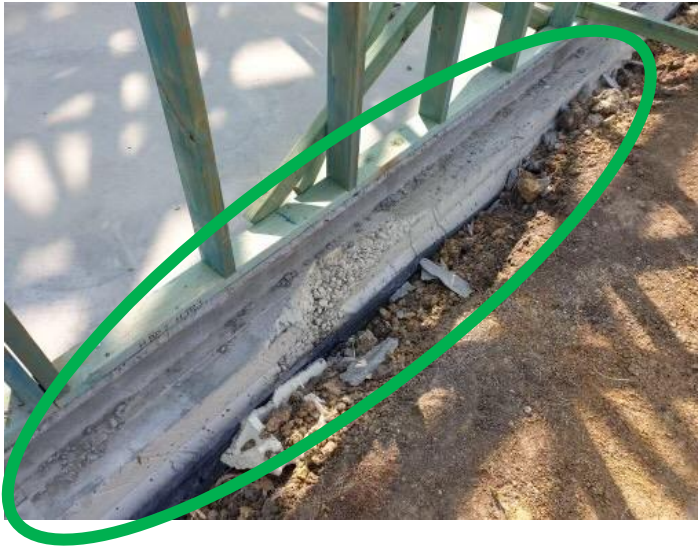
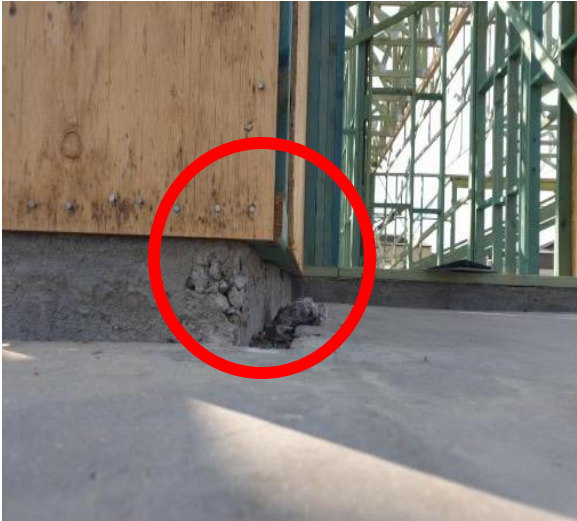
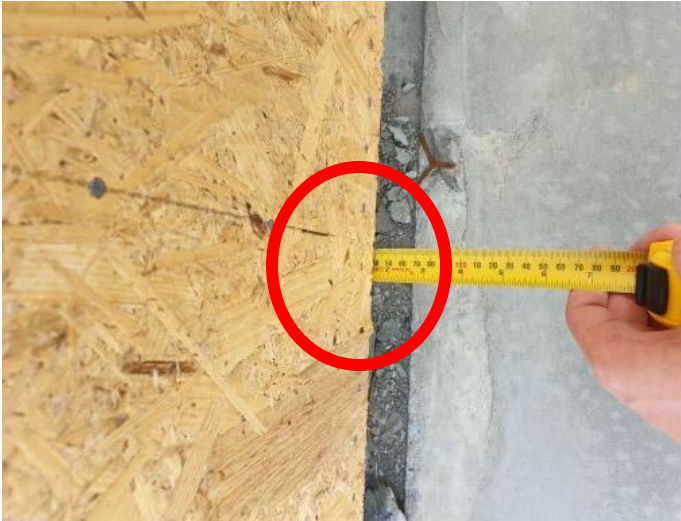
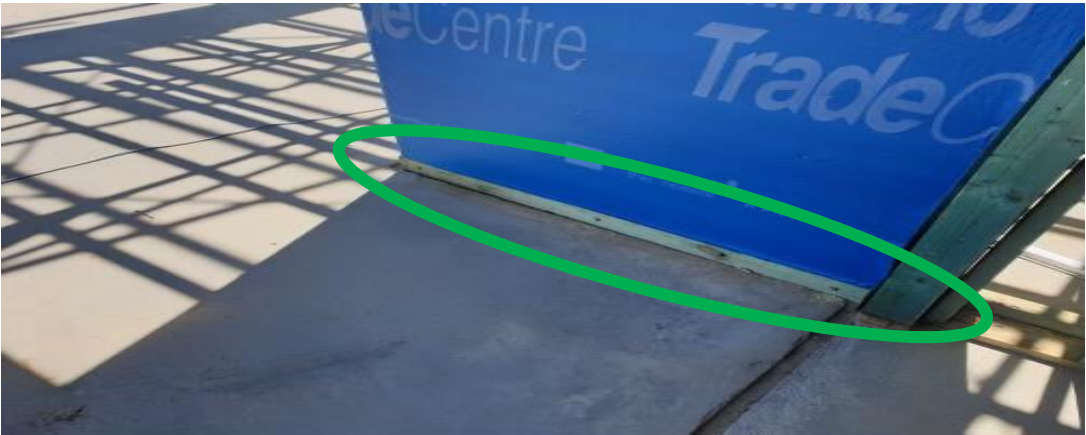
# Bottom Plates that overhang concrete slabs

- Under AS1684.2 there are no prescribed allowance for timber frame overhangs.
- The Guide to Standards and Tolerances (currently under review) only allows a 90mm wide stud to overhang a maximum of 10mm
- Areas that exceed the allowed tolerance require a review from the relevant registered civil engineer to provide evidence that compliance with the NCC 2019 Volume 2 Part 2.1 is being achieved.

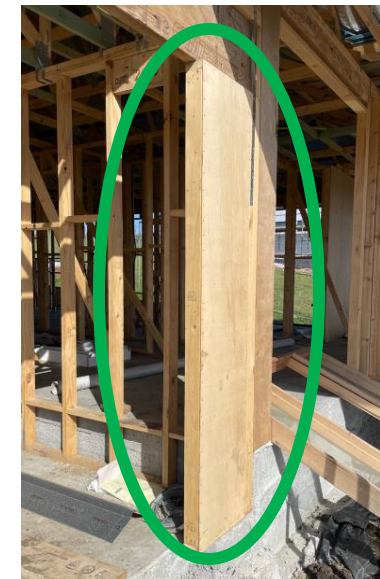
- Penetrations have occurred within the sheet bracing contrary to the manufacturers installation guidelines.
- It is critical to ensure that the manufacturers installation guides are being followed.
- Unless otherwise specified the sheet bracing must span a minimum of 900mm wide

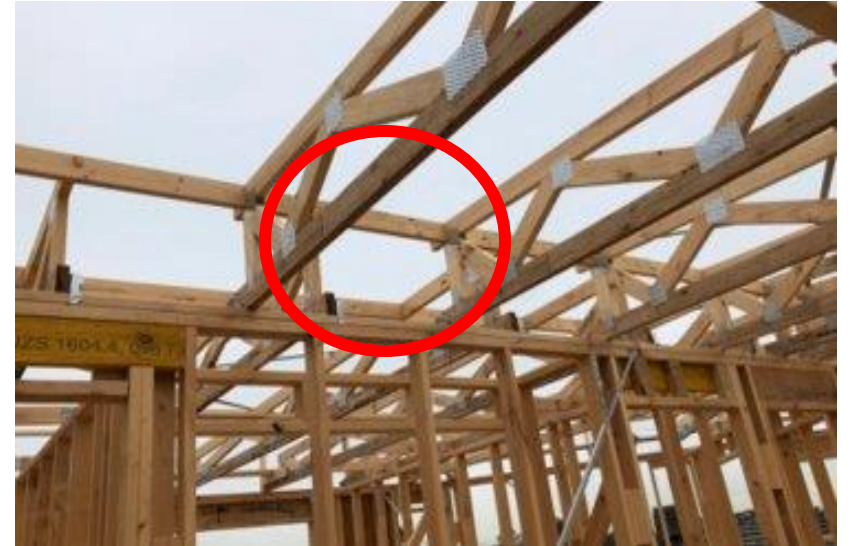
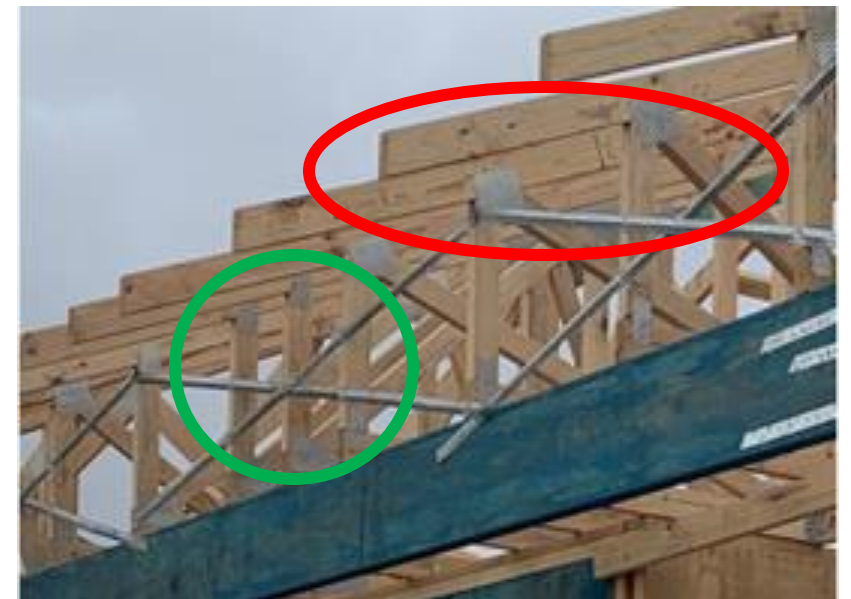
- Timber diagonal bracing installed to cut-off/half trusses
  - Speed bracing installed to half trusses
  - Blocking and fixing not provided as per manufacture's details

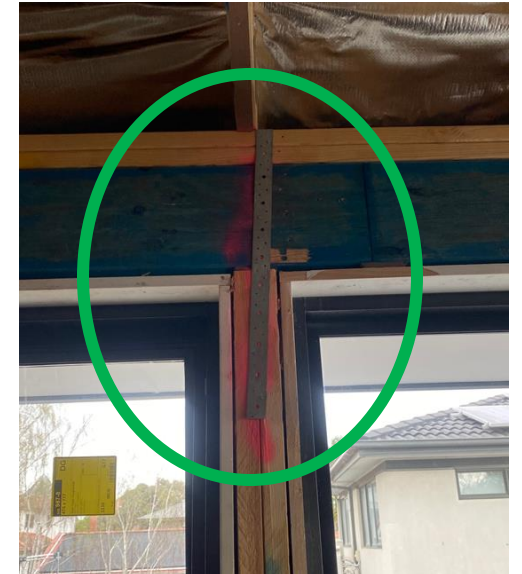
- Tie downs at jamb studs.
