# Rendered expanded polystyrene clad wall system AS 5113 external wall fire spread test

Fire test witness and review report

Report number: EP205417

Client: Victorian Building Authority

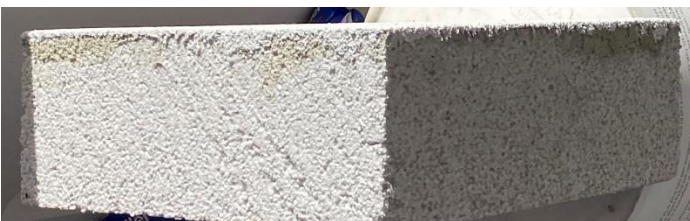
Figure 6. Cut section of 100 mm thick EPS with 1 mm base coat render to one side (left over section not installed to specimen) during CSIRO inspection of completed construction at Warringtonfire.
