Moisture accumulation and mould growth for 6 Star and 7 Star  
housing  
Research Report 3

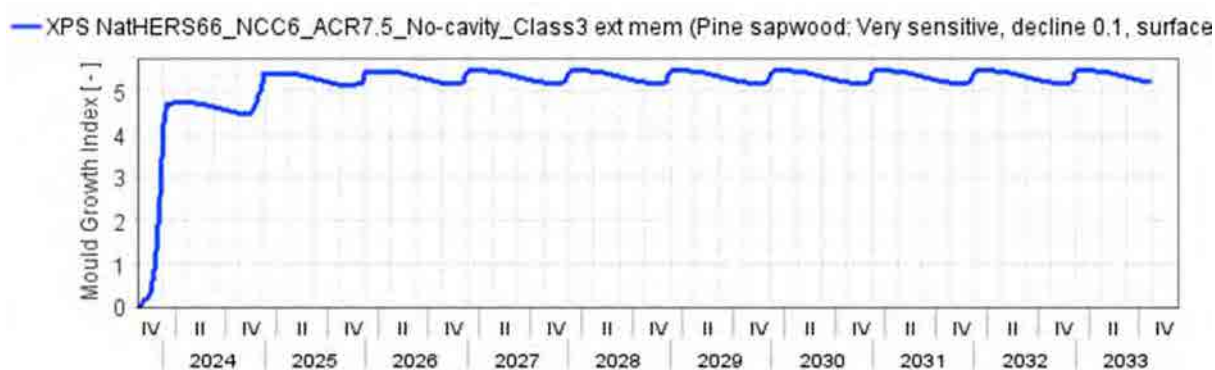
Mould Growth – Mould growth occurs within the insulated timber frame. The Mould Growth Index exceeds 3.0. This wall system may be climatically inappropriate.

Figure 391: 7 STAR XPS NatHERS CZ 66 - NCC CZ 6 South orientation ACR 7.5, No Cavity – Ext. Memb. Class 4 – 175.4 – Mould growth within insulated timber frame

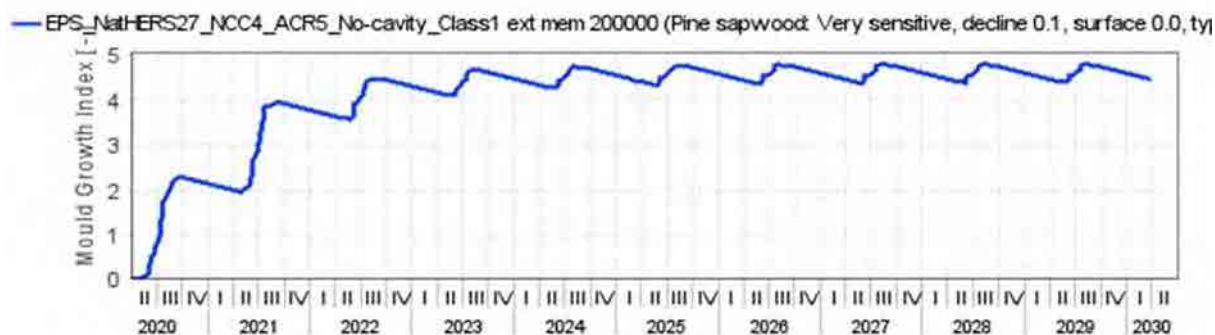
Mould Growth – Mould growth occurs within the insulated timber frame. The Mould Growth Index exceeds 3.0. This wall system may be climatically inappropriate.

Figure 29: Expanded Polystyrene (EPS) NatHERS CZ 27 - NCC CZ 4 South orientation ACR 5 No Cavity – Ext. Memb. Class 1 – 200000 – Mould growth within insulated timber frame

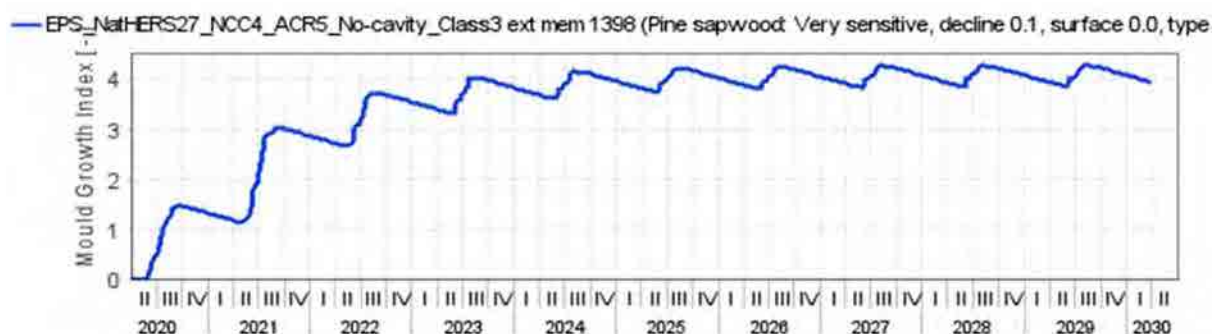
Mould Growth – Mould growth occurs within the insulated timber frame. The Mould Growth Index exceeds 3.0. This wall system may be climatically inappropriate.

Figure 30: Expanded Polystyrene (EPS) NatHERS CZ 27 - NCC CZ 4 South orientation ACR 5 No Cavity – Ext. Memb. Class 3 – 1398 – Mould growth within insulated timber frame

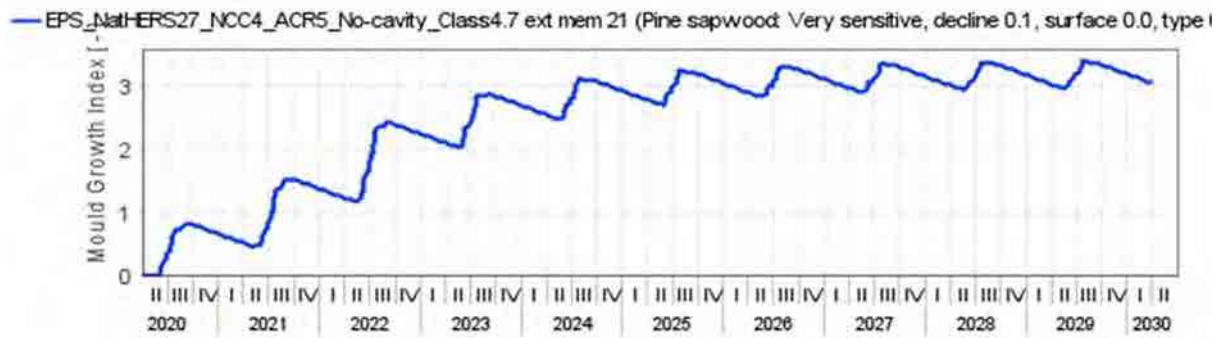
Mould Growth – Mould growth occurs within the insulated timber frame. The Mould Growth Index exceeds 3.0. This wall system may be climatically inappropriate.

Figure 33: Expanded Polystyrene (EPS) NatHERS CZ 27 - NCC CZ 4 South orientation ACR 5 No Cavity – Ext. Memb. Class 4 – 21 – Mould growth within insulated timber frame

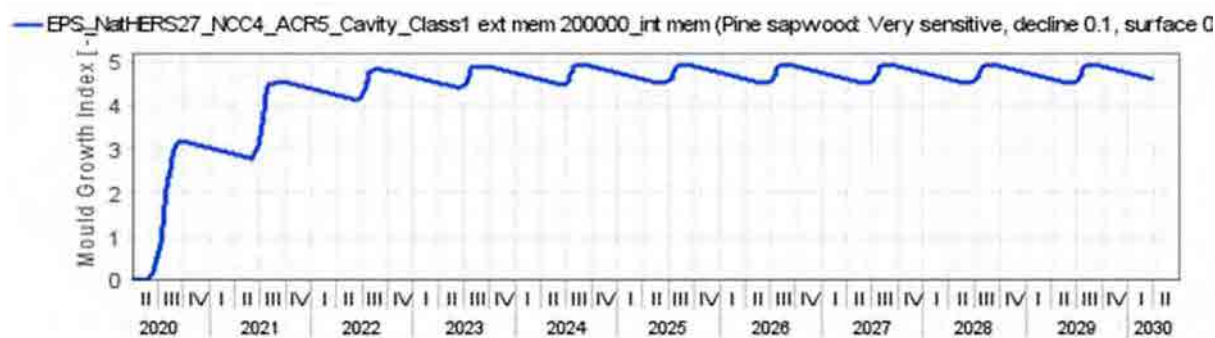
Mould Growth – Mould growth occurs within the insulated timber frame. The Mould Growth Index exceeds 3.0. This wall system may be climatically inappropriate.

Figure 41: Expanded Polystyrene (EPS) NatHERS CZ 27 - NCC CZ 4 South orientation ACR 5 With Cavity – Ext. Memb. Class 1 – 200000 with Int. Memb. Mould growth within insulated timber frame

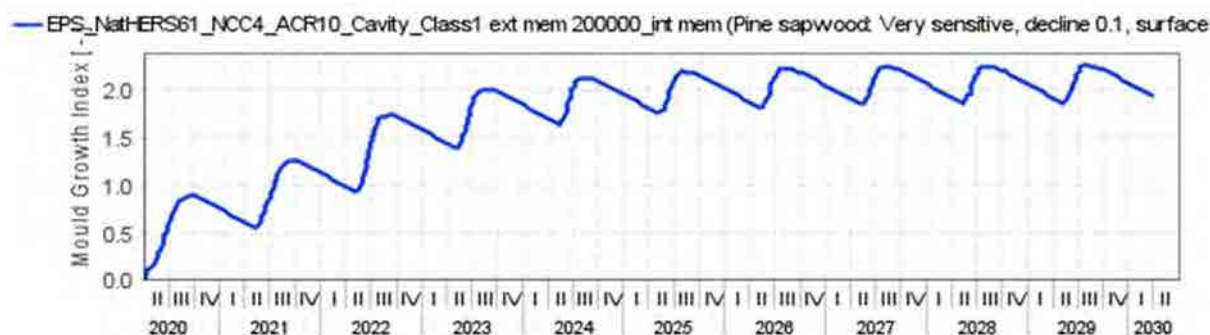
Mould Growth – Mould growth occurs within the insulated timber frame. The Mould Growth Index exceeds 1.0 but is less than 3.0. This wall type requires further investigation.

Figure 55: Expanded Polystyrene (EPS) NatHERS CZ 61 - NCC CZ 4 South orientation ACR 10 With Cavity – Ext. Memb. Class 1 – 200000 with Int. Memb. Mould growth within insulated timber frame

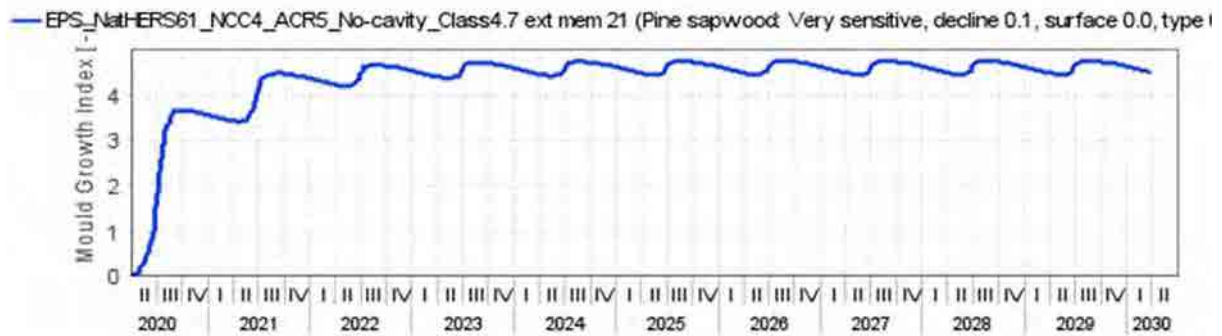
#### 5. No Cavity – Exterior Membrane Class 4 – 21

Mould Growth – Mould growth occurs within the insulated timber frame. The Mould Growth Index exceeds 3.0. This wall system may be climatically inappropriate.

Figure 75: Expanded Polystyrene (EPS) NatHERS CZ 61 - NCC CZ 4 South orientation ACR 5 No Cavity – Ext. Memb. Class 4 – 21 – Mould growth within insulated timber frame

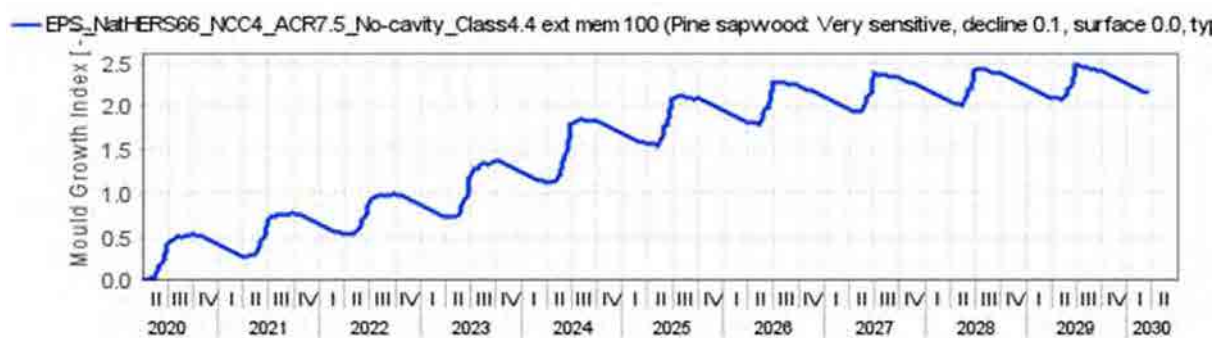
### 4. No Cavity – Exterior Membrane Class 4 – 100

Mould Growth – Mould growth occurs within the insulated timber frame. The Mould Growth Index exceeds 1.0 but is less than 3.0. This wall type requires further investigation.

Figure 102 Expanded Polystyrene (EPS) NatHERS CZ 66 - NCC CZ 4 South orientation ACR 7.5 No Cavity – Ext. Memb. Class 4 – 100 – Mould growth within insulated timber frame

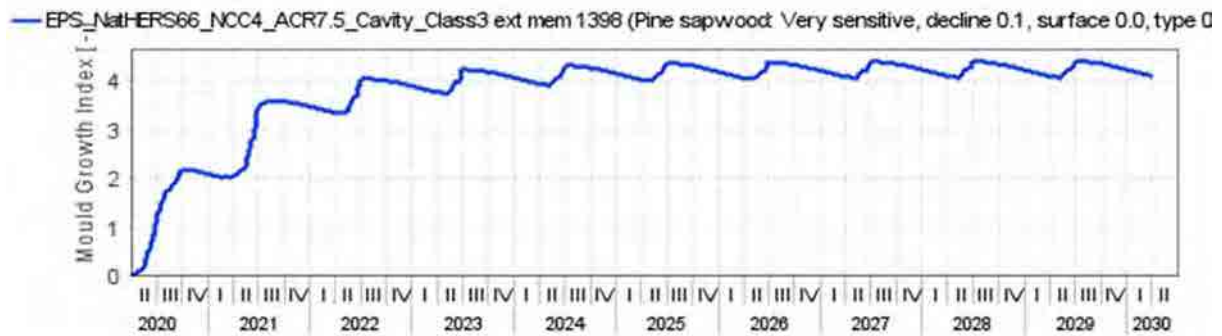
## 7. With Cavity – Exterior Membrane Class 3 – 1398

Mould Growth – Mould growth occurs within the insulated timber frame. The Mould Growth Index exceeds 3.0. This wall system may be climatically inappropriate.

Figure 105: Expanded Polystyrene (EPS) NatHERS CZ 66 - NCC CZ 4 South orientation ACR 7.5, With Cavity – Ext. Memb. Class 3 – 1398 – Mould growth within insulated timber frame

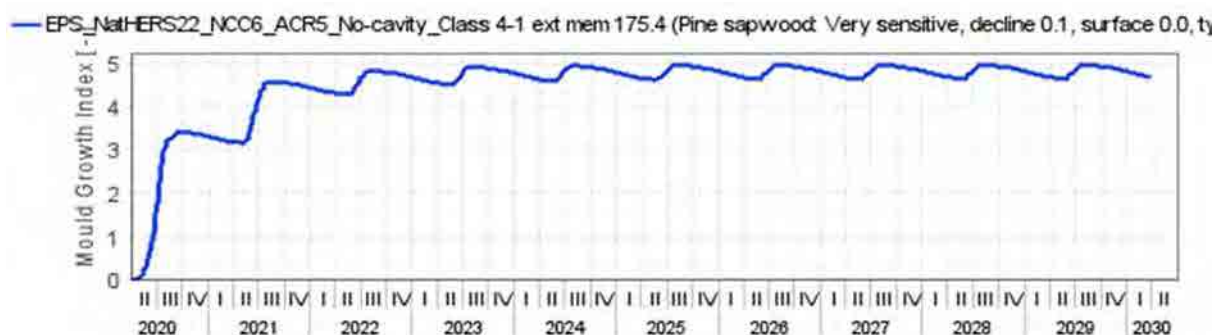
### 2. No Cavity – Exterior Membrane Class 4 – 175.4

Mould Growth – Mould growth occurs within the insulated timber frame. The Mould Growth Index exceeds 3.0. This wall system may be climatically inappropriate.

Figure 188: Expanded Polystyrene (EPS) NatHERS CZ 22 - NCC CZ 6 South orientation ACR 5 No Cavity – Ext. Memb. Class 4 – 175.4 – Mould growth within insulated timber frame

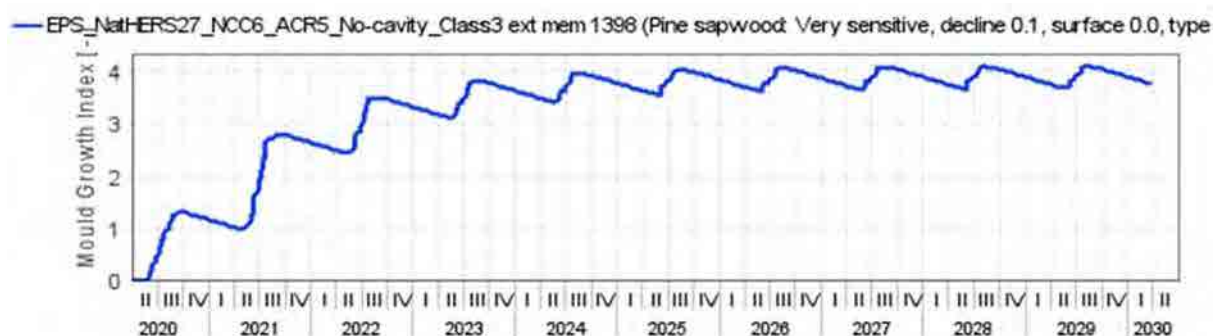
Mould Growth – Mould growth occurs within the insulated timber frame. The Mould Growth Index exceeds 3.0. This wall system may be climatically inappropriate.

Figure 223: Expanded Polystyrene (EPS) NatHERS CZ 27 - NCC CZ 6 South orientation ACR 5 No Cavity – Ext. Memb. Class 3 – 1398 – Mould growth within insulated timber frame

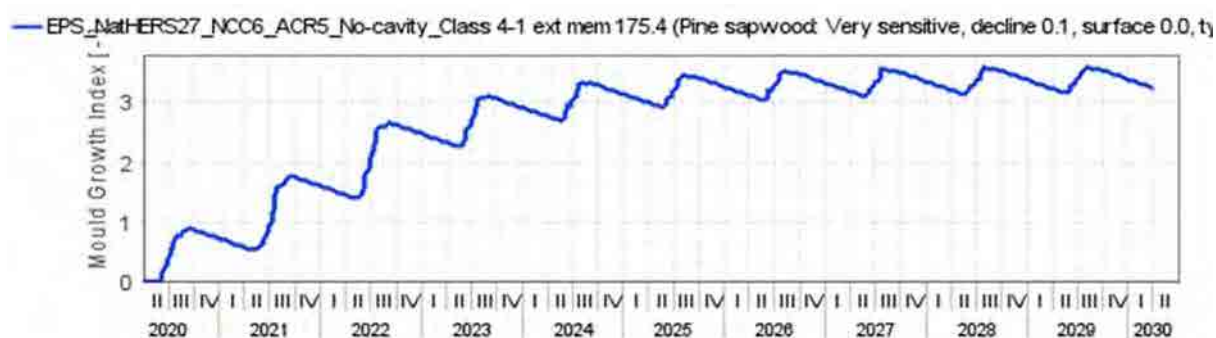
Mould Growth – Mould growth occurs within the insulated timber frame. The Mould Growth Index exceeds 3.0. This wall system may be climatically inappropriate.

Figure 224: Expanded Polystyrene (EPS) NatHERS CZ 27 - NCC CZ 6 South orientation ACR 5 No Cavity – Ext. Memb. Class 4 – 175.4 – Mould growth within insulated timber frame

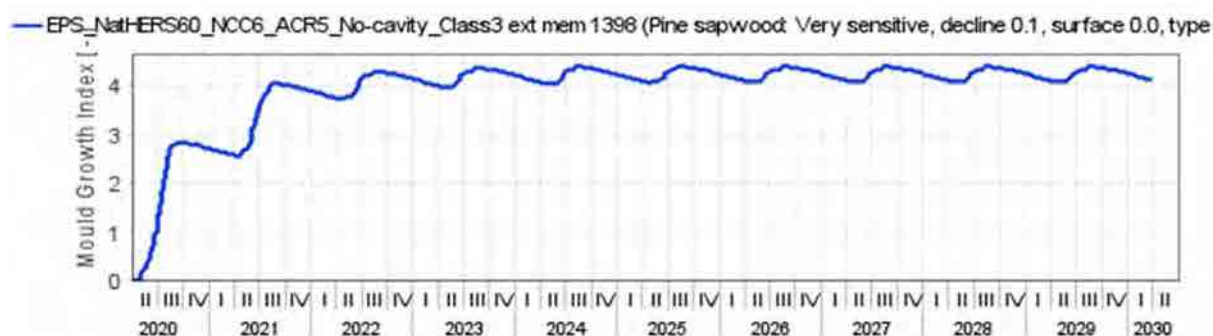
Mould Growth – Mould growth occurs within the insulated timber frame. The Mould Growth Index exceeds 3.0. This wall system may be climatically inappropriate.

Figure 259: Expanded Polystyrene (EPS) NatHERS CZ 60 - NCC CZ 6 South orientation ACR 5 No Cavity – Ext. Memb. Class 3 – 1398 – Mould growth within insulated timber frame

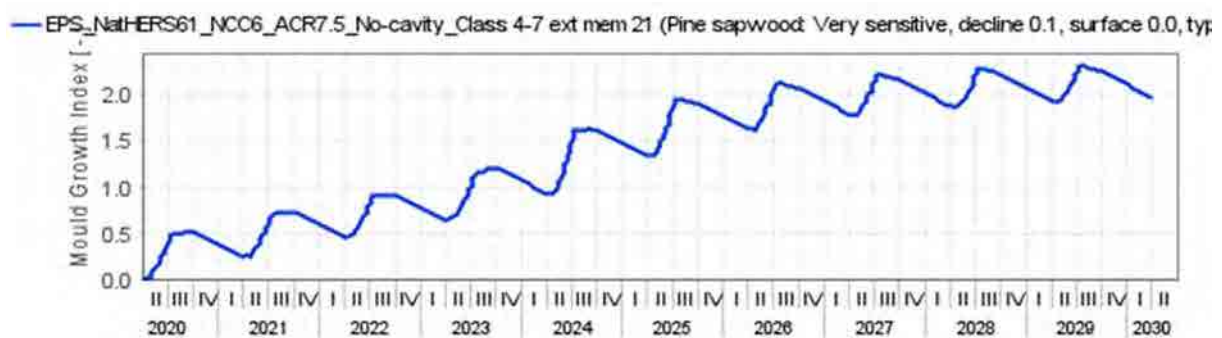
### 4. No Cavity – Exterior Membrane Class 4 – 21

Mould Growth – Mould growth occurs within the insulated timber frame. The Mould Growth Index exceeds 1.0 but is less than 3.0. This wall type requires further investigation.

Figure 286: Expanded Polystyrene (EPS) NatHERS CZ 61 - NCC CZ 6 South orientation ACR 7.5 No Cavity – Ext. Memb. Class 4 – 21 – Mould growth within insulated timber frame

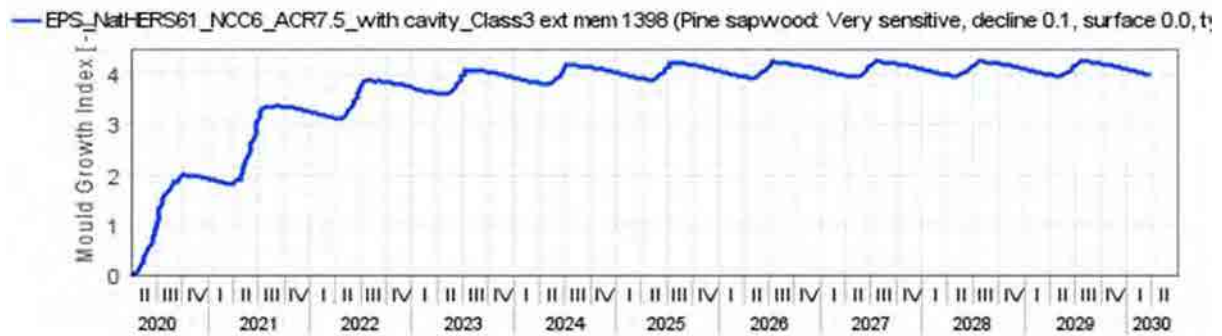
5. With Cavity – Exterior Membrane Class 3 – 1398

Mould Growth – Mould growth occurs within the insulated timber frame. The Mould Growth Index exceeds 3.0. This wall system may be climatically inappropriate.

Figure 287: Expanded Polystyrene (EPS) NatHERS CZ 61 - NCC CZ 6 South orientation ACR 7.5, With Cavity – Ext. Memb. Class 3 – 1398 – Mould growth within insulated timber frame

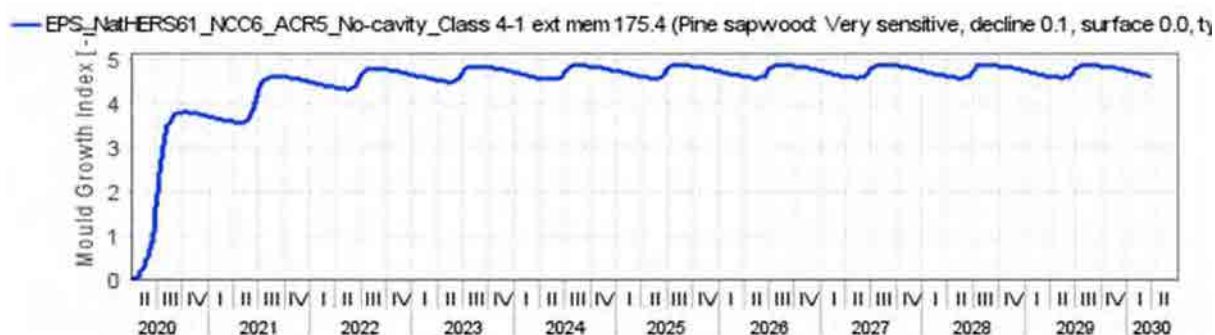
Mould Growth – Mould growth occurs within the insulated timber frame. The Mould Growth Index exceeds 3.0. This wall system may be climatically inappropriate.

Figure 296: Expanded Polystyrene (EPS) NatHERS CZ 61 - NCC CZ 6 South orientation ACR 5 No Cavity – Ext. Memb. Class 4 – 175.4 – Mould growth within insulated timber frame

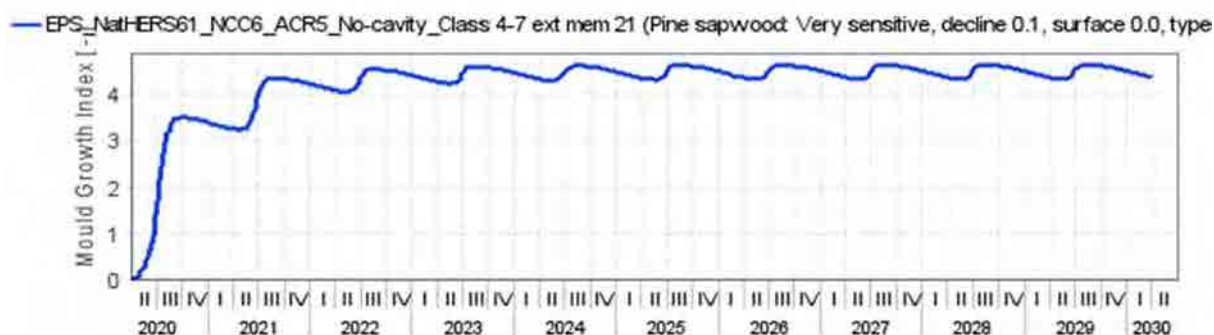
Mould Growth – Mould growth occurs within the insulated timber frame. The Mould Growth Index exceeds 3.0. This wall system may be climatically inappropriate.

Figure 298: Expanded Polystyrene (EPS) NatHERS CZ 61 - NCC CZ 6 South orientation ACR 5 No Cavity – Ext. Memb. Class 4 – 21 – Mould growth within insulated timber frame

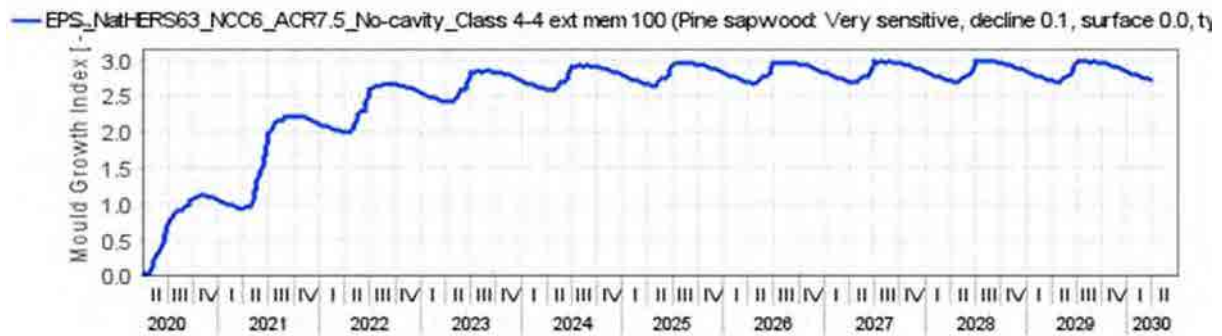
Mould Growth – Mould growth occurs within the insulated timber frame. The Mould Growth Index exceeds 3.0. This wall system may be climatically inappropriate.

Figure 321 Expanded Polystyrene (EPS) NatHERS CZ 63 - NCC CZ 6 South orientation ACR 7.5 No Cavity – Ext. Memb. Class 4 – 100 – Mould growth within insulated timber frame

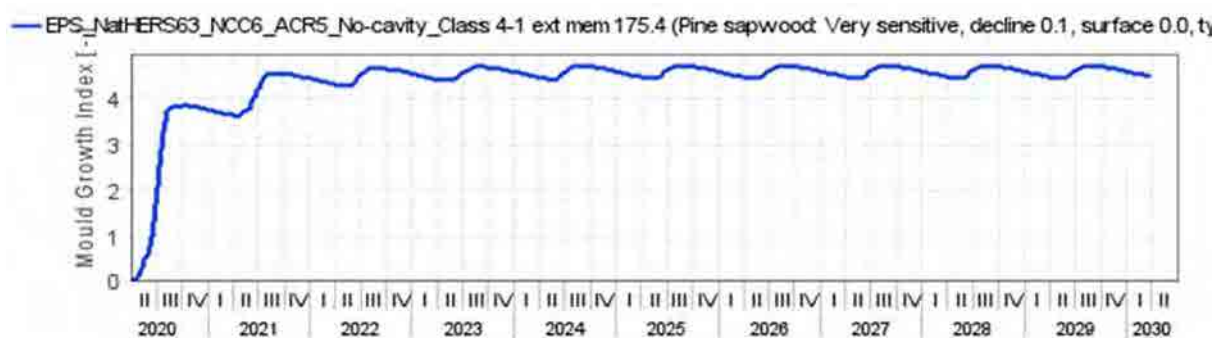
### 2. No Cavity – Exterior Membrane Class 4 – 175.4

Moisture Accumulation – Nil

Mould Growth – Mould growth occurs within the insulated timber frame. The Mould Growth Index exceeds 3.0. This wall system may be climatically inappropriate.

Figure 332: Expanded Polystyrene (EPS) NatHERS CZ 63 - NCC CZ 6 South orientation ACR 5 No Cavity – Ext. Memb. Class 4 – 175.4 – Mould growth within insulated timber frame

Figure 332: Expanded Polystyrene (EPS) NatHERS CZ 63 - NCC CZ 6 South orientation ACR 5 No Cavity – Ext. Memb. Class 4 – 175.4 – Mould growth within timber frame

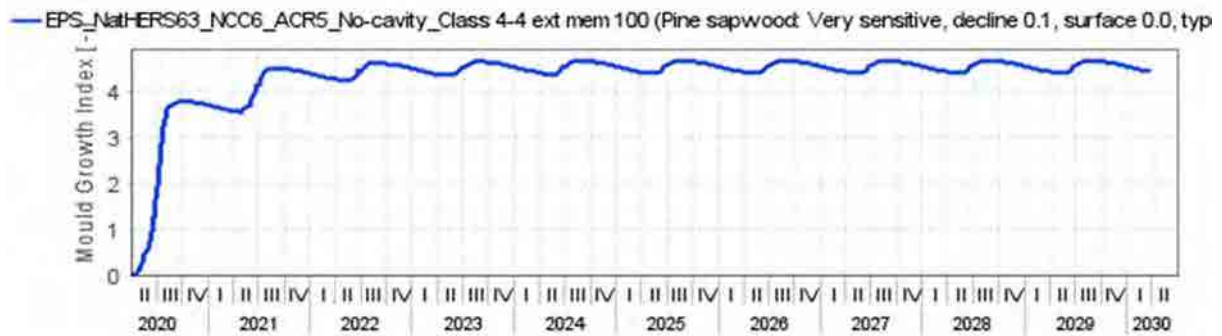
### 3. No Cavity – Exterior Membrane Class 4 – 100

Moisture Accumulation – Nil

Mould Growth – Mould growth occurs within the insulated timber frame. The Mould Growth Index exceeds 3.0. This wall system may be climatically inappropriate.

Figure 333 Expanded Polystyrene (EPS) NatHERS CZ 63 - NCC CZ 6 South orientation ACR 5 No Cavity – Ext. Memb. Class 4 – 100 – Mould growth within insulated timber frame

Figure 333 Expanded Polystyrene (EPS) NatHERS CZ 63 - NCC CZ 6 South orientation ACR 5 No Cavity – Ext. Memb. Class 4 – 100 – Mould growth within timber frame

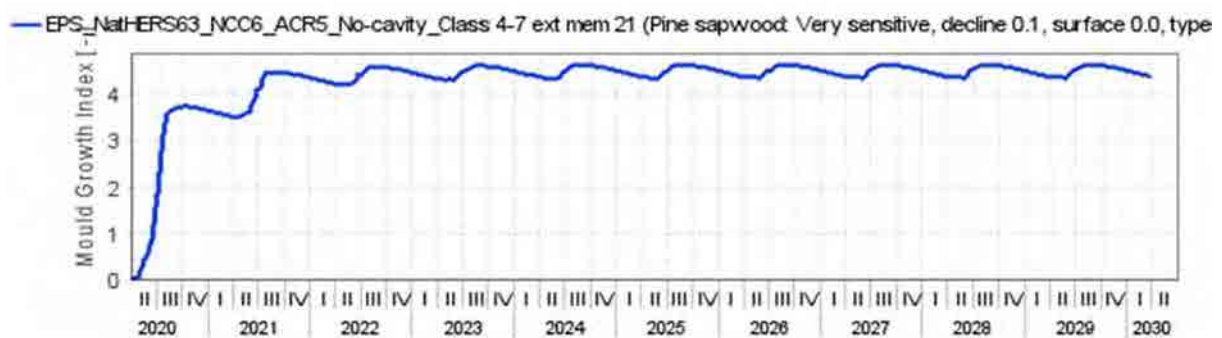
### 4. No Cavity – Exterior Membrane Class 4 – 21

Moisture Accumulation – Nil

Mould Growth – Mould growth occurs within the insulated timber frame. The Mould Growth Index exceeds 3.0. This wall system may be climatically inappropriate.

Figure 334: Expanded Polystyrene (EPS) NatHERS CZ 63 - NCC CZ 6 South orientation ACR 5 No Cavity – Ext. Memb. Class 4 – 21 – Mould growth within insulated timber frame

Figure 334: Expanded Polystyrene (EPS) NatHERS CZ 63 - NCC CZ 6 South orientation ACR 5 No Cavity – Ext. Memb. Class 4 – 21 – Mould growth within timber frame

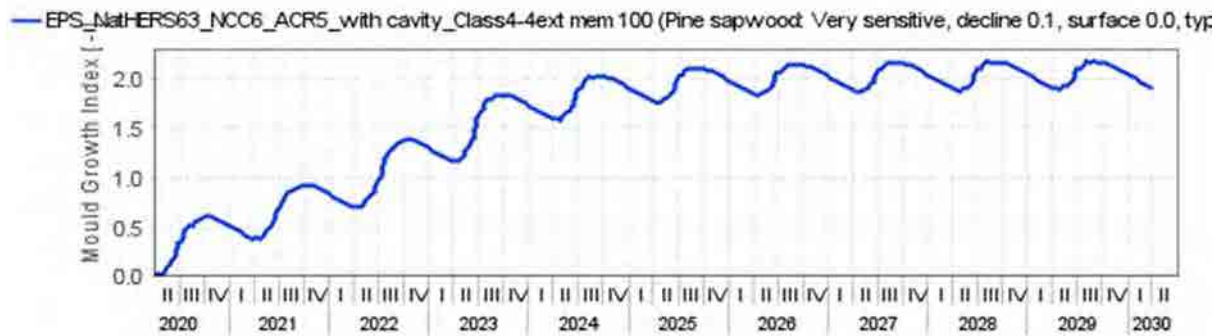
## 7. With Cavity – Exterior Membrane Class 4 – 100

Moisture Accumulation – Nil

Mould Growth – Mould growth occurs within the insulated timber frame. The Mould Growth Index exceeds 1.0 but is less than 3.0. This wall type requires further investigation.

Figure 337 Expanded Polystyrene (EPS) NatHERS CZ 63 - NCC CZ 6 South orientation ACR 5 With Cavity – Ext. Memb. Class 4 – 100 – Mould growth within insulated timber frame

Figure 337 Expanded Polystyrene (EPS) NatHERS CZ 63 - NCC CZ 6 South orientation ACR 5 With Cavity – Ext. Memb. Class 4 – 100 – Mould growth within timber frame

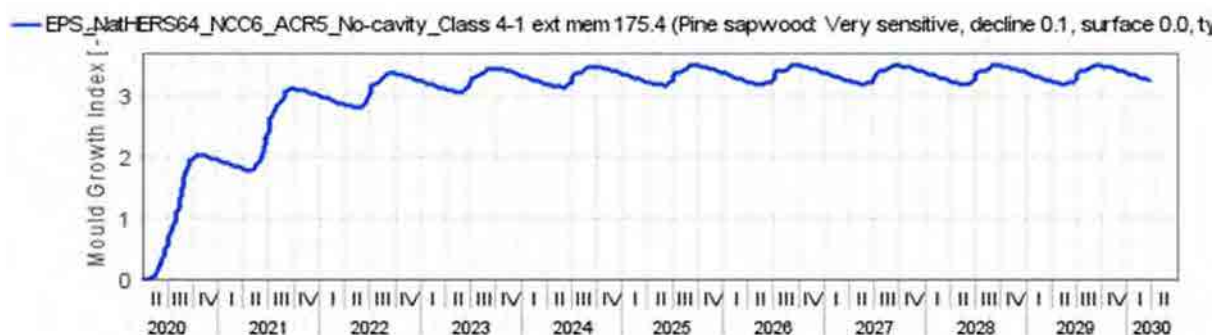
Mould Growth – Mould growth occurs within the insulated timber frame. The Mould Growth Index exceeds 3.0. This wall system may be climatically inappropriate.

Figure 368: Expanded Polystyrene (EPS) NatHERS CZ 64 - NCC CZ 6 South orientation ACR 5 No Cavity – Ext. Memb. Class 4 – 175.4 – Mould growth within insulated timber frame

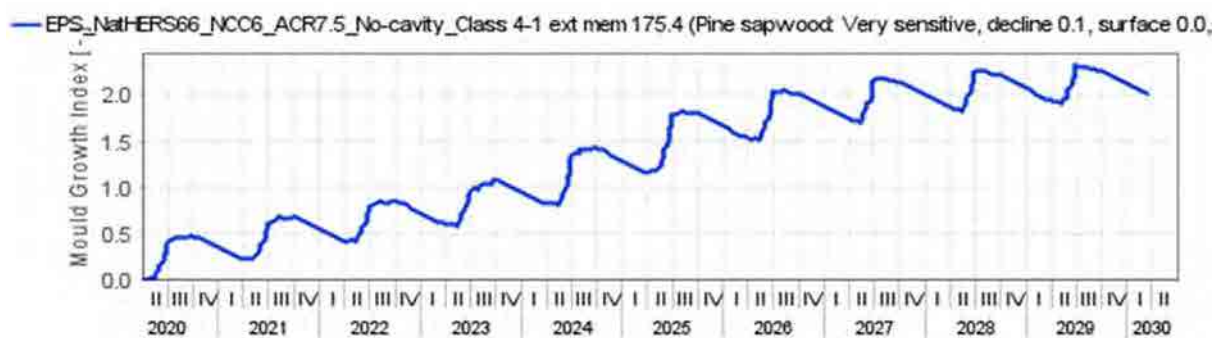
Mould Growth – Mould growth occurs within the insulated timber frame. The Mould Growth Index exceeds 1.0 but is less than 3.0. This wall type requires further investigation.

Figure 392: Expanded Polystyrene (EPS) NatHERS CZ 66 - NCC CZ 6 South orientation ACR 7.5, No Cavity – Ext. Memb. Class 4 – 175.4 – Mould growth within insulated timber frame

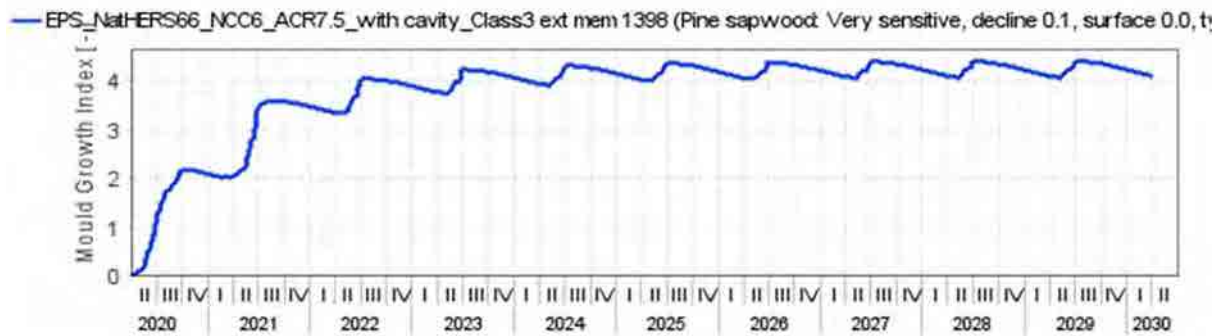
Mould Growth – Mould growth occurs within the insulated timber frame. The Mould Growth Index exceeds 3.0. This wall system may be climatically inappropriate.

Figure 395: Expanded Polystyrene (EPS) NatHERS CZ 66 - NCC CZ 6 South orientation ACR 7.5, With Cavity – Ext. Memb. Class 3 – 1398 – Mould growth within insulated timber frame

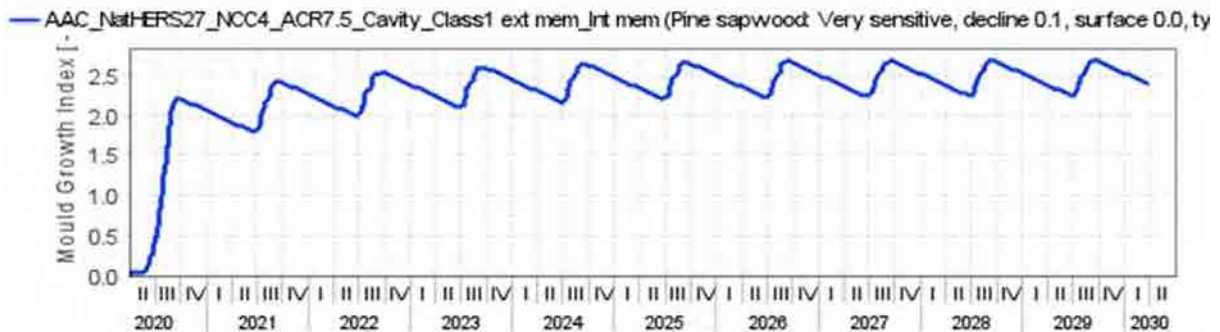
6. With cavity – External Exterior Membrane Class 1 – 200000 with Internal Membrane

Mould Growth – The Mould Growth Index exceeds 1.0 but is less than 3.0. This wall type requires further investigation.

Figure 14 Autoclaved aerated concrete masonry NatHERS CZ 27 - NCC CZ 4 South orientation ACR 7.5 With Cavity – Ext. Memb. Class1 – 200000 with Int. Memb.  
Mould growth within insulated timber frame

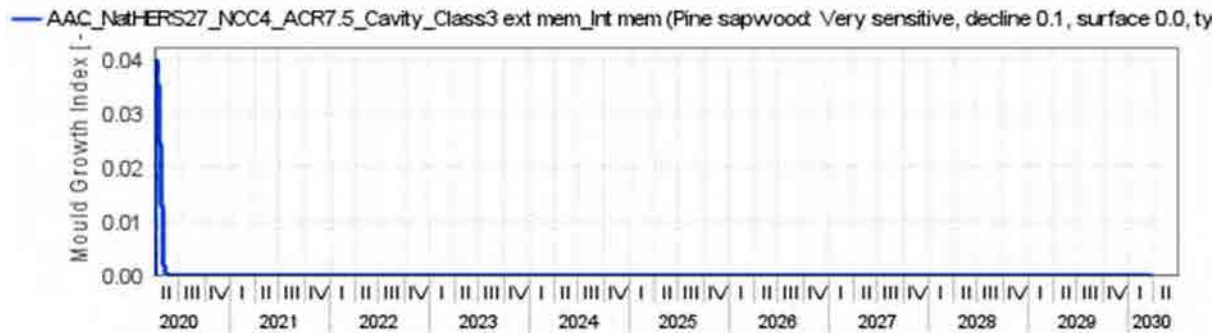
7. With cavity – External Exterior Membrane Class 3 – 1398 with Internal Membrane

Mould Growth – The Mould Growth Index within this wall system does not exceed 1.0.

Figure 15 Autoclaved aerated concrete masonry NatHERS CZ 27 - NCC CZ 4 South orientation ACR 7.5 With Cavity – Ext. Memb. Class 4 – 1398 with Int. Memb.  
Mould growth within insulated timber frame

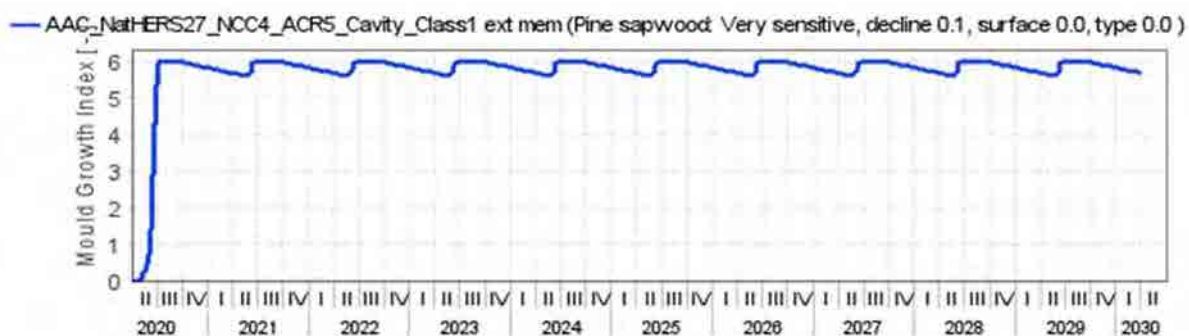
Mould Growth – Mould growth occurs within the insulated timber frame. The Mould Growth Index exceeds 3.0. This wall system may be climatically inappropriate.

Figure 17: Autoclaved aerated concrete masonry NatHERS CZ 27 - NCC CZ 4 South orientation ACR 5 With Cavity – Ext. Memb. Class 1 – 200000  
Mould growth within insulated timber frame

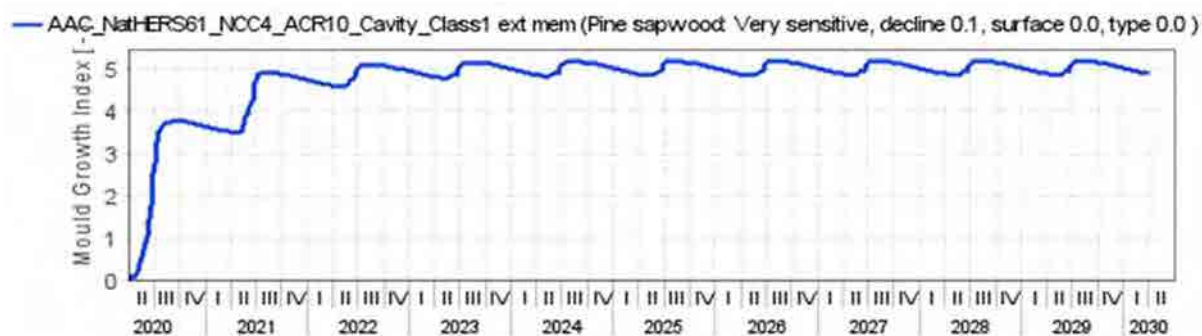
Mould Growth – Mould growth occurs within the insulated timber frame. The Mould Growth Index exceeds 3.0. This wall system may be climatically inappropriate.

Figure 25: Autoclaved aerated concrete masonry NatHERS CZ 61 - NCC CZ 4 South orientation ACR 10 With Cavity – Ext. Memb. Class 1 – 200000  
Mould growth within insulated timber frame

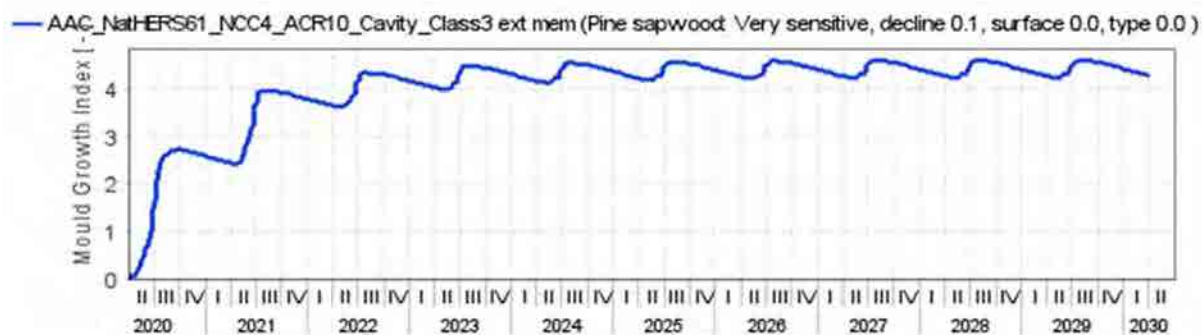
2. With Cavity – Exterior Membrane Class 3 – 1398

Mould Growth – Mould growth occurs within the insulated timber frame. The Mould Growth Index exceeds 3.0. This wall system may be climatically inappropriate.

Figure 26: Autoclaved aerated concrete masonry NatHERS CZ 61 - NCC CZ 4 South orientation ACR 10 With Cavity – Ext. Memb. Class 3 – 1398  
Mould growth within insulated timber frame

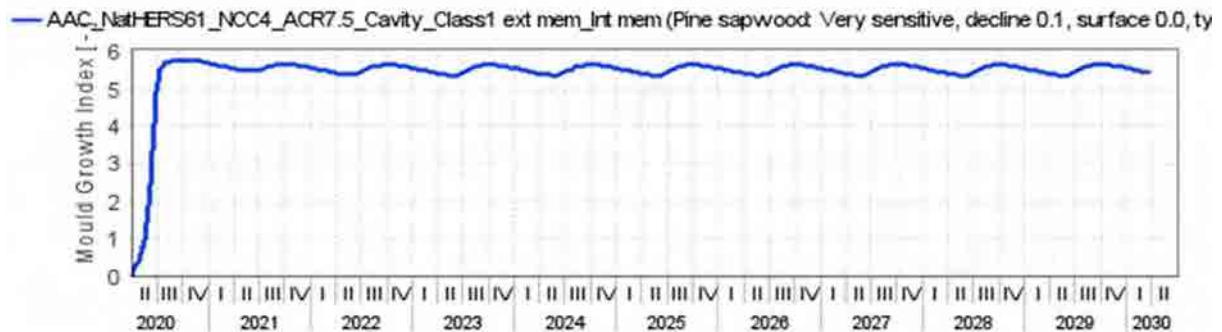
Mould Growth – Mould growth occurs within the insulated timber frame. The Mould Growth Index exceeds 3.0. This wall system may be climatically inappropriate.

Figure 38 Autoclaved aerated concrete masonry NatHERS CZ 61 - NCC CZ 4 South orientation ACR 7.5 With Cavity – Ext. Memb. Class1 – 200000 with Int. Memb.  
Mould growth within insulated timber frame

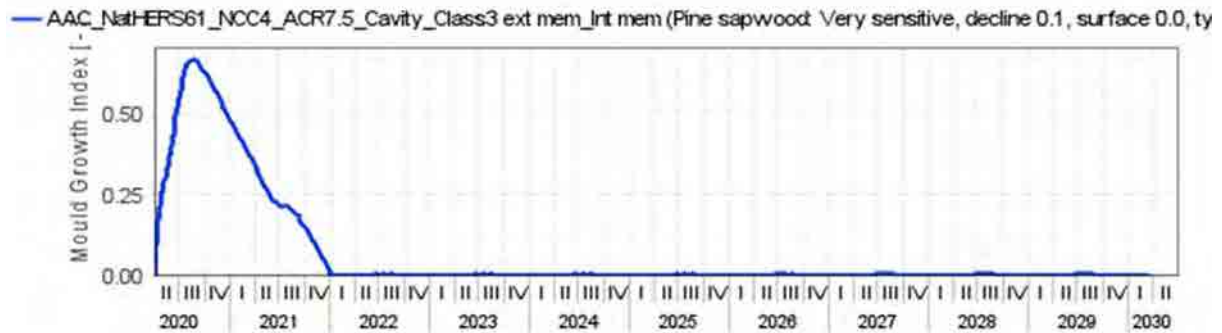
Mould Growth – The Mould Growth Index within this wall system does not exceed 1.0.

Figure 39 Autoclaved aerated concrete masonry NatHERS CZ 61 - NCC CZ 4 South orientation ACR 7.5 With Cavity – Ext. Memb. Class 4 – 1398 with Int. Memb.  
Mould growth within insulated timber frame

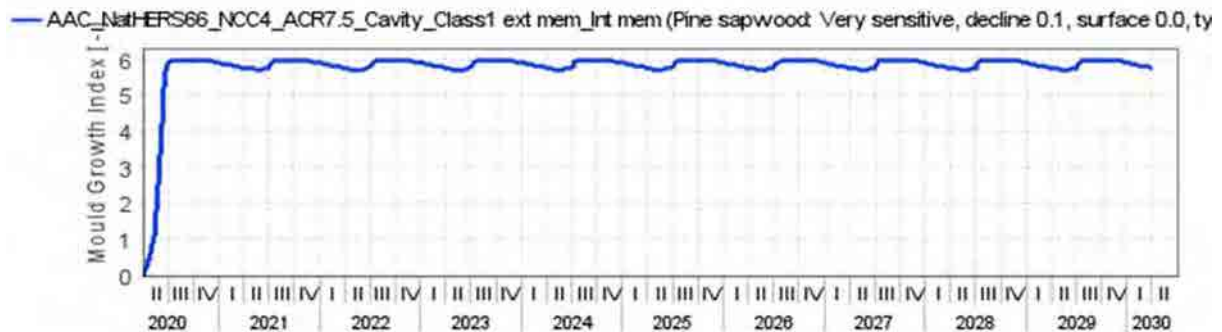
Mould Growth – Mould growth occurs within the insulated timber frame. The Mould Growth Index exceeds 3.0. This wall system may be climatically inappropriate.

Figure 62 Autoclaved aerated concrete masonry NatHERS CZ 66 - NCC CZ 4 South orientation ACR 7.5 With Cavity – Ext. Memb. Class1 – 200000 with Int. Memb.  
Mould growth within insulated timber frame

Figure 62 Autoclaved aerated concrete masonry NatHERS CZ 66 - NCC CZ 4 South orientation ACR 7.5 No Cavity – Ext. Memb. Class 1 – 200000 with Int. Memb. Mould growth within insulated timber frame

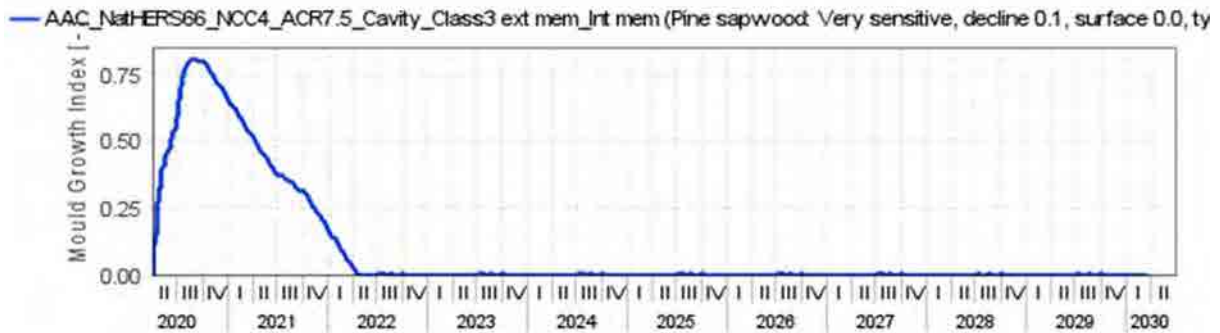
Mould Growth – The Mould Growth Index within this wall system does not exceed 1.0.

Figure 63 Autoclaved aerated concrete masonry NatHERS CZ 66 - NCC CZ 4 South orientation ACR 7.5 With Cavity – Ext. Memb. Class 4 – 1398 with Int. Memb.  
Mould growth within insulated timber frame

*Figure 63 Autoclaved aerated concrete masonry NatHERS CZ 66 - NCC CZ 4 South orientation ACR 7.5 No Cavity – Ext. Memb. Class 3 – 1398 with Int. Memb. Mould growth within insulated timber frame*

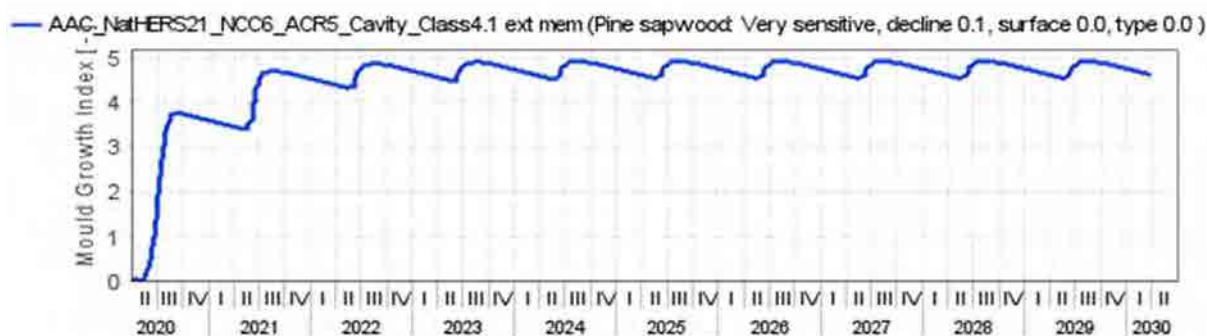
### 2. With Cavity – Exterior Membrane Class 4 – 175.4

Moisture Accumulation – Nil

Mould Growth – Mould growth occurs within the insulated timber frame. The Mould Growth Index exceeds 3.0. This wall system may be climatically inappropriate.

Figure 86: Autoclaved aerated concrete masonry NatHERS CZ 21 - NCC CZ 6 South orientation ACR 5 With Cavity – Ext. Memb. Class 4 – 175.4  
Mould growth within insulated timber frame

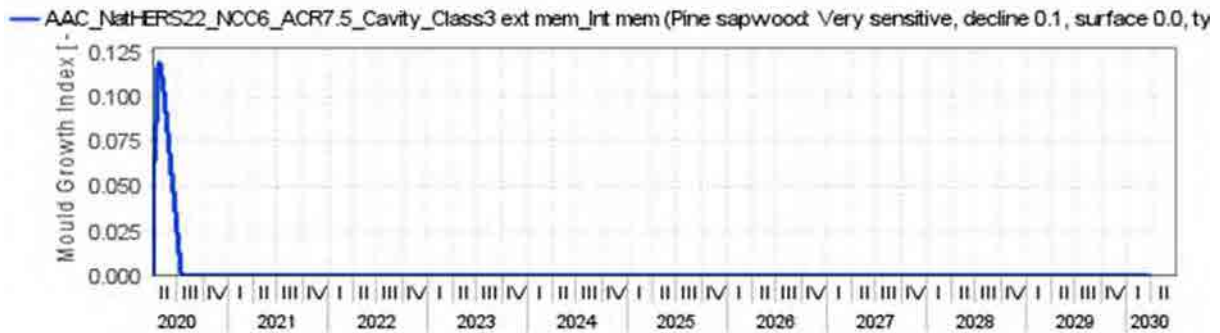
5. With cavity – External Exterior Membrane Class 3 – 1398 with Internal Membrane

Mould Growth – The Mould Growth Index within this wall system does not exceed 1.0.

*Figure 101 Autoclaved aerated concrete masonry NatHERS CZ 22 - NCC CZ 6 South orientation ACR 7.5 With Cavity – Ext. Memb. Class 4 – 1398 with Int. Memb. Mould growth within insulated timber frame*

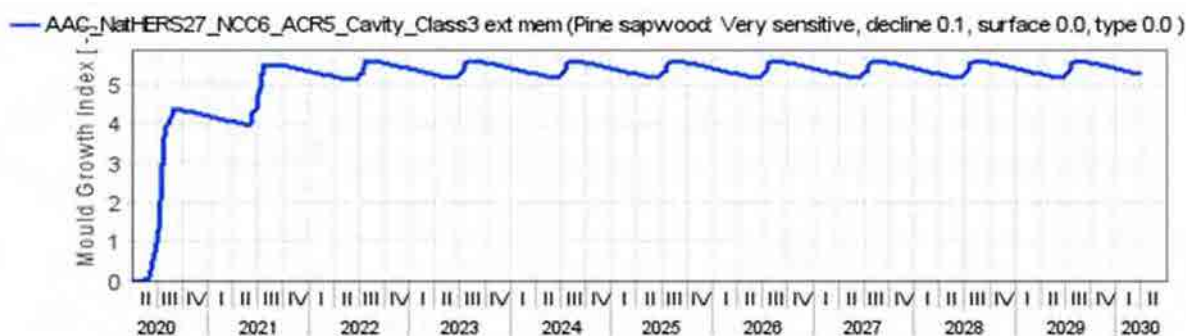
Mould Growth – Mould growth occurs within the insulated timber frame. The Mould Growth Index exceeds 3.0. This wall system may be climatically inappropriate.

Figure 121: Autoclaved aerated concrete masonry NatHERS CZ 27 - NCC CZ 6 South orientation ACR 5 With Cavity – Ext. Memb. Class 3 – 1398  
Mould growth within insulated timber frame

Figure 121: Autoclaved aerated concrete masonry NatHERS CZ 27 - NCC CZ 6 South orientation ACR 5 With Cavity – Ext. Memb. Class 3 – 1398 – Mould growth within insulated timber frame

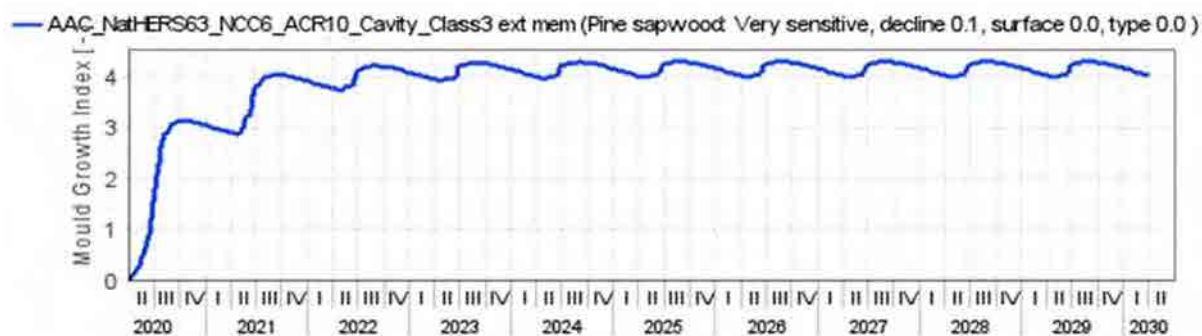
Mould Growth – Mould growth occurs within the insulated timber frame. The Mould Growth Index exceeds 3.0. This wall system may be climatically inappropriate.

Figure 163: Autoclaved aerated concrete masonry NatHERS CZ 63 - NCC CZ 6 South orientation ACR 10 With Cavity – Ext. Memb. Class 3 – 1398  
Mould growth within insulated timber frame

Figure 163: Autoclaved aerated concrete masonry NatHERS CZ 63 - NCC CZ 6 South orientation ACR 10 With Cavity – Ext. Memb. Class 3 – 1398 – Mould growth within insulated timber frame

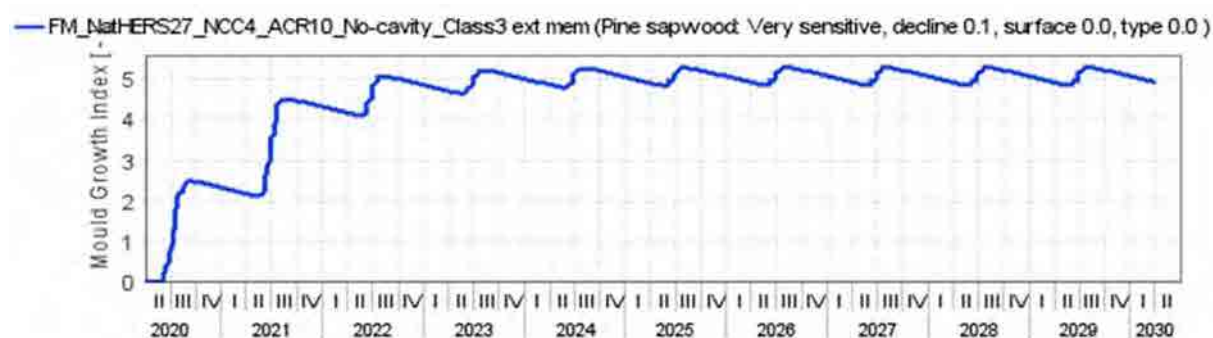
Mould Growth – Mould growth occurs within the insulated timber frame. The Mould Growth Index exceeds 3.0. This wall system may be climatically inappropriate.

Figure 2: Flat Metal Cladding NatHERS CZ 27 - NCC CZ 4 South orientation ACR 10 No Cavity – Ext. Memb. Class 3 – 1398 – Mould growth within insulated timber frame

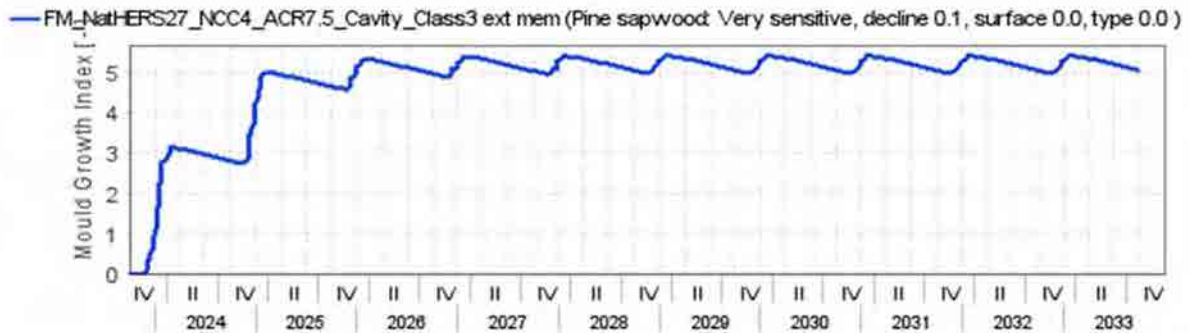
7. With Cavity – Exterior Membrane Class 3 – 1398

Moisture Accumulation – Nil

Mould Growth – Mould growth occurs within the insulated timber frame. The Mould Growth Index exceeds 3.0. This wall system may be climatically inappropriate.

Figure 21: Flat Metal Cladding NatHERS CZ 27 - NCC CZ 4 South orientation ACR 7.5 With Cavity – Ext. Memb. Class 3 – 1398 – Mould growth within insulated timber frame

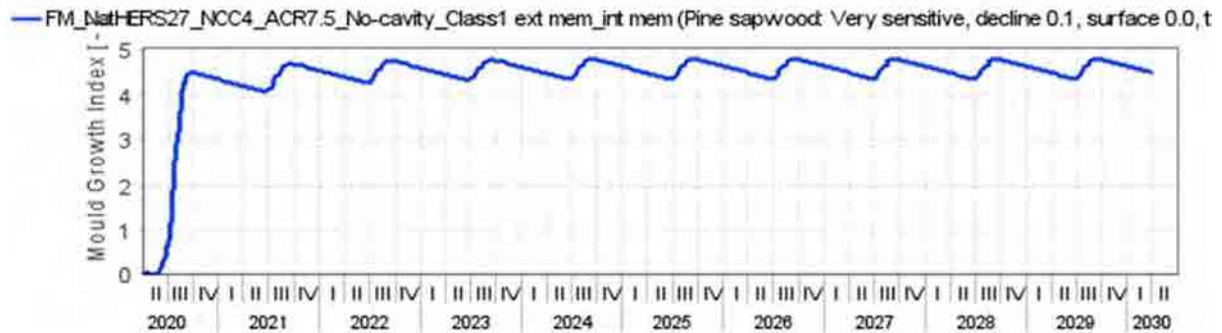
11. No Cavity – Exterior Membrane Class 1 – 200000 with Internal Membrane

Moisture Accumulation – Nil

Mould Growth – Mould growth occurs within the insulated timber frame. The Mould Growth Index exceeds 3.0. This wall system may be climatically inappropriate.

Figure 25: Flat Metal Cladding NatHERS CZ 27 - NCC CZ 4 South orientation ACR 7.5 No Cavity – Ext. Memb. Class 1 – 200000 with Int. Memb. Mould growth within insulated timber frame

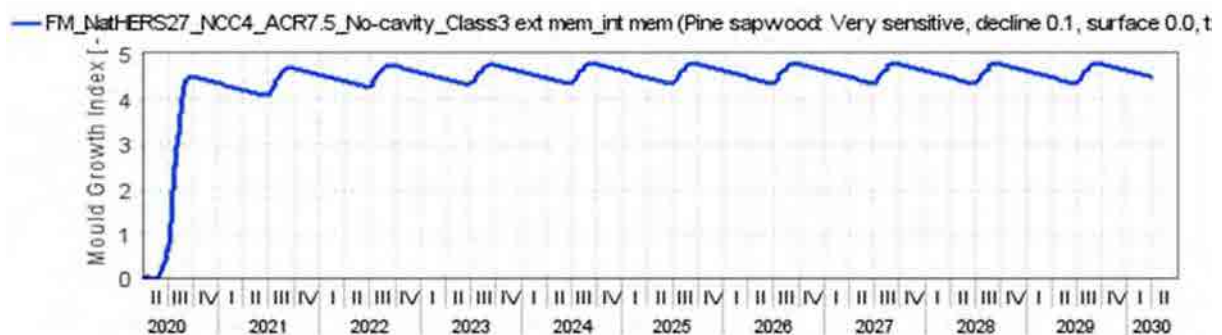
12. No Cavity – Exterior Membrane 1 Class 3 – 1398 with Internal Membrane

Moisture Accumulation – Nil

Mould Growth – Mould growth occurs within the insulated timber frame. The Mould Growth Index exceeds 3.0. This wall system may be climatically inappropriate.

Figure 26: Flat Metal Cladding NatHERS CZ 27 - NCC CZ 4 South orientation ACR 7.5 No Cavity – Ext. Memb. Class 3– 1398 with Int. Memb. Mould growth within insulated timber frame

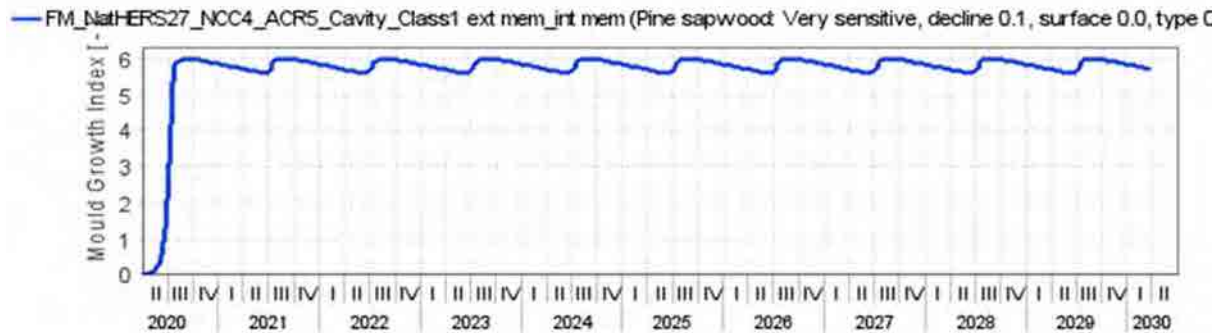
13. With Cavity – Exterior Membrane Class 1 – 200000 with Internal Membrane

Moisture Accumulation – Nil

Mould Growth – Mould growth occurs within the insulated timber frame. The Mould Growth Index exceeds 3.0. This wall system may be climatically inappropriate.

Figure 41: Flat Metal Cladding NatHERS CZ 27 - NCC CZ 4 South orientation ACR 5 With Cavity – Ext. Memb. Class 1 – 200000 with Int. Memb. Mould growth within insulated timber frame

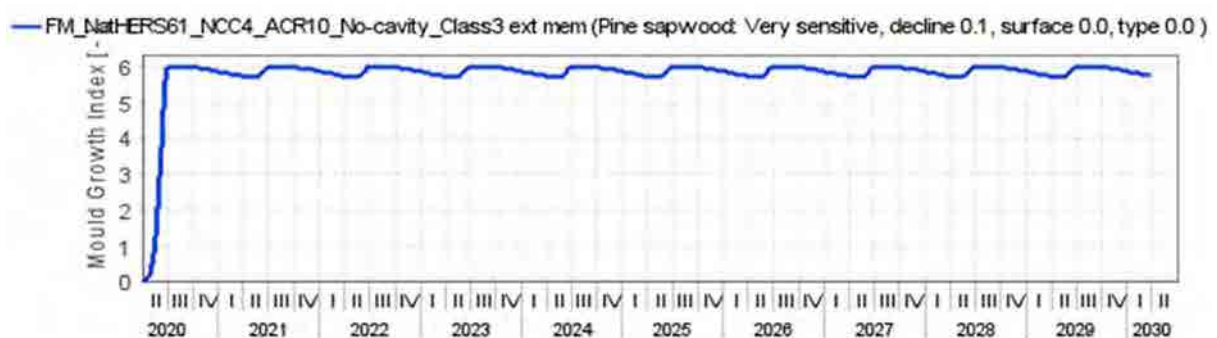
2. No Cavity – Exterior Membrane Class 3 – 1398

Moisture Accumulation – Nil

Mould Growth – Mould growth occurs within the insulated timber frame. The Mould Growth Index exceeds 3.0. This wall system may be climatically inappropriate.

Figure 44: Flat Metal Cladding NatHERS CZ 61 - NCC CZ 4 South orientation ACR 10 No Cavity – Ext. Memb. Class 3 – 1398 – Mould growth within insulated timber frame
