Moisture accumulation and mould growth for 6 Star and 7 Star  
housing  
Research Report 3

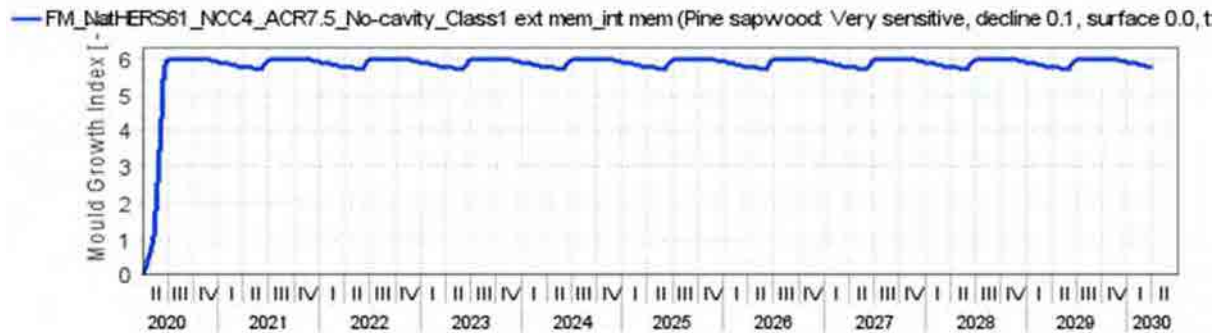
Moisture Accumulation – Nil

Mould Growth – Mould growth occurs within the insulated timber frame. The Mould Growth Index exceeds 3.0. This wall system may be climatically inappropriate.

Figure 67: Flat Metal Cladding NatHERS CZ 61 - NCC CZ 4 South orientation ACR 7.5 No Cavity – Ext. Memb. Class 1 – 200000 with Int. Memb. Mould growth within insulated timber frame

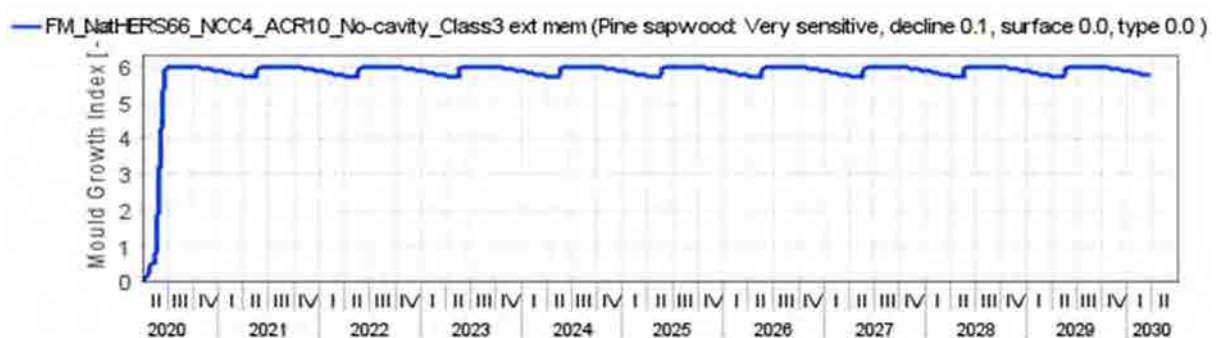
2. No Cavity – Exterior Membrane Class 3 – 1398

Mould Growth – Mould growth occurs within the insulated timber frame. The Mould Growth Index exceeds 3.0. This wall system may be climatically inappropriate.

Figure 86: Flat Metal Cladding NatHERS CZ 66 - NCC CZ 4 South orientation ACR 10 No Cavity – Ext. Memb. Class 3 – 1398 – Mould growth within insulated timber frame

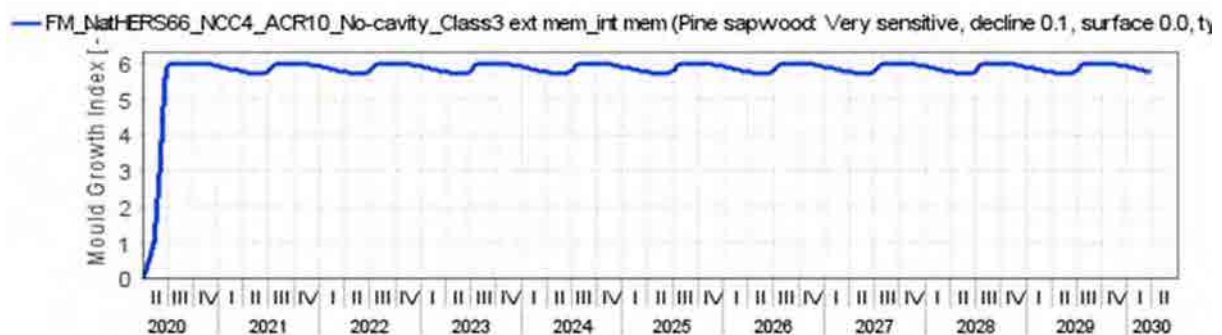
# 12. No Cavity – Exterior Membrane 1 Class 3 – 1398 with Internal Membrane

Mould Growth – Mould growth occurs within the insulated timber frame. The Mould Growth Index exceeds 3.0. This wall system may be climatically inappropriate.

Figure 96: Flat Metal Cladding NatHERS CZ 66 - NCC CZ 4 South orientation ACR 10 No Cavity – Ext. Memb. Class 3– 1398 with Int. Memb. Mould growth within insulated timber frame

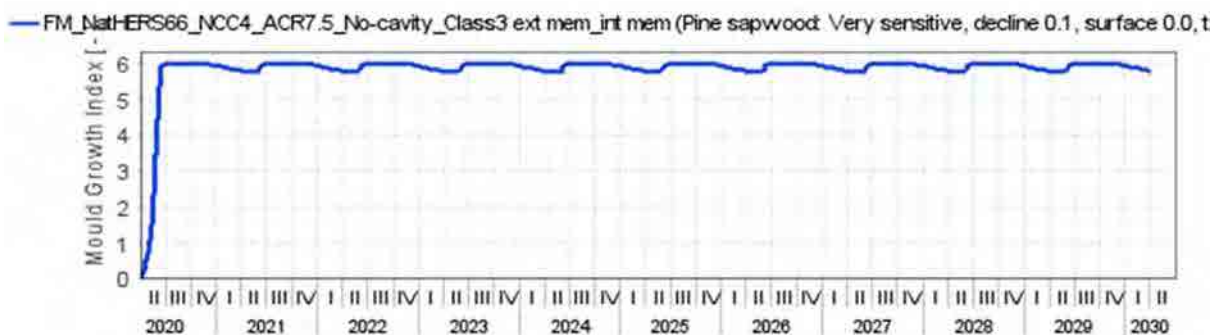
12. No Cavity – Exterior Membrane 1 Class 3 – 1398 with Internal Membrane

Mould Growth – Mould growth occurs within the insulated timber frame. The Mould Growth Index exceeds 3.0. This wall system may be climatically inappropriate.

Figure 110: Flat Metal Cladding NatHERS CZ 66 - NCC CZ 4 South orientation ACR 7.5 No Cavity – Ext. Memb. Class 3– 1398 with Int. Memb. Mould growth within insulated timber frame

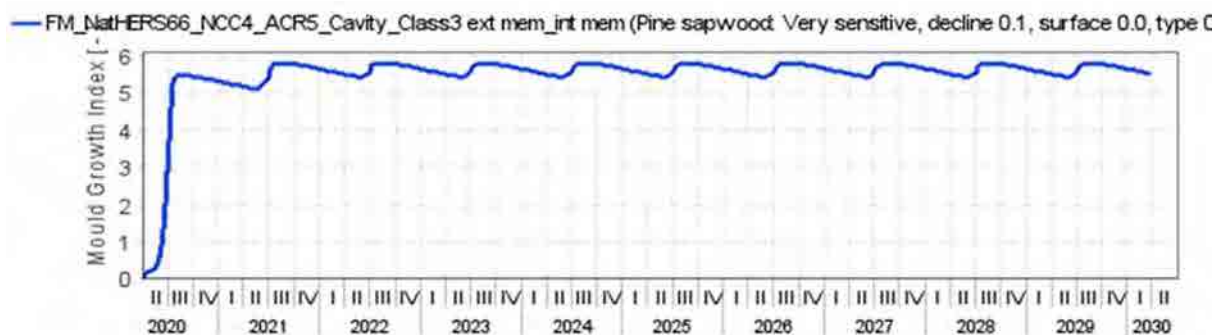
14. With Cavity – Exterior Membrane 1 Class 3 – 1398 with Internal Membrane

Mould Growth – Mould growth occurs within the insulated timber frame. The Mould Growth Index exceeds 3.0. This wall system may be climatically inappropriate.

Figure 126: Flat Metal Cladding NatHERS CZ 66 - NCC CZ 4 South orientation ACR 5 With Cavity – Ext. Memb. Class 3– 1398 with Int. Memb. Mould growth within insulated timber frame

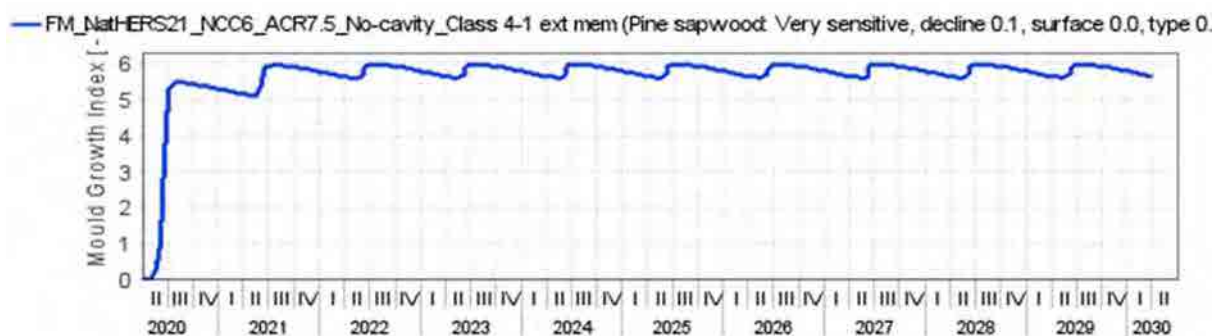
Mould Growth – Mould growth occurs within the insulated timber frame. The Mould Growth Index exceeds 3.0. This wall system may be climatically inappropriate.

Figure 140: Flat Metal Cladding NatHERS CZ 21 - NCC CZ 6 South orientation ACR 7.5 No Cavity – Ext. Memb. Class 4 – 175.4 – Mould growth within insulated timber frame

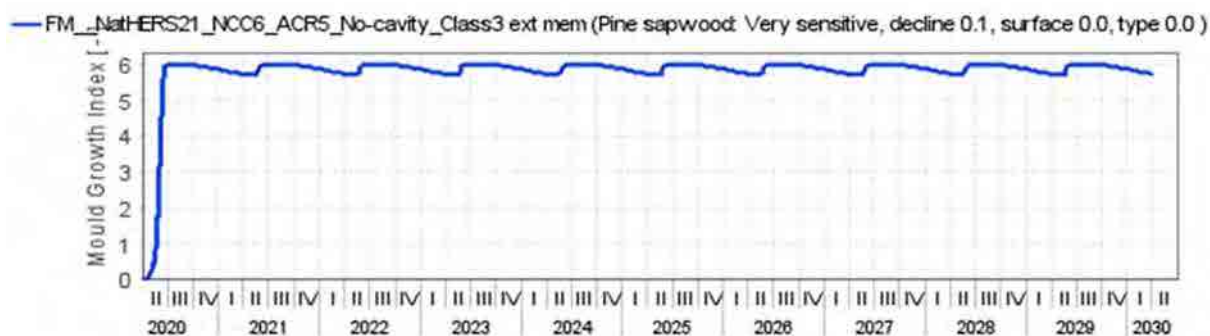
Mould Growth – Mould growth occurs within the insulated timber frame. The Mould Growth Index exceeds 3.0. This wall system may be climatically inappropriate.

Figure 151: Flat Metal Cladding NatHERS CZ 21 - NCC CZ 6 South orientation ACR 5 No Cavity – Ext. Memb. Class 3 – 1398 – Mould growth within insulated timber frame

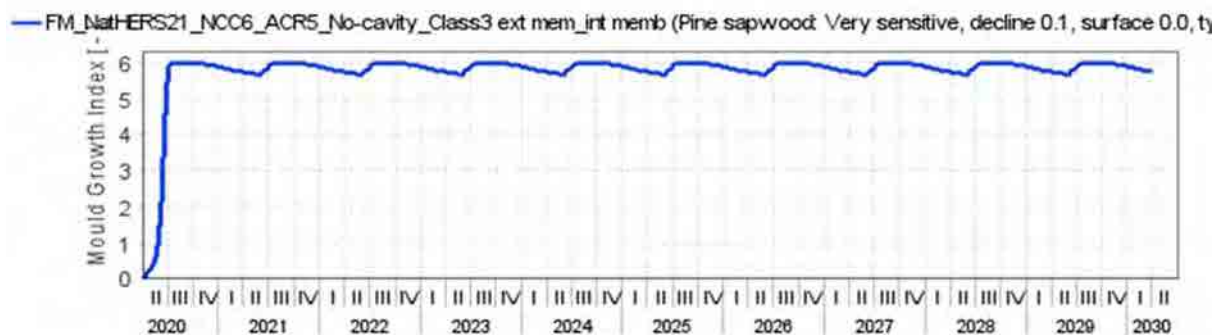
Mould Growth – Mould growth occurs within the insulated timber frame. The Mould Growth Index exceeds 3.0. This wall system may be climatically inappropriate.

Figure 159: Flat Metal Cladding NatHERS CZ 21 - NCC CZ 6 South orientation ACR 5 No Cavity – Ext. Memb. Class 3– 1398 with Int. Memb. Mould growth within insulated timber frame

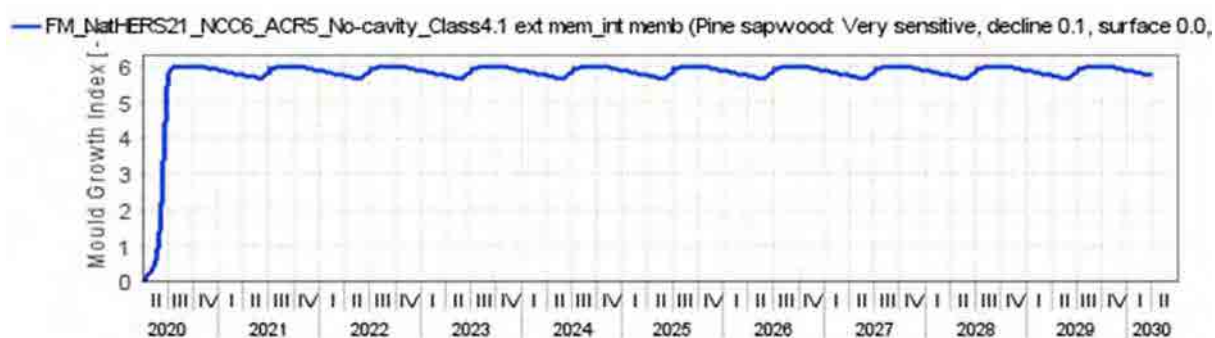
Mould Growth – Mould growth occurs within the insulated timber frame. The Mould Growth Index exceeds 3.0. This wall system may be climatically inappropriate.

Figure 160: Flat Metal Cladding NatHERS CZ 21 - NCC CZ 6 South orientation ACR 5 No Cavity – Ext. Memb. Class 4 – 175.4 with Int. Memb. Mould growth within insulated timber frame

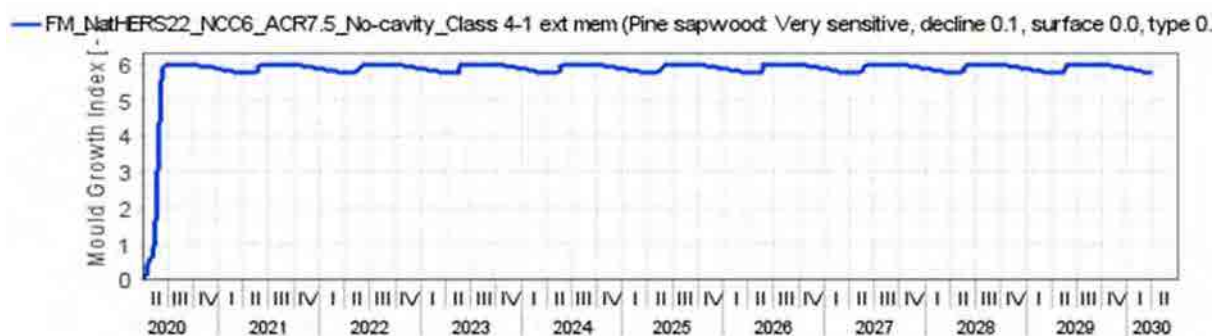
### 2. No Cavity – Exterior Membrane Class 4 – 175.4

Mould Growth – Mould growth occurs within the insulated timber frame. The Mould Growth Index exceeds 3.0. This wall system may be climatically inappropriate.

Figure 176: Flat Metal Cladding NatHERS CZ 22 - NCC CZ 6 South orientation ACR 7.5 No Cavity – Ext. Memb. Class 4 – 175.4 – Mould growth within insulated timber frame

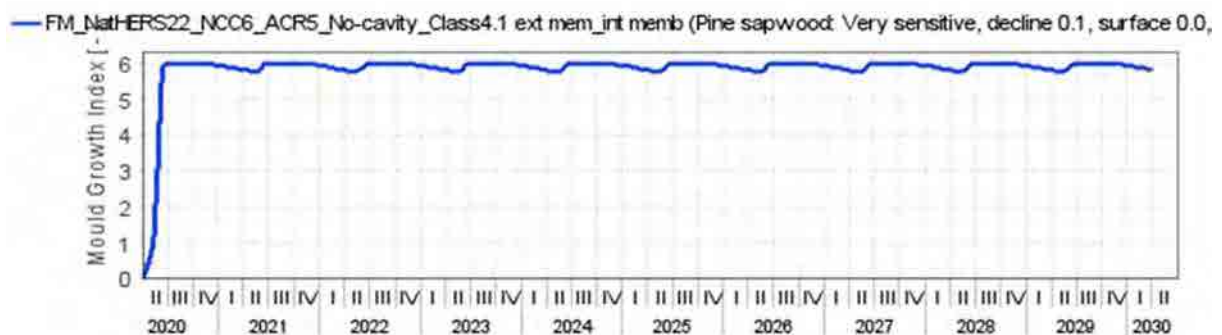
10. No Cavity – Exterior Membrane Class 4 – 175.4 with Internal Membrane

Mould Growth – Mould growth occurs within the insulated timber frame. The Mould Growth Index exceeds 3.0. This wall system may be climatically inappropriate.

Figure 196: Flat Metal Cladding NatHERS CZ 22 - NCC CZ 6 South orientation ACR 5 No Cavity – Ext. Memb. Class 4 – 175.4 with Int. Memb. Mould growth within insulated timber frame

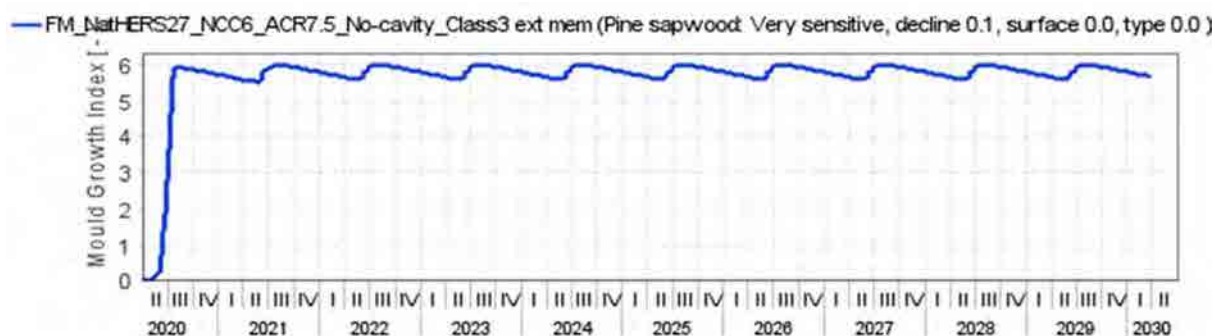
Mould Growth – Mould growth occurs within the insulated timber frame. The Mould Growth Index exceeds 3.0. This wall system may be climatically inappropriate.

Figure 211: Flat Metal Cladding NatHERS CZ 27 - NCC CZ 6 South orientation ACR 7.5 No Cavity – Ext. Memb. Class 3 – 1398 – Mould growth within insulated timber frame

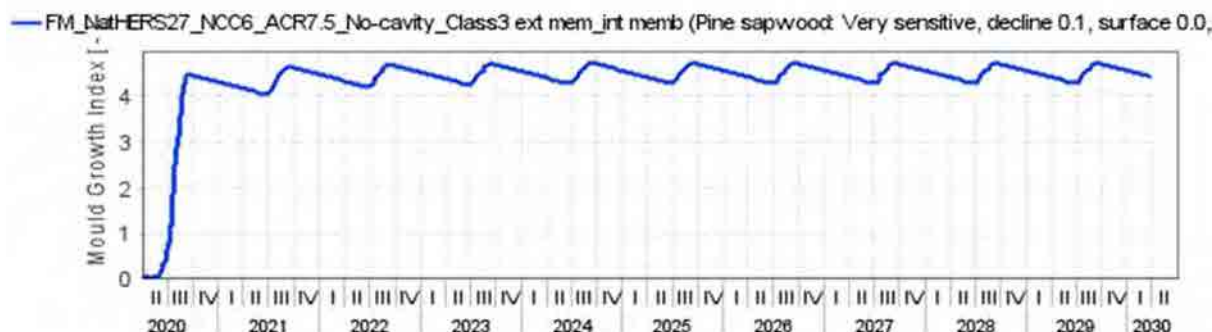
Mould Growth – Mould growth occurs within the insulated timber frame. The Mould Growth Index exceeds 3.0. This wall system may be climatically inappropriate.

Figure 219: Flat Metal Cladding NatHERS CZ 27 - NCC CZ 6 South orientation ACR 7.5 No Cavity – Ext. Memb. Class 3– 1398 with Int. Memb. Mould growth within insulated timber frame

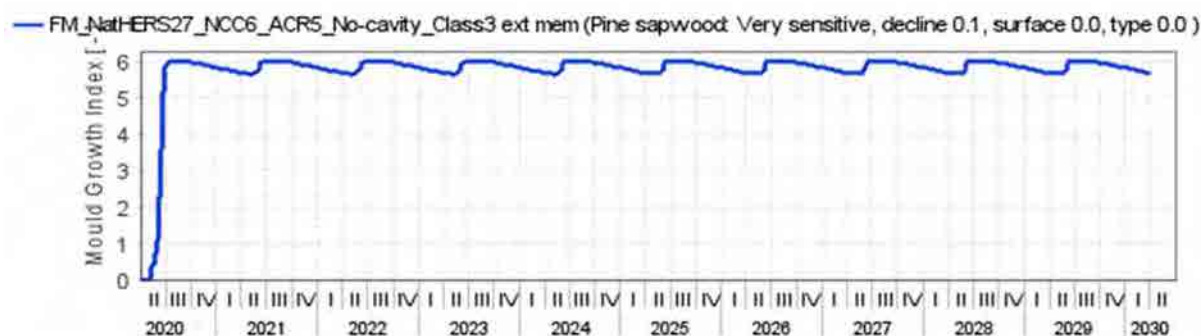
Mould Growth – Mould growth occurs within the insulated timber frame. The Mould Growth Index exceeds 3.0. This wall system may be climatically inappropriate.

Figure 223: Flat Metal Cladding NatHERS CZ 27 - NCC CZ 6 South orientation ACR 5 No Cavity – Ext. Memb. Class 3 – 1398 – Mould growth within insulated timber frame

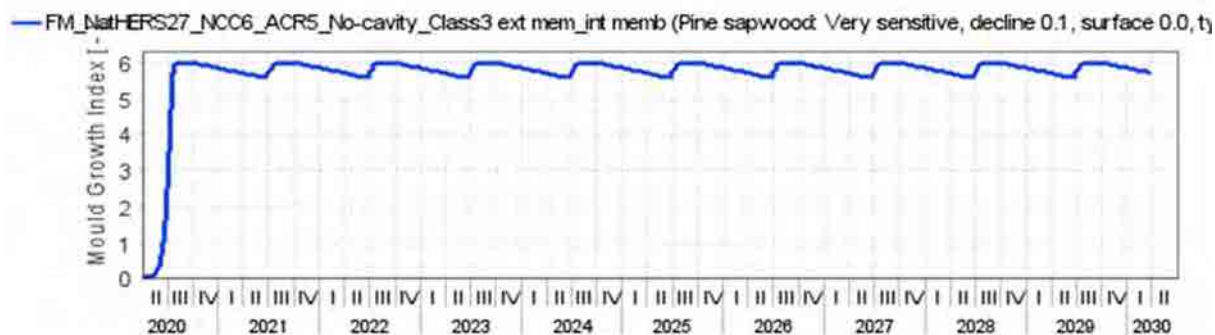
Mould Growth – Mould growth occurs within the insulated timber frame. The Mould Growth Index exceeds 3.0. This wall system may be climatically inappropriate.

Figure 231: Flat Metal Cladding NatHERS CZ 27 - NCC CZ 6 South orientation ACR 5 No Cavity – Ext. Memb. Class 3– 1398 with Int. Memb. Mould growth within insulated timber frame

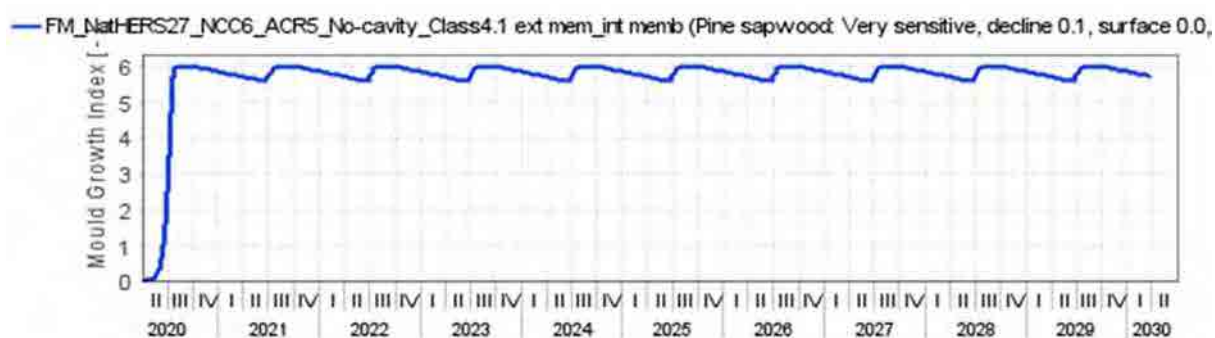
Mould Growth – Mould growth occurs within the insulated timber frame. The Mould Growth Index exceeds 3.0. This wall system may be climatically inappropriate.

Figure 232: Flat Metal Cladding NatHERS CZ 27 - NCC CZ 6 South orientation ACR 5 No Cavity – Ext. Memb. Class 4 – 175.4 with Int. Memb. Mould growth within insulated timber frame

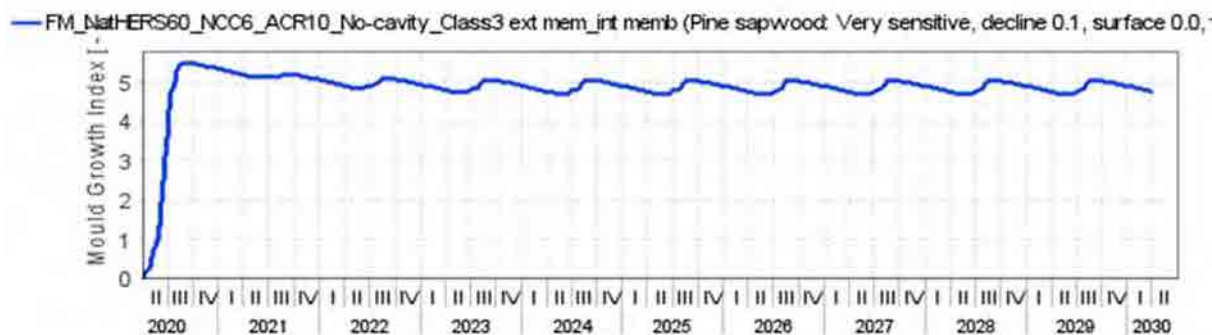
Mould Growth – Mould growth occurs within the insulated timber frame. The Mould Growth Index exceeds 3.0. This wall system may be climatically inappropriate.

Figure 243: Flat Metal Cladding NatHERS CZ 60 - NCC CZ 6 South orientation ACR 10 No Cavity – Ext. Memb. Class 3– 1398 with Int. Memb. Mould growth within insulated timber frame

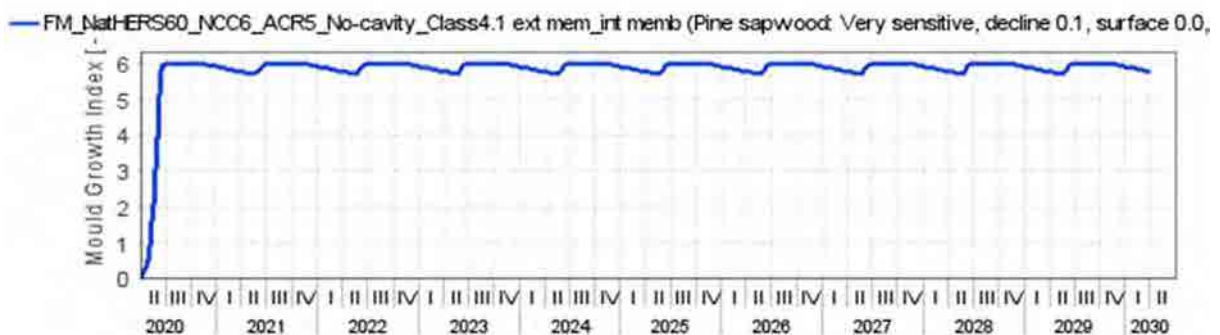
10. No Cavity – Exterior Membrane Class 4 – 175.4 with Internal Membrane

Mould Growth – Mould growth occurs within the insulated timber frame. The Mould Growth Index exceeds 3.0. This wall system may be climatically inappropriate.

Figure 268: Flat Metal Cladding NatHERS CZ 60 - NCC CZ 6 South orientation ACR 5 No Cavity – Ext. Memb. Class 4 – 175.4 with Int. Memb. Mould growth within insulated timber frame

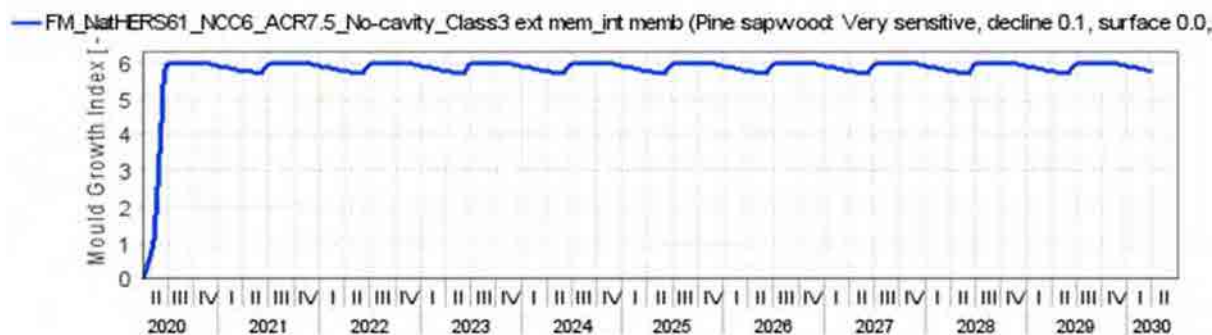
9. No Cavity – Exterior Membrane 1 Class 3 – 1398 with Internal Membrane

Mould Growth – Mould growth occurs within the insulated timber frame. The Mould Growth Index exceeds 3.0. This wall system may be climatically inappropriate.

Figure 291: Flat Metal Cladding NatHERS CZ 61 - NCC CZ 6 South orientation ACR 7.5 No Cavity – Ext. Memb. Class 3– 1398 with Int. Memb. Mould growth within insulated timber frame

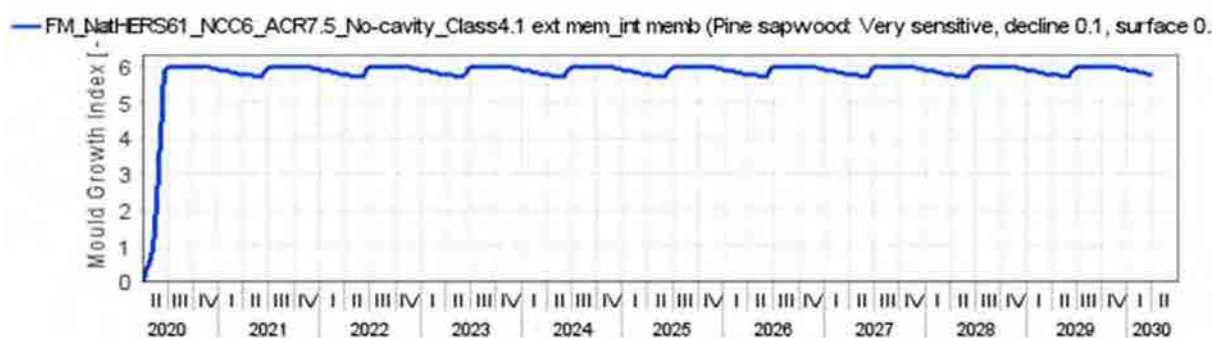
10. No Cavity – Exterior Membrane Class 4 – 175.4 with Internal Membrane

Mould Growth – Mould growth occurs within the insulated timber frame. The Mould Growth Index exceeds 3.0. This wall system may be climatically inappropriate.

Figure 292: Flat Metal Cladding NatHERS CZ 61 - NCC CZ 6 South orientation ACR 7.5 No Cavity – Ext. Memb. Class 4 – 175.4 with Int. Memb. Mould growth within insulated timber frame

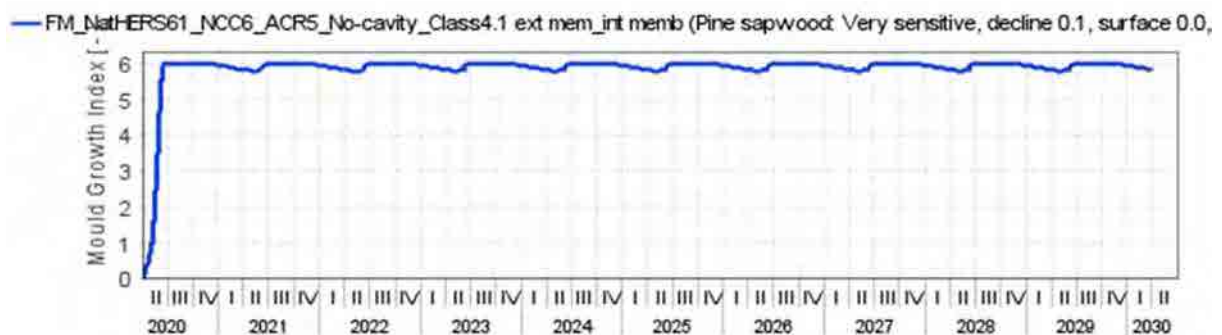
10. No Cavity – Exterior Membrane Class 4 – 175.4 with Internal Membrane

Moisture Accumulation – Nil

Mould Growth – Mould growth occurs within the insulated timber frame. The Mould Growth Index exceeds 3.0. This wall system may be climatically inappropriate.

Figure 304: Flat Metal Cladding NatHERS CZ 61 - NCC CZ 6 South orientation ACR 5 No Cavity – Ext. Memb. Class 4 – 175.4 with Int. Memb. Mould growth within insulated timber frame

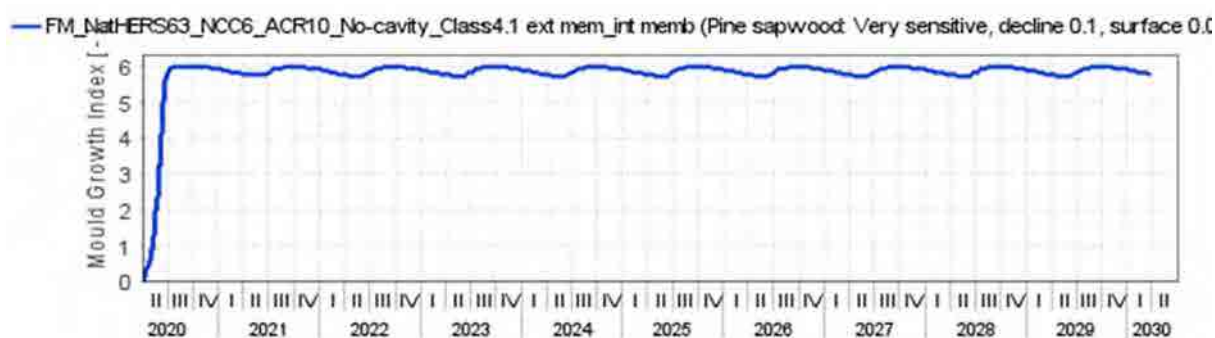
10. No Cavity – Exterior Membrane Class 4 – 175.4 with Internal Membrane

Moisture Accumulation – Nil

Mould Growth – Mould growth occurs within the insulated timber frame. The Mould Growth Index exceeds 3.0. This wall system may be climatically inappropriate.

Figure 316: Flat Metal Cladding NatHERS CZ 63 - NCC CZ 6 South orientation ACR 10 No Cavity – Ext. Memb. Class 4 – 175.4 with Int. Memb. Mould growth within insulated timber frame

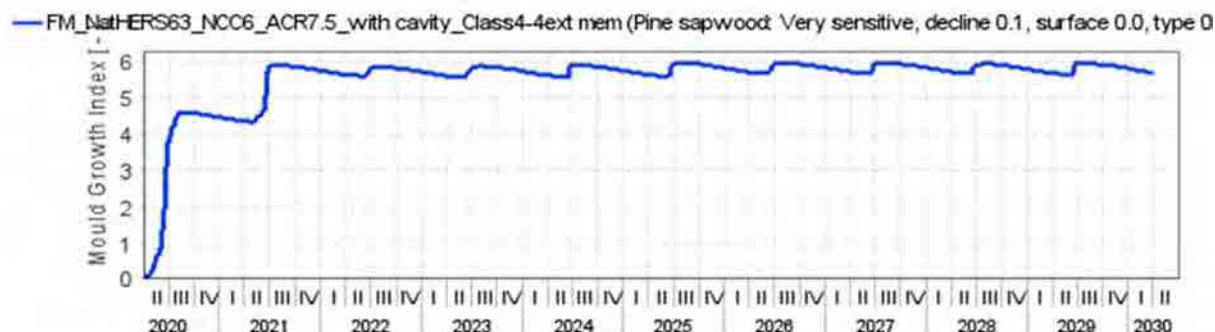
# 7. With Cavity – Exterior Membrane Class 4 – 100

Moisture Accumulation – Nil

Mould Growth – Mould growth occurs within the insulated timber frame. The Mould Growth Index exceeds 3.0. This wall system may be climatically inappropriate.

Figure 325 Flat Metal Cladding NatHERS CZ 63 - NCC CZ 6 South orientation ACR 7.5 With Cavity – Ext. Memb. Class 4 – 100 – Mould growth within insulated timber frame

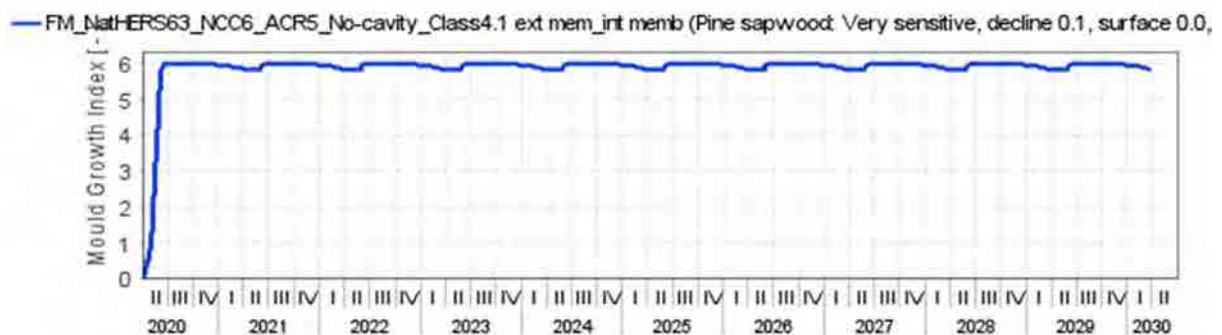
10. No Cavity – Exterior Membrane Class 4 – 175.4 with Internal Membrane

Mould Growth – Mould growth occurs within the insulated timber frame. The Mould Growth Index exceeds 3.0. This wall system may be climatically inappropriate.

Figure 340: Flat Metal Cladding NatHERS CZ 63 - NCC CZ 6 South orientation ACR 5 No Cavity – Ext. Memb. Class 4 – 175.4 with Int. Memb. Mould growth within insulated timber frame

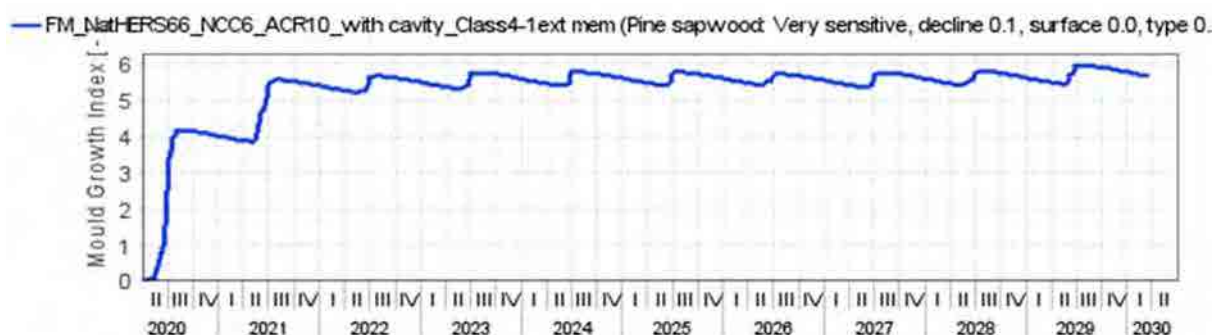
Mould Growth – Mould growth occurs within the insulated timber frame. The Mould Growth Index exceeds 3.0. This wall system may be climatically inappropriate.

Figure 384: Flat Metal Cladding NatHERS CZ 66 - NCC CZ 6 South orientation ACR 10 With Cavity – Ext. Memb. Class 4 – 175.4 – Mould growth within insulated timber frame

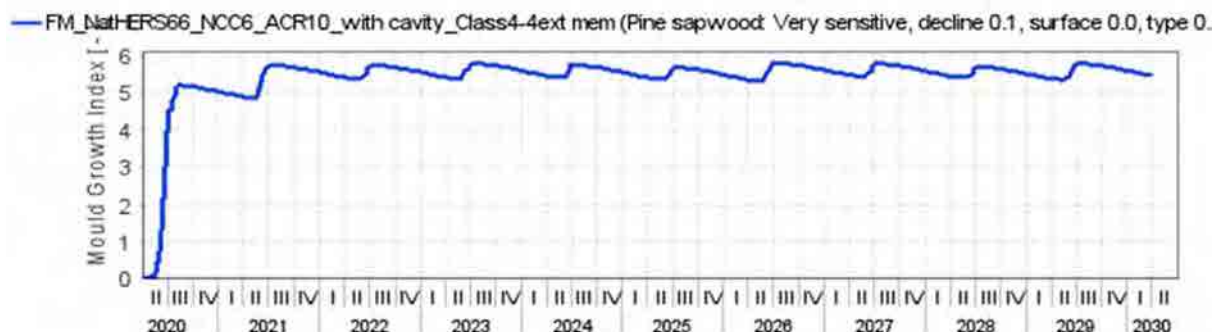
Mould Growth – Mould growth occurs within the insulated timber frame. The Mould Growth Index exceeds 3.0. This wall system may be climatically inappropriate.

Figure 385 Flat Metal Cladding NatHERS CZ 66 - NCC CZ 6 South orientation ACR 10 With Cavity – Ext. Memb. Class 4 – 100 – Mould growth within insulated timber frame

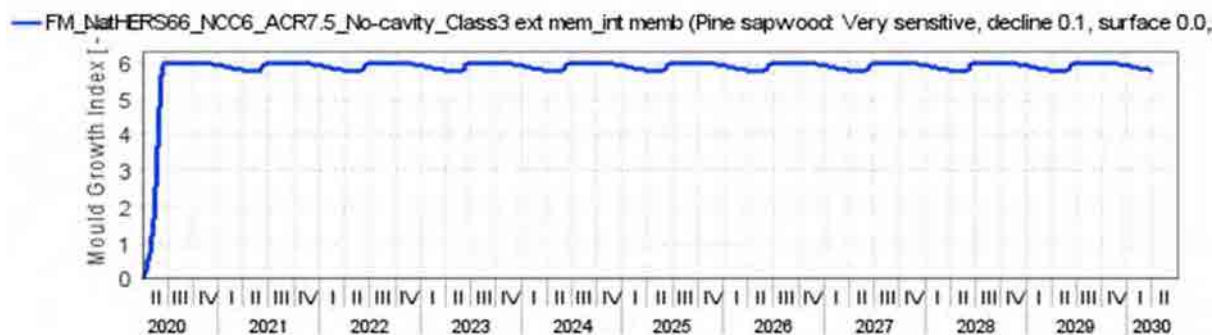
9. No Cavity – Exterior Membrane 1 Class 3 – 1398 with Internal Membrane

Mould Growth – Mould growth occurs within the insulated timber frame. The Mould Growth Index exceeds 3.0. This wall system may be climatically inappropriate.

Figure 399: Flat Metal Cladding NatHERS CZ 66 - NCC CZ 6 South orientation ACR 7.5 No Cavity – Ext. Memb. Class 3– 1398 with Int. Memb. Mould growth within insulated timber frame

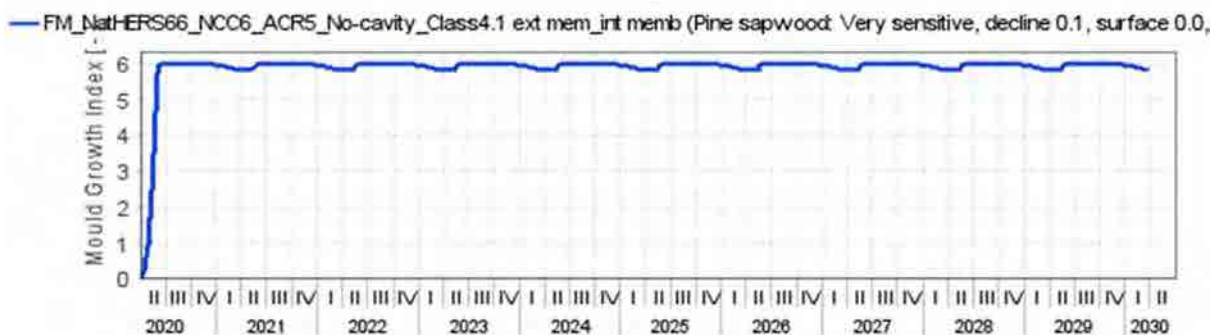
10. No Cavity – Exterior Membrane Class 4 – 175.4 with Internal Membrane

Mould Growth – Mould growth occurs within the insulated timber frame. The Mould Growth Index exceeds 3.0. This wall system may be climatically inappropriate.

Figure 412: Flat Metal Cladding NatHERS CZ 66 - NCC CZ 6 South orientation ACR 5 No Cavity – Ext. Memb. Class 4 – 175.4 with Int. Memb. Mould growth within insulated timber frame
